UNITED STATES
DEPARTMENT OF LABOR
MINE SAFETY AND HEALTH ADMINISTRATION

REPORT OF INVESTIGATION

Fatal Machinery Accident
April 18, 2008

Little Toby Mine
Rosebud Mining Company
6227 Route 219
Brockport, Elk County, Pennsylvania
ID No. 3608847

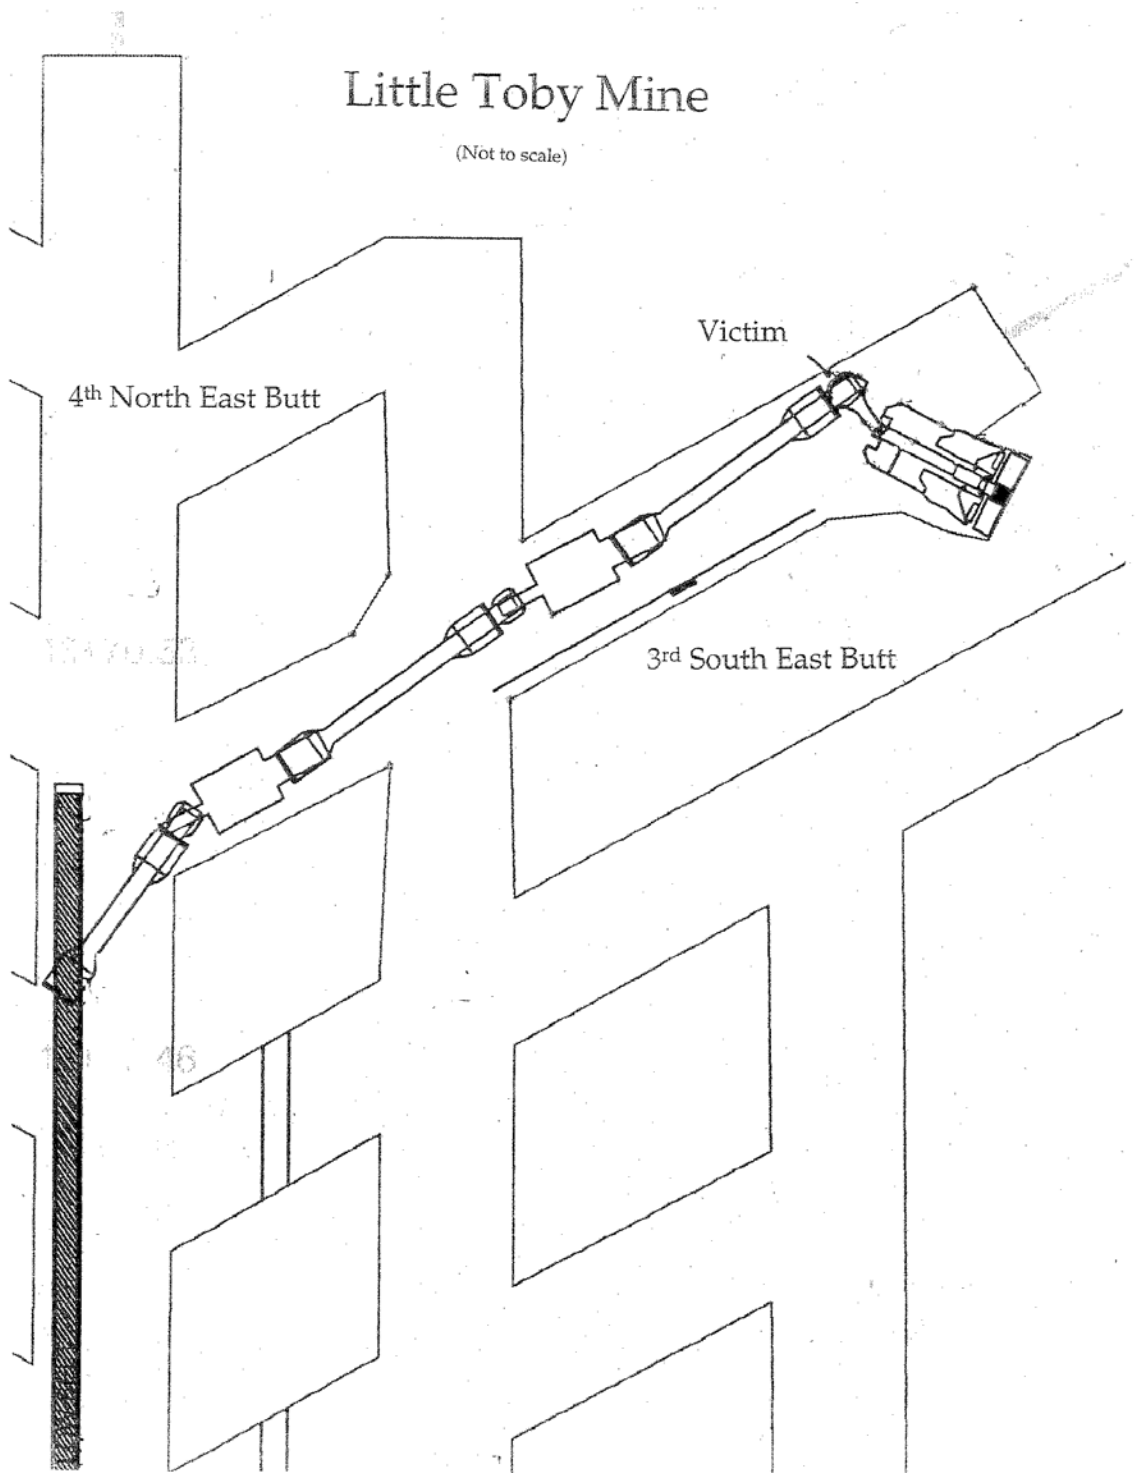
Little Toby Mine

The pre-accident position of the boom and bridge basket (swung outby) provided 24 inches of clearance between the edge of the bridge basket and the mine rib. When the boom and bridge basket were in the post-accident position (swung inby) the clearance

between the edge of the bridge basket and the rib was 7 inches. The measurements were taken at the exact location of the accident pinch point.

During the reenactment, it was found that when the boom of the mining machine was in the outby, or pre-accident position, the skid plate underneath the front of the inby bridge was in a hole in the mine floor. The hole measured from 4 ½ to 6 inches in depth and the same length and width of the skid plate.

Through the reenactment process it was determined that the skid plate on the front of the inby bridge positioned in the hole in the mine floor inhibited the swinging of the mining machine boom into the desired inby, or post- accident position. As attempts were made to swing the boom, the skid plate came out of the hole allowing the boom to swing abruptly inby to the post-accident position. This abrupt movement reduced the distance between the basket and the rib at the accident pinch point from 24 inches to 7 inches.
