REPORT OF INVESTIGATION

**FALL OF ROOF ACCIDENT
April 22, 2008**

**Mine No. 1
Osaka Mining Corporation
Appalachia, Wise County, Virginia
ID No. 44-07150**

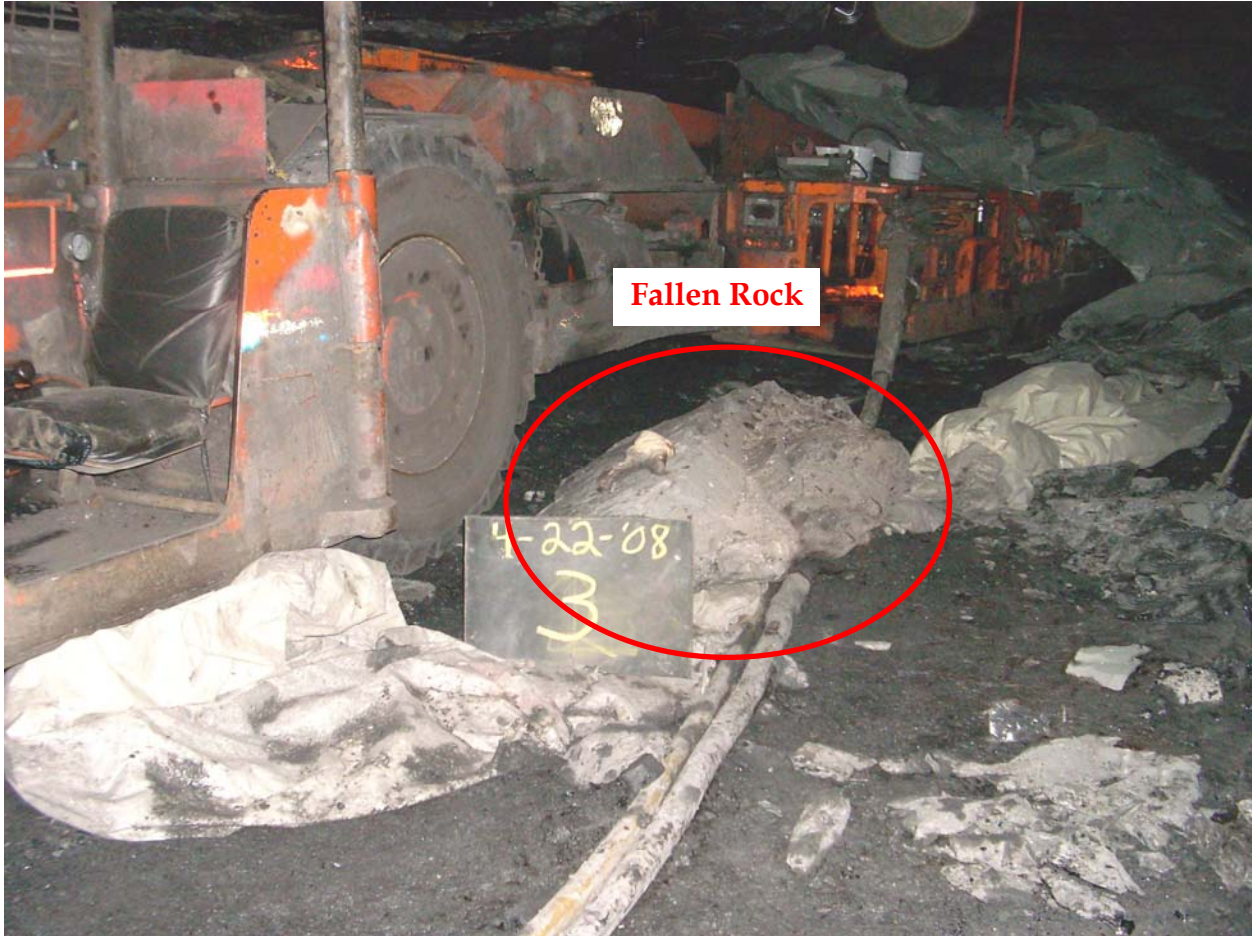
The portion of the mine roof and rib that fell striking both miners, measured approximately 6 feet long by 3 feet wide at the inby end and 19 inches wide at the outby end by 0-14 inches thick, see Appendix B - Photograph 1. Sandstone has a density of approximately 145 pounds per cubic foot. The rock is about 5.44 cubic feet which corresponds to a weight of about 790 pounds.

Photograph 1 - Fallen Roof and Rib Rock

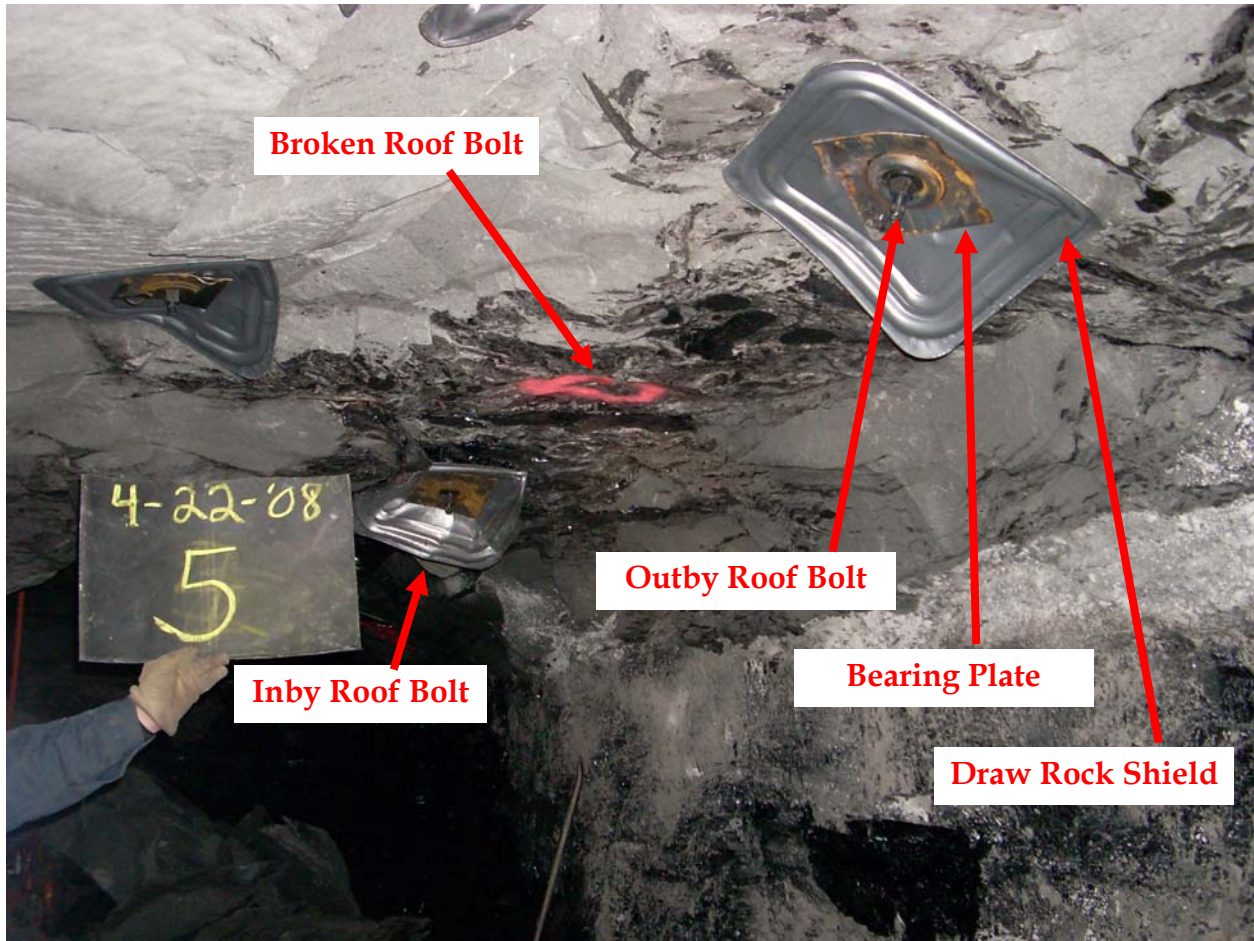
The three roof bolts surrounding the rock were not installed through it. These bolts had bearing plates and draw rock shields. The edges of the draw rock shields on the inby and outby roof bolts that were closest to the rock were bent downward; indicating the rock was partially over these shields. The edges of the draw rock shield and bearing plate attached to the middle roof bolt that were closest to the rock were also bent downward. The middle roof bolt broke as a result of the fall. This indicates the edge of the rock was over more of the draw rock shield and bearing plate (see Appendix B - Photograph 2).

Photograph 2 - Roof and Rib Fall Cavity with Roof Bolts

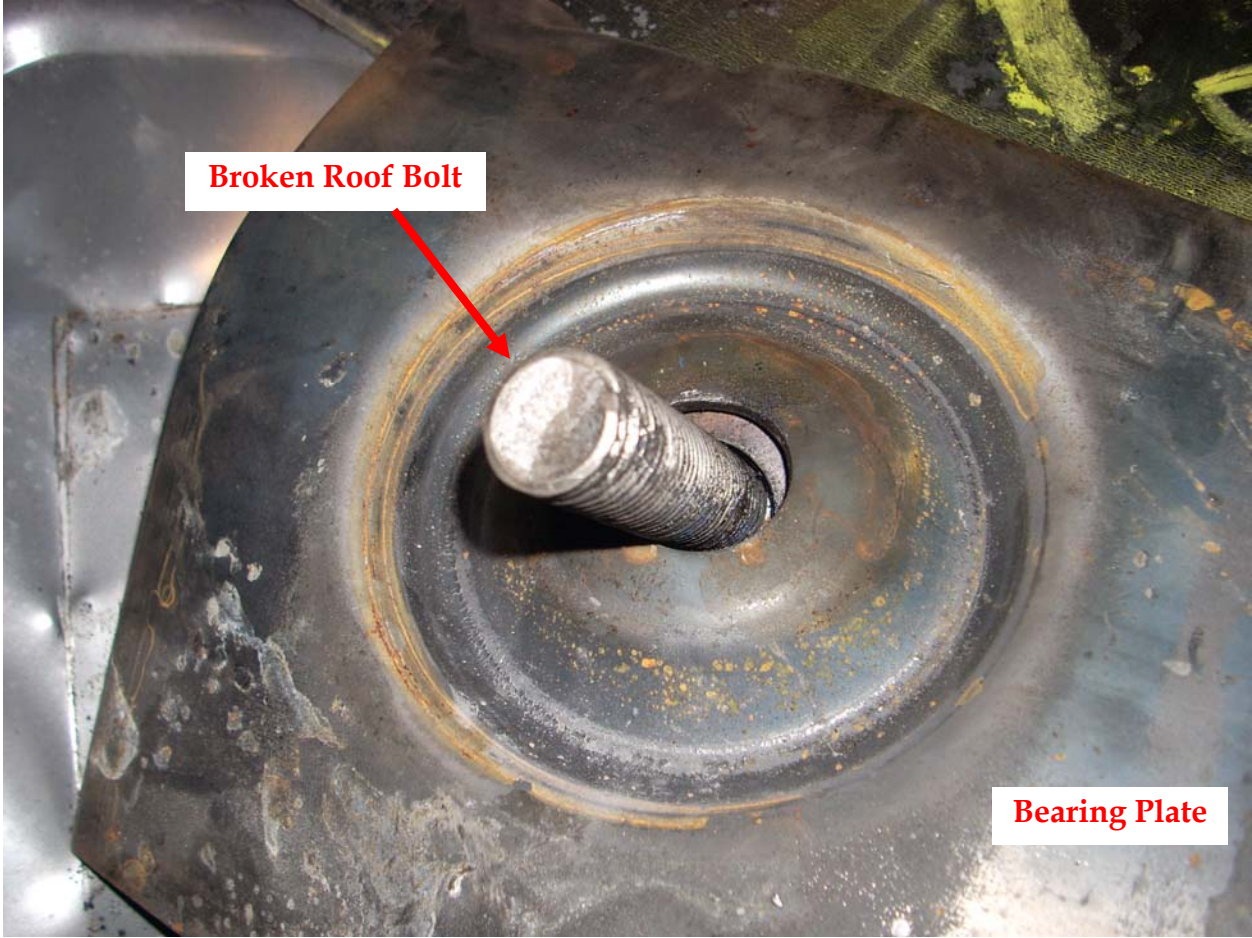
Personnel from the MSHA Approval and Certification Center (A&CC) examined the broken bolt, bolt plate and draw rock shield on June 3, 2008. The middle roof bolt broke 5 inches from the head-end of the bolt, where the threads of the bolt end (see Appendix B - Photograph 3). Examination of the roof bolt piece revealed it was bent. The bend may have occurred during installation of the bolt. Also, examination of the roof bolt piece, bearing plate and draw rock shield showed that no damage had occurred to them from moving equipment or other sources. The full report, indexed under PAR No. 95335, can be obtained from A&CC.

1. The failed bolt met the applicable specification requirements identified in ASTM F432-95.
2. The failure occurred due to brittle fracture that resulted from a combination of poor fracture toughness properties of the bolt material, coupled with the presence of a large notch defect introduced during installation.

3. Low material strength contributed to formation of the notch defect during installation. The evaluation of the bolt suggests it was subject to a larger bend angle than ten degrees, however, the actual value is not accurately known. Insufficient controls on the chemical composition allowed for poor fracture toughness properties.
4. A combination of melt practice and chemical composition modifications are warranted to improve the bolt strength and fracture toughness.
5. A detailed review of all applicable specification requirements is strongly recommended to eliminate similar failures in the future.

Photograph 3 - Broken Roof Bolt

Corrective Action: The mine operator has included a specialized washer into the assembly of all pattern bolts. This washer reduces the bending affect on the roof bolt during its installation. Also, current with the release of this report, MSHA is developing an informational bulletin to emphasize the importance of the use of compensating devices required by 75.204(f)(8) to mitigate against the possibility of notch defects occurring during installation.

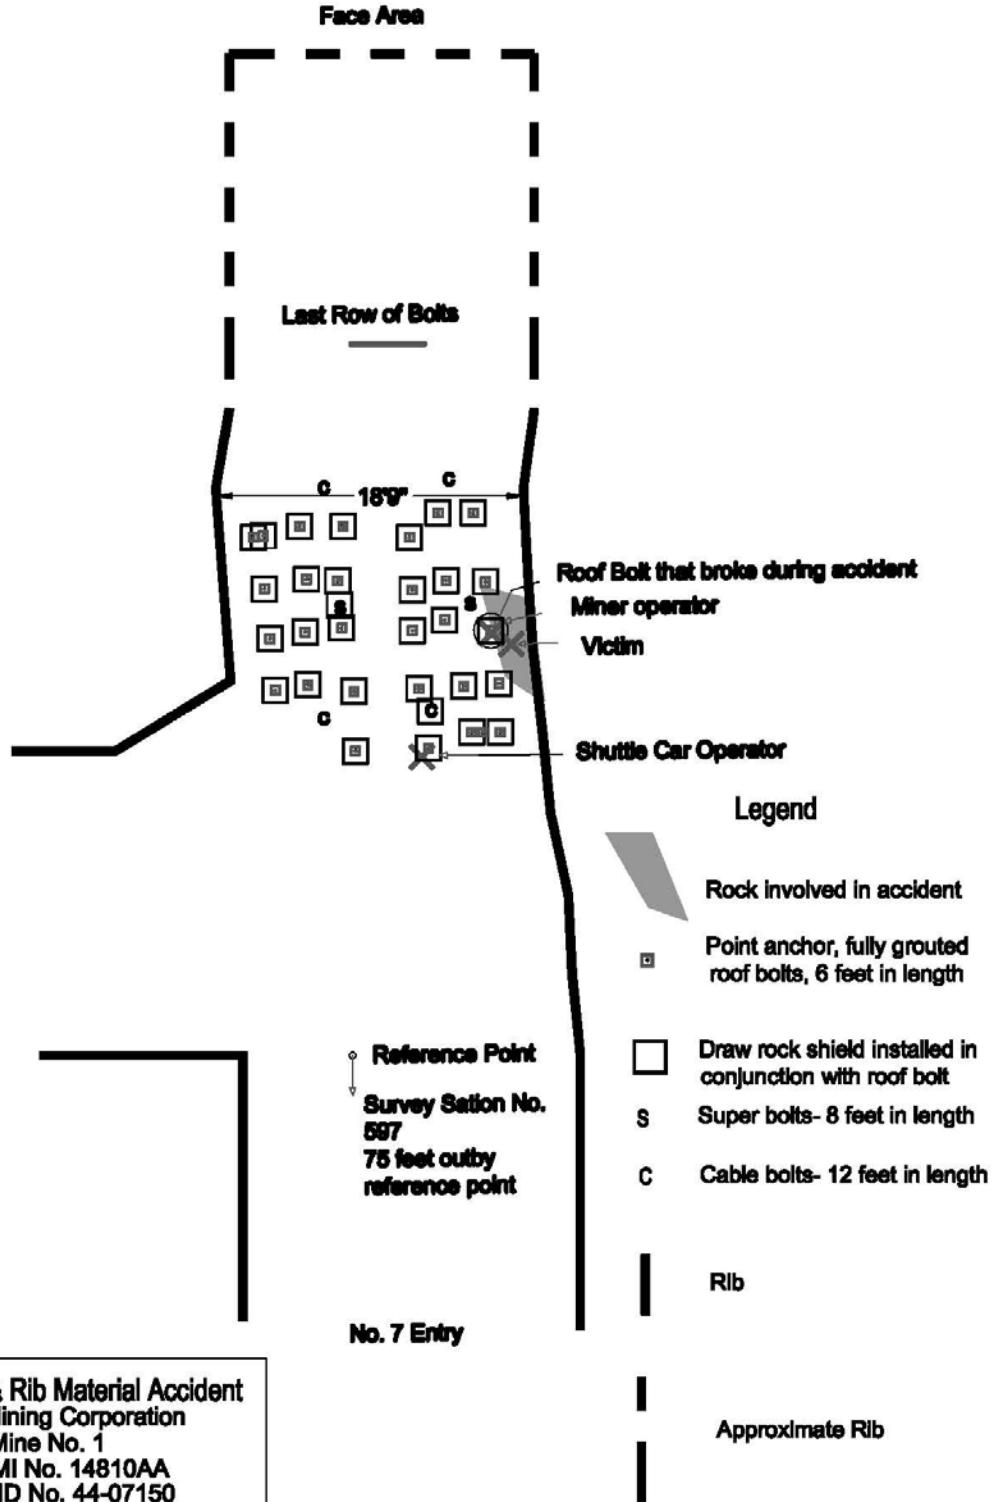
Fall of Roof and Rib Accident
Before Fall

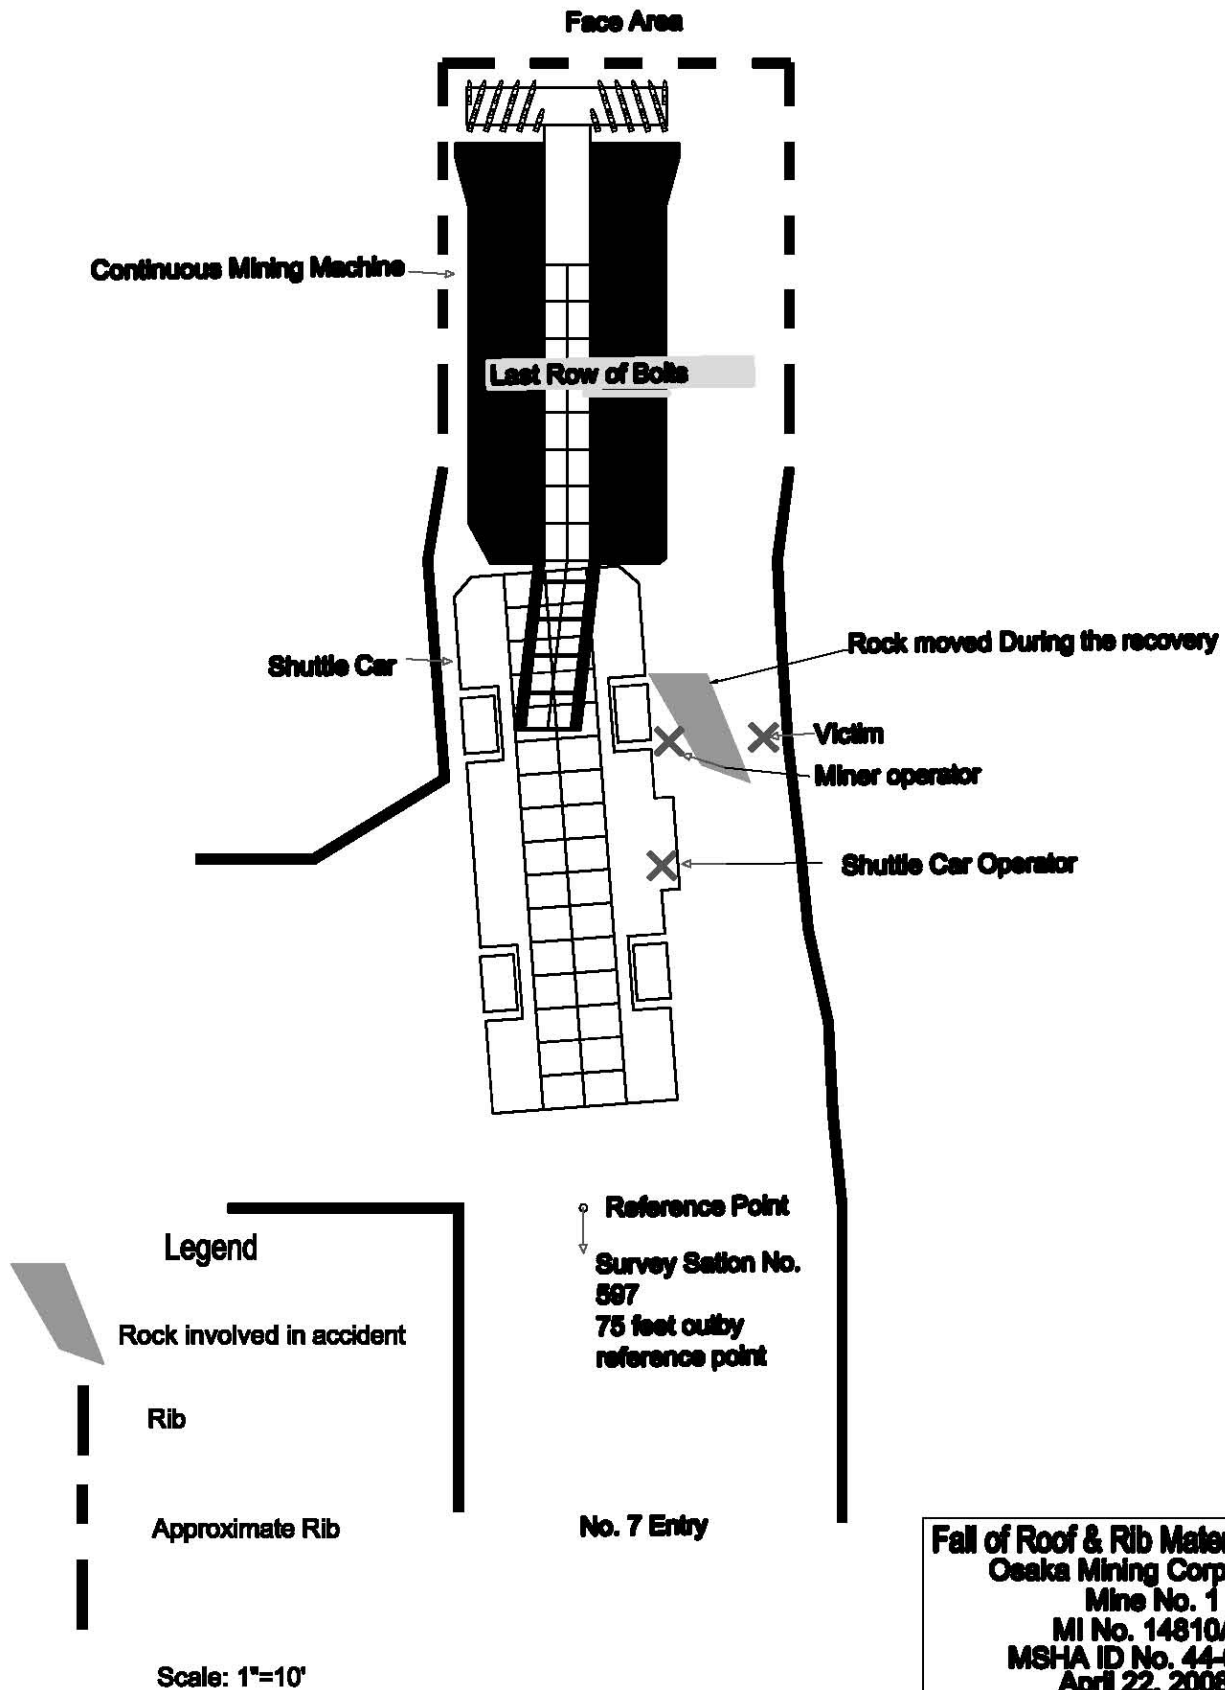
Fall of Roof and Rib Accident After Fall
