**REPORT OF INVESTIGATION**

**Fatal Powered Haulage Accident  
May 22, 2008**

**Oak Grove Resources LLC  
Oak Grove Mine  
Adger, Jefferson County, Alabama  
I.D. No. 01-00851**

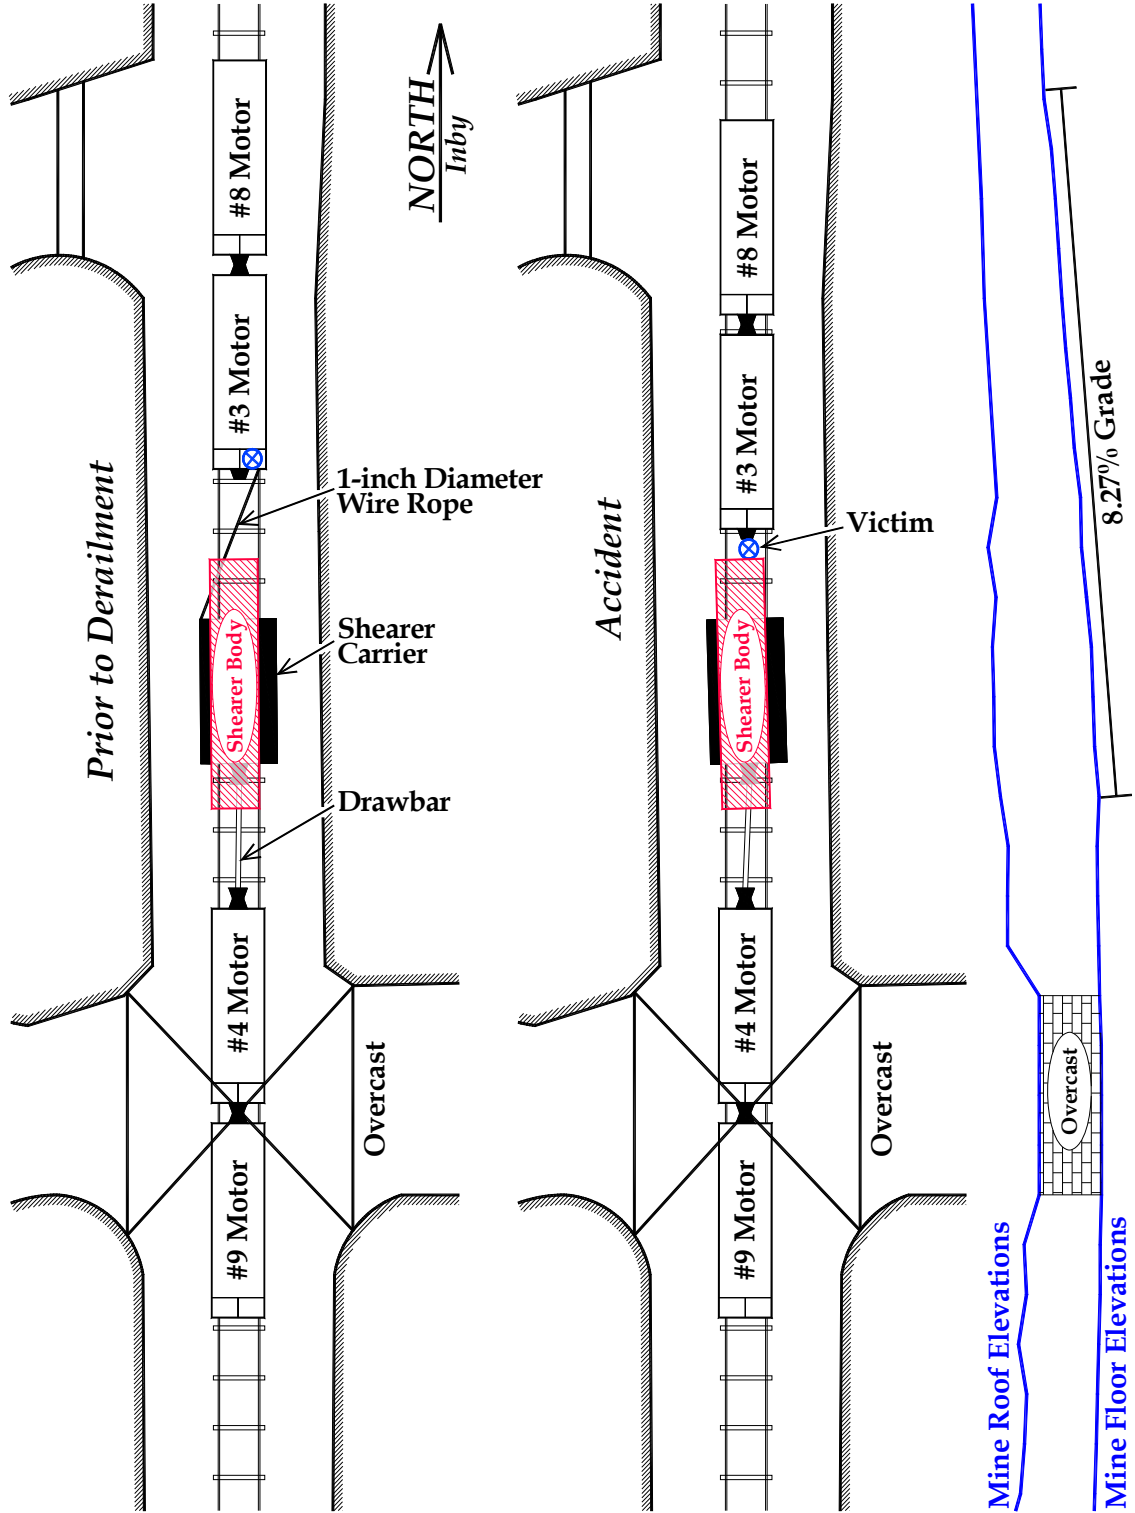
Accident Scene Sketch  
(no scale)

On Thursday, May 22, 2008, Lee Graham (victim) and three other motormen were transporting a longwall shearer body along the main track haulage road from the bottom area to the 12-West Longwall set-up. The shearer body was being transported on a carrier designed specifically for the job. The order of the motors, by company number, and carrier from the inby end to the outby end was: #8 motor (operated by Kevin Prunesti), #3 motor (operated by Graham), shearer carrier, #4 motor (operated by Alfred Purifoy), and #9 motor (operated by Garey Vincent). Chad Johnson, Assistant General Mine Foreman, was a passenger on the #4 motor. The #4 and #9 motors were coupled together and the #3 and #8 motors were coupled together (see APPENDIX B).

The #3 motor was attached to the shearer carrier by a one-inch diameter wire rope from the east outby end of the motor to the west inby end of the carrier. This wire rope was used to help guide the carrier, particularly around curves, and to prevent derailments by using tension. The #8 motor was coupled to the inby end of the #3 motor. (see APPENDIX B)

The area was surveyed following the accident. The track is on an uphill grade of 8.27% inby the low area. Following the derailment of the shearer carrier, the #3 and #8 motors were stopped on this grade. (see APPENDIX B)
