**UNITED STATES  
DEPARTMENT OF LABOR  
MINE SAFETY AND HEALTH ADMINISTRATION**

**COAL MINE SAFETY AND HEALTH  
REPORT OF INVESTIGATION**

**Fatal Powered Haulage Accident  
May 30, 2008**

**Sentinel Mine  
Wolf Run Mining Company  
I.D. No. 46-04168**

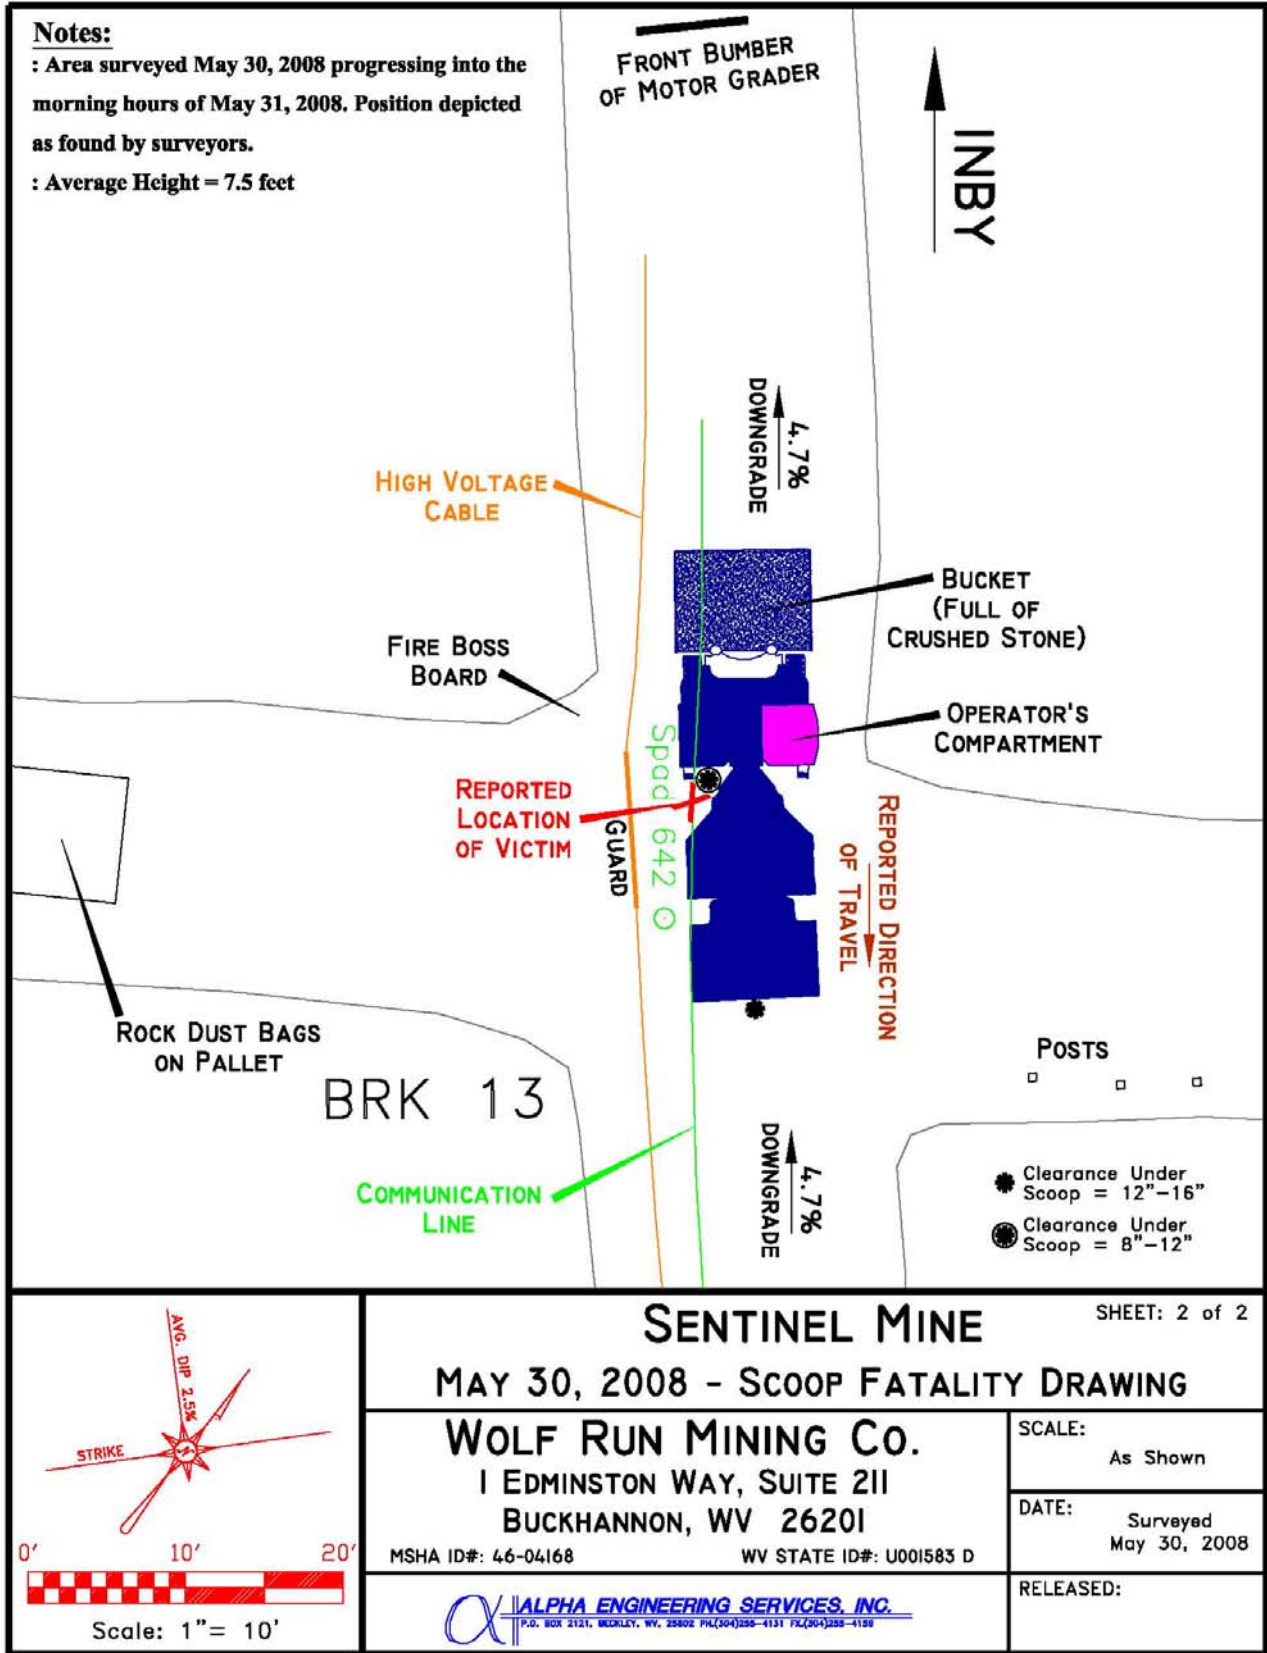
APPENDIX B  
Drawing 1

On Friday, May 30, 2008, at approximately 2:37 p.m., Adam Lanham, an 18-year old General Inside Laborer was struck and fatally injured by a Fairchild 35C-WH scoop. Lanham, a contractor employed by Mine Temp, LLC had approximately 33 days experience in the mining industry. The victim had been assigned to assist two other miners in repairing the haul road in the No. 5 entry of the North West Mains area of the mine. The men were traveling to the No. 12 block to repair the roadway (this would be the last area to be repaired on the shift). The victim was walking in the outby direction and was being followed by the scoop which was being followed by a diesel road grader. The scoop inadvertently struck the victim at the No. 13 block intersection causing fatal injuries (see attached drawing - Appendix B).

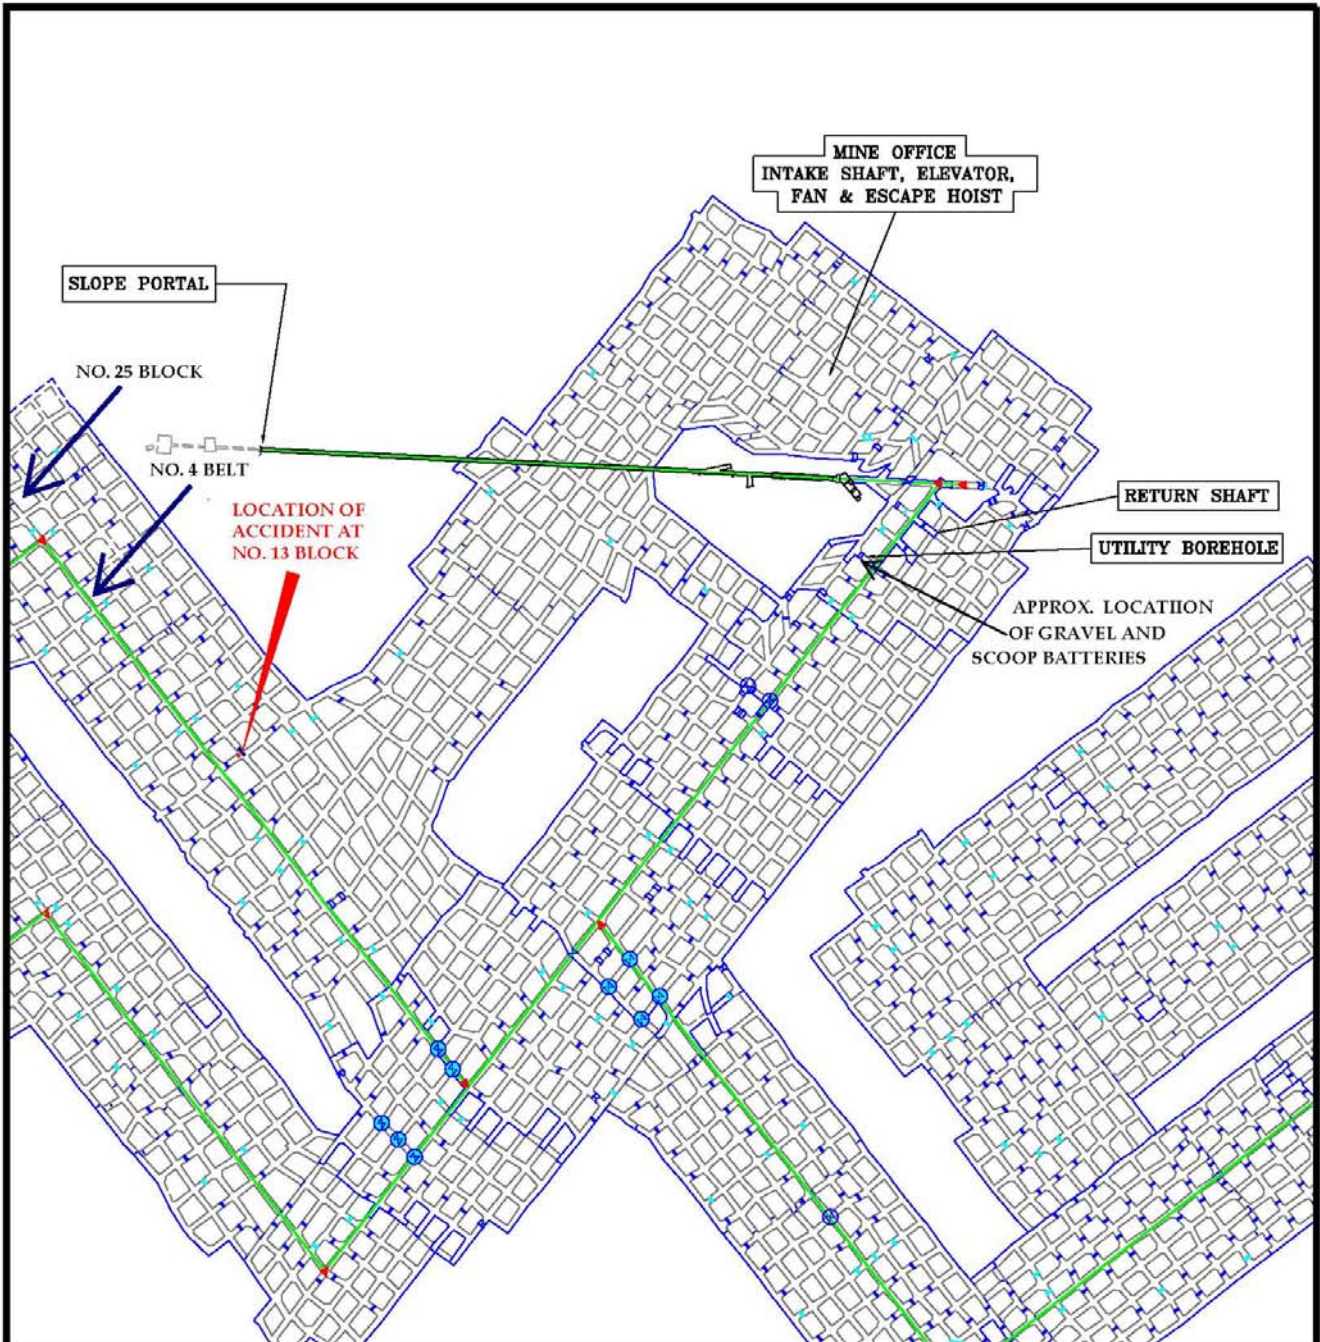
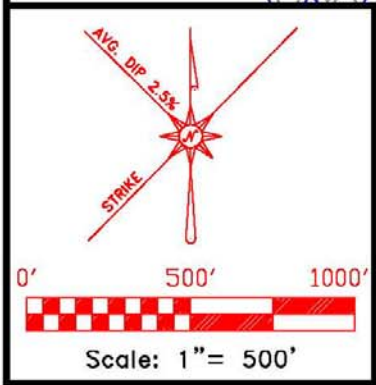
APPENDIX C  
Drawing 2

Lanham boarded Weaver's battery operated personnel carrier and they proceeded ahead of Jackson. Weaver dropped off Lanham at the No. 4 block adjacent to the No. 5 conveyor belt (See Appendix C for an overview of the area). Weaver left Lanham in the company of Robert Fitchett, Grader Operator, because Lanham was a red hat/miner trainee and state regulations prohibited him being alone. Fitchett had been operating a diesel powered road grader repairing haulage roads in the area and was waiting at the No. 4 block for Jackson to deliver a load of gravel. A short time later, he arrived with the load of gravel to repair the haulage road.
