REPORT OF INVESTIGATION

Fatal Machinery Accident  
June 3, 2008

Gopher Contracting (R828)

Premier Elkhorn Coal Company  
Job 49  
Myra, Pike County, Kentucky  
I.D. No. 15-18946

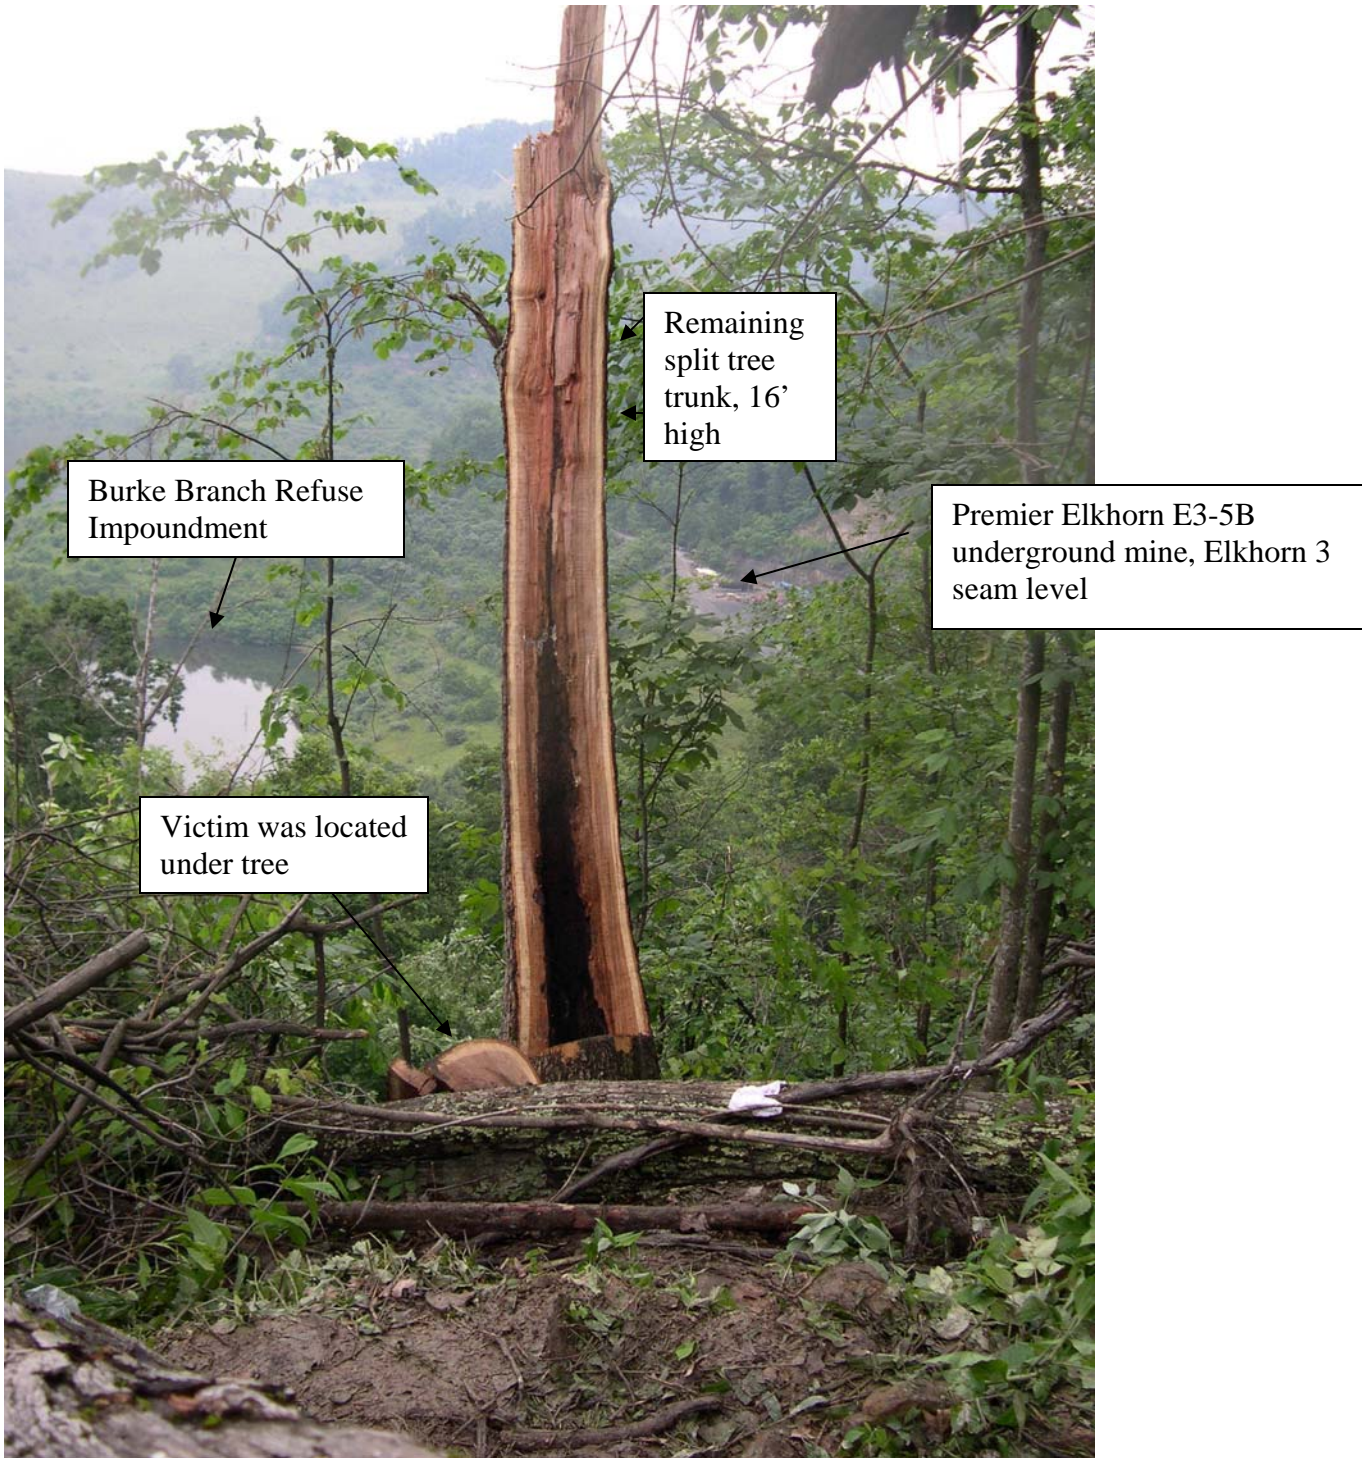
Photo of Accident Scene  
Premier Elkhorn Coal Company, Job 49  
MSHA I.D. No. 15-18946  
Gopher Contracting (R828)  
June 3, 2008

At approximately 11:47 a.m., on Tuesday, June 3, 2008, William S. Hill, a 33-year old tree cutter for Gopher Contracting, Contractor I.D. R828, received fatal injuries when the tree which he was in the process of felling, split and fell on him. Hill had approximately 10 years experience in tree cutting according to testimony, 6 days with this contractor and two days at this mine. Hill had completed a notch cut from the downhill side of the tree and was making the final back cut when the tree split. The tree was approximately 27 inches in average diameter, had an approximate ten-inch diameter hollow center, and was leaning downhill approximately 19 degrees. As the back cut proceeded into the hollow center, the tree split sixteen feet high before breaking off and falling on the victim.

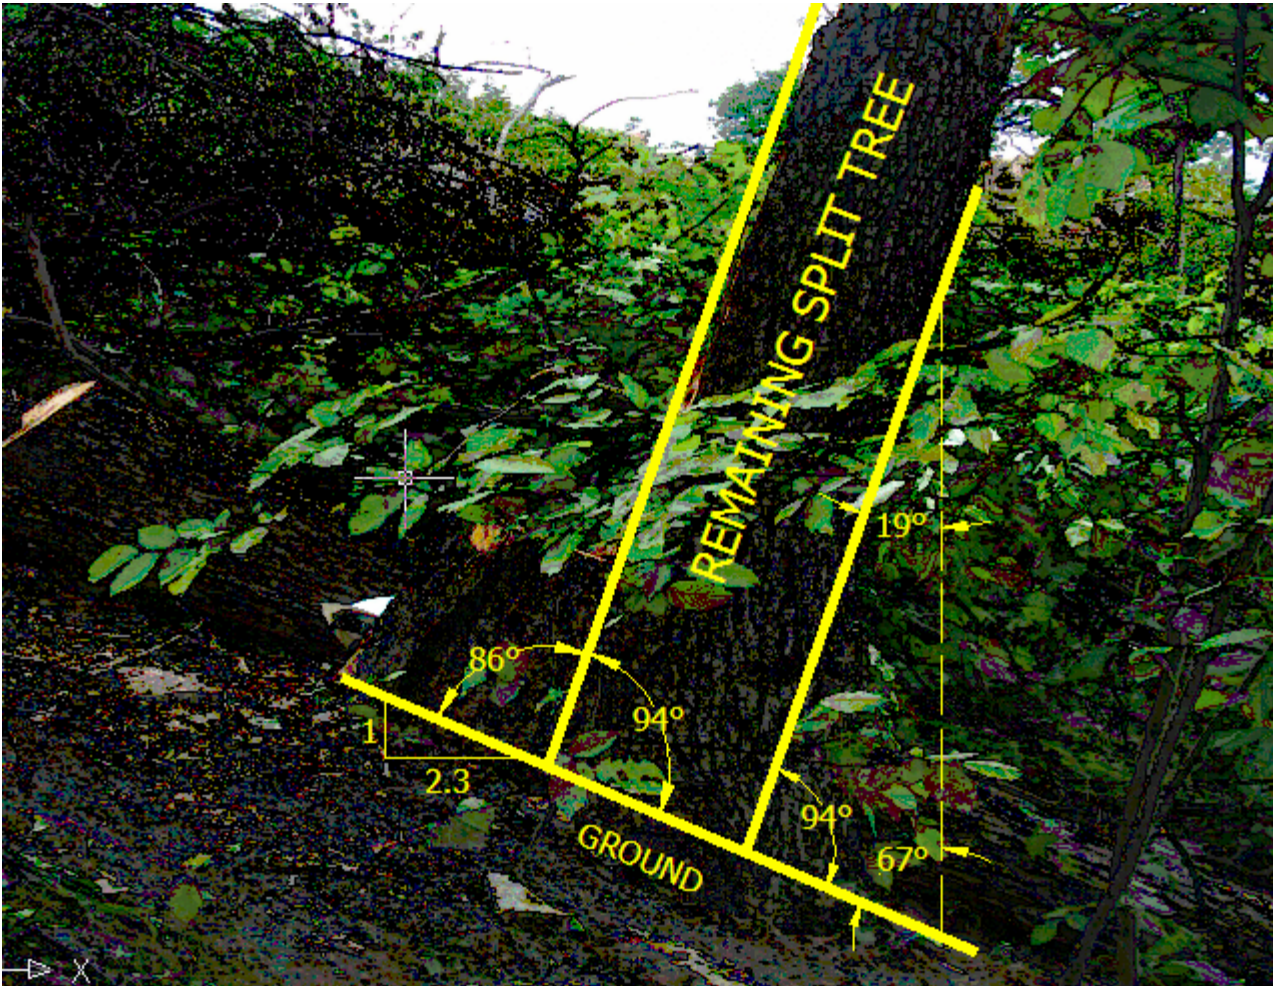
The tree being cut by Hill when the accident occurred was a white oak approximately 70 feet high and 27 inches in average diameter. The tree was leaning down slope approximately 19 degrees and was heavily branched in the upper portion, making it top-heavy. In addition, the tree had an approximate ten-inch diameter hollow center, which was likely unknown to Hill prior to cutting the tree.

Photo 1 Orientation of tree and ground slope

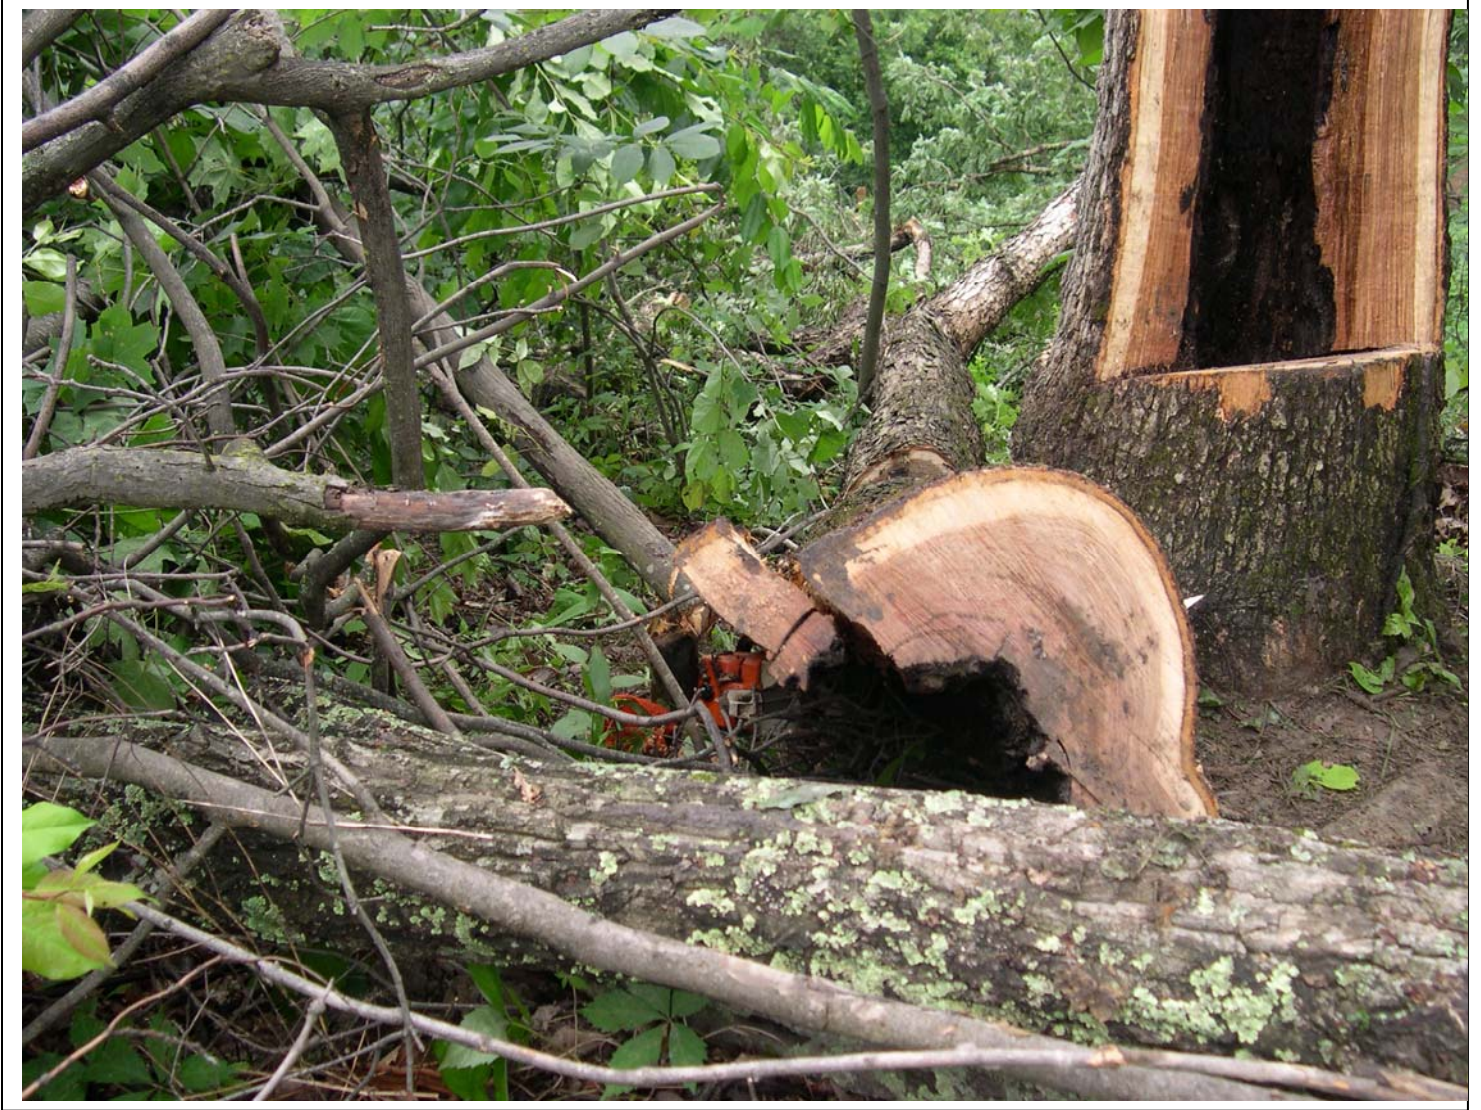
3. A clear escape route from the base of the tree was not provided. Brush and small trees were present to Hill's backside and a fallen tree was lying on the ground immediately above Hill's location. The ground slope was steep (approximately 23 degrees), which made it difficult to retreat from the tree in the uphill direction.

**Photo 2 View showing fallen timber and brush blocking escape route. Victim's chainsaw is located under the tree.**

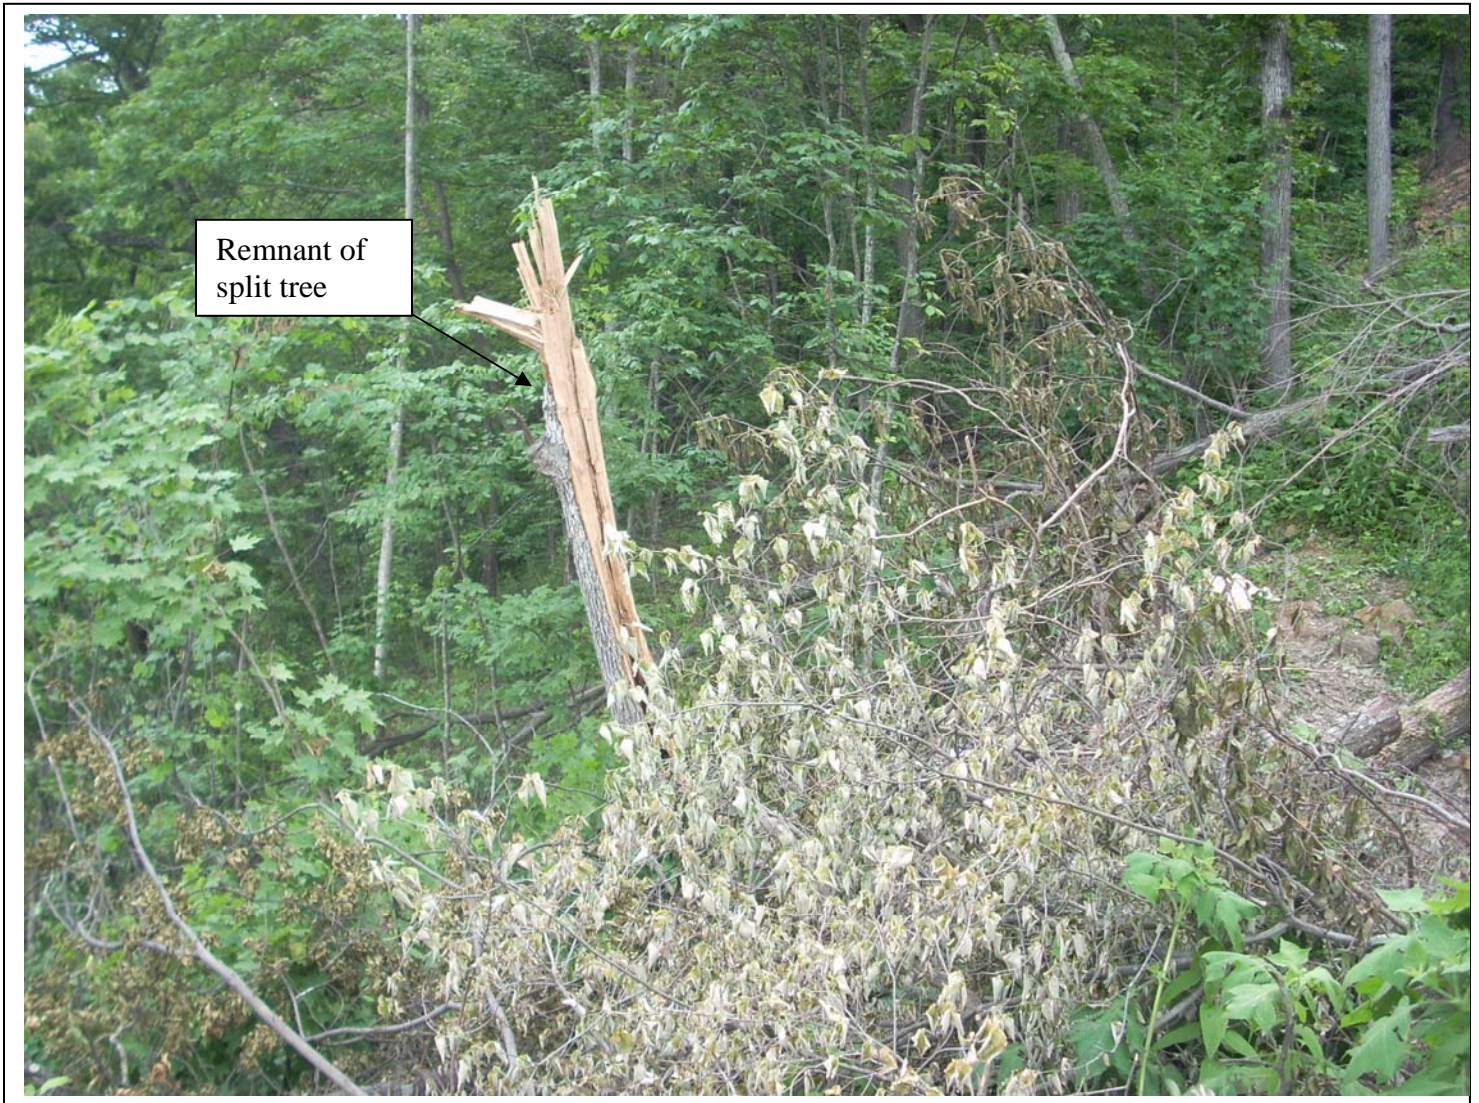
**Photo 3 View from side showing uncleared area in background of accident site. Note the lean of the split tree compared to standing trees in background**

The size, top-heavy shape, and lean of the tree that Hill was cutting made it a dangerous tree. Evaluation of the tree should have resulted in a decision to fell the tree by mechanical means. A dozer or excavator could have been used to push the tree down. However, Gopher Contracting employees stated during interviews that they believed every tree had to be cut down with a chainsaw.

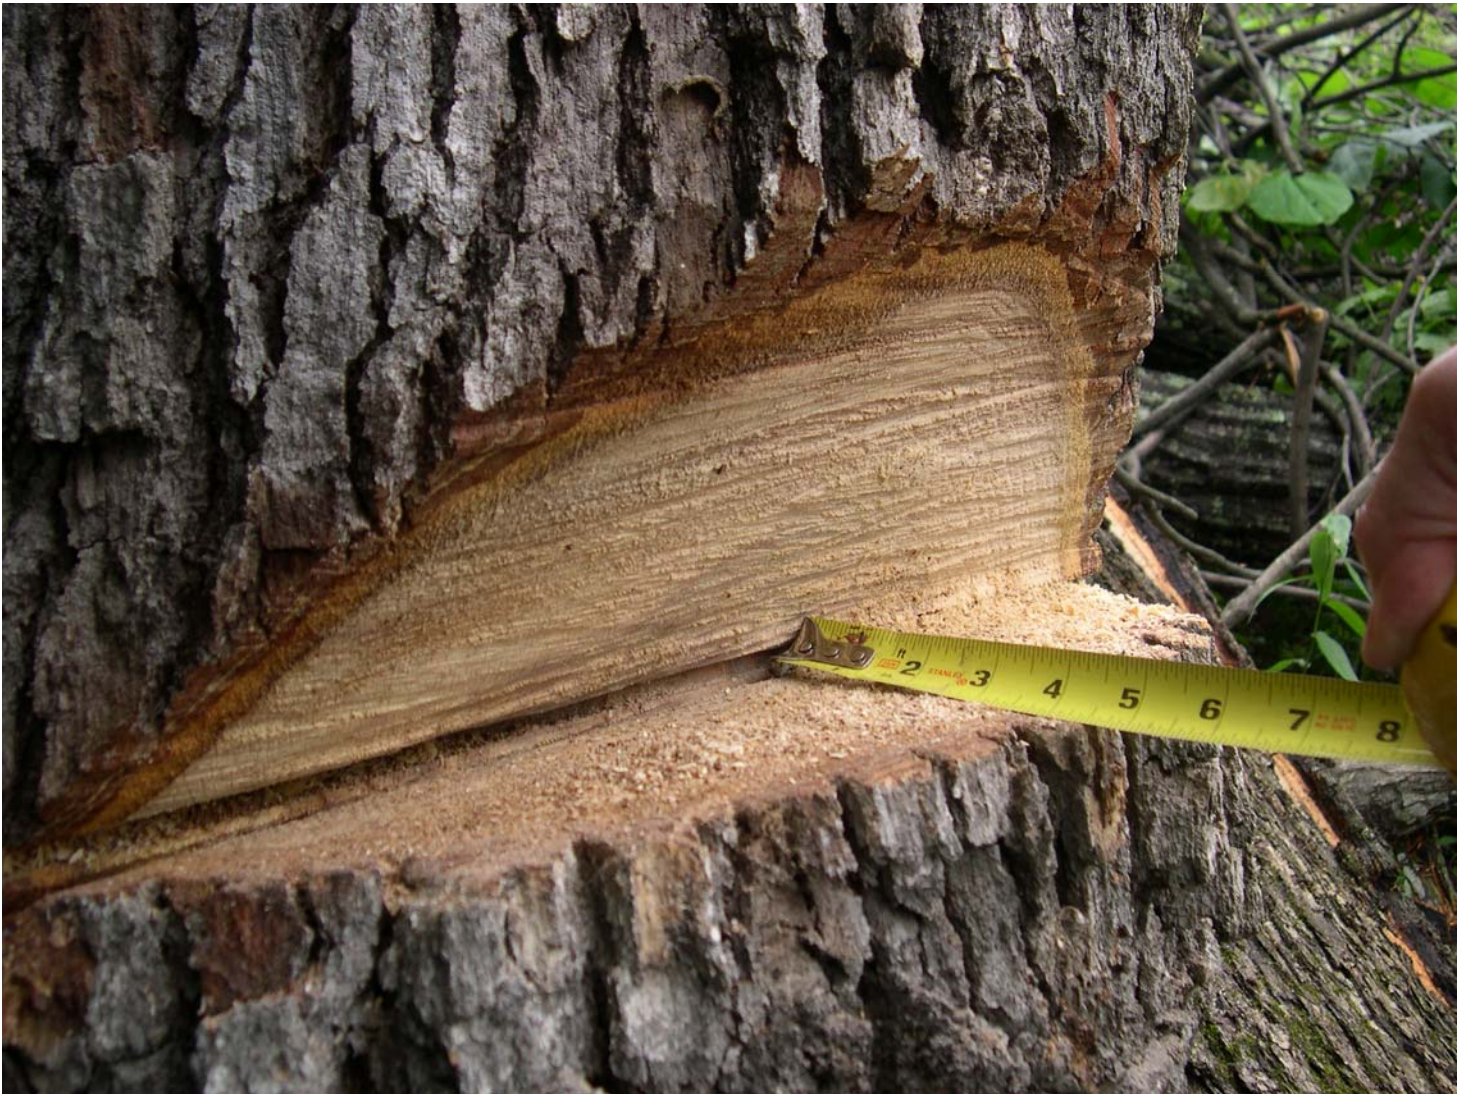
1. The notch on the downhill (intended direction of fall) side was less than 25 percent of the 27-inch diameter. The notch was only four inches deep. The angle of the notch was approximately 54 degrees,
2. A bore cut through the center of the tree was not used after completing the notch. In this case, with the center of the tree being hollow, a proper hinge could not have been developed. Had a bore cut been used, Hill would likely have realized the tree was hollow and had time to disengage the chainsaw and

**Photo 4 Dimension of notch cut on lower side of split tree**

3. Proper tree cutting procedures require that an uncut hinge of wood be provided when felling a tree in order to guide the fall of the tree and hold it to the stump during most of the duration of the fall. The hinge should be a thickness of at least 10 per cent of the diameter of the tree. The procedure for developing the hinge is to first make a notch cut on the side of the tree in the desired direction of fall. The notch cut should be of a depth equal to 25 percent of the tree diameter and the angle created should be at least 70 degrees, 90 degrees is recommended. In order to assure that a proper hinge is provided on a large tree, a bore cut through the center of the tree, leaving the hinge, should be made after the notch is completed. The final cut should be made by either continuing the bore cut through the back of the tree or by starting a level final cut from the back side of the tree into the bore cut.

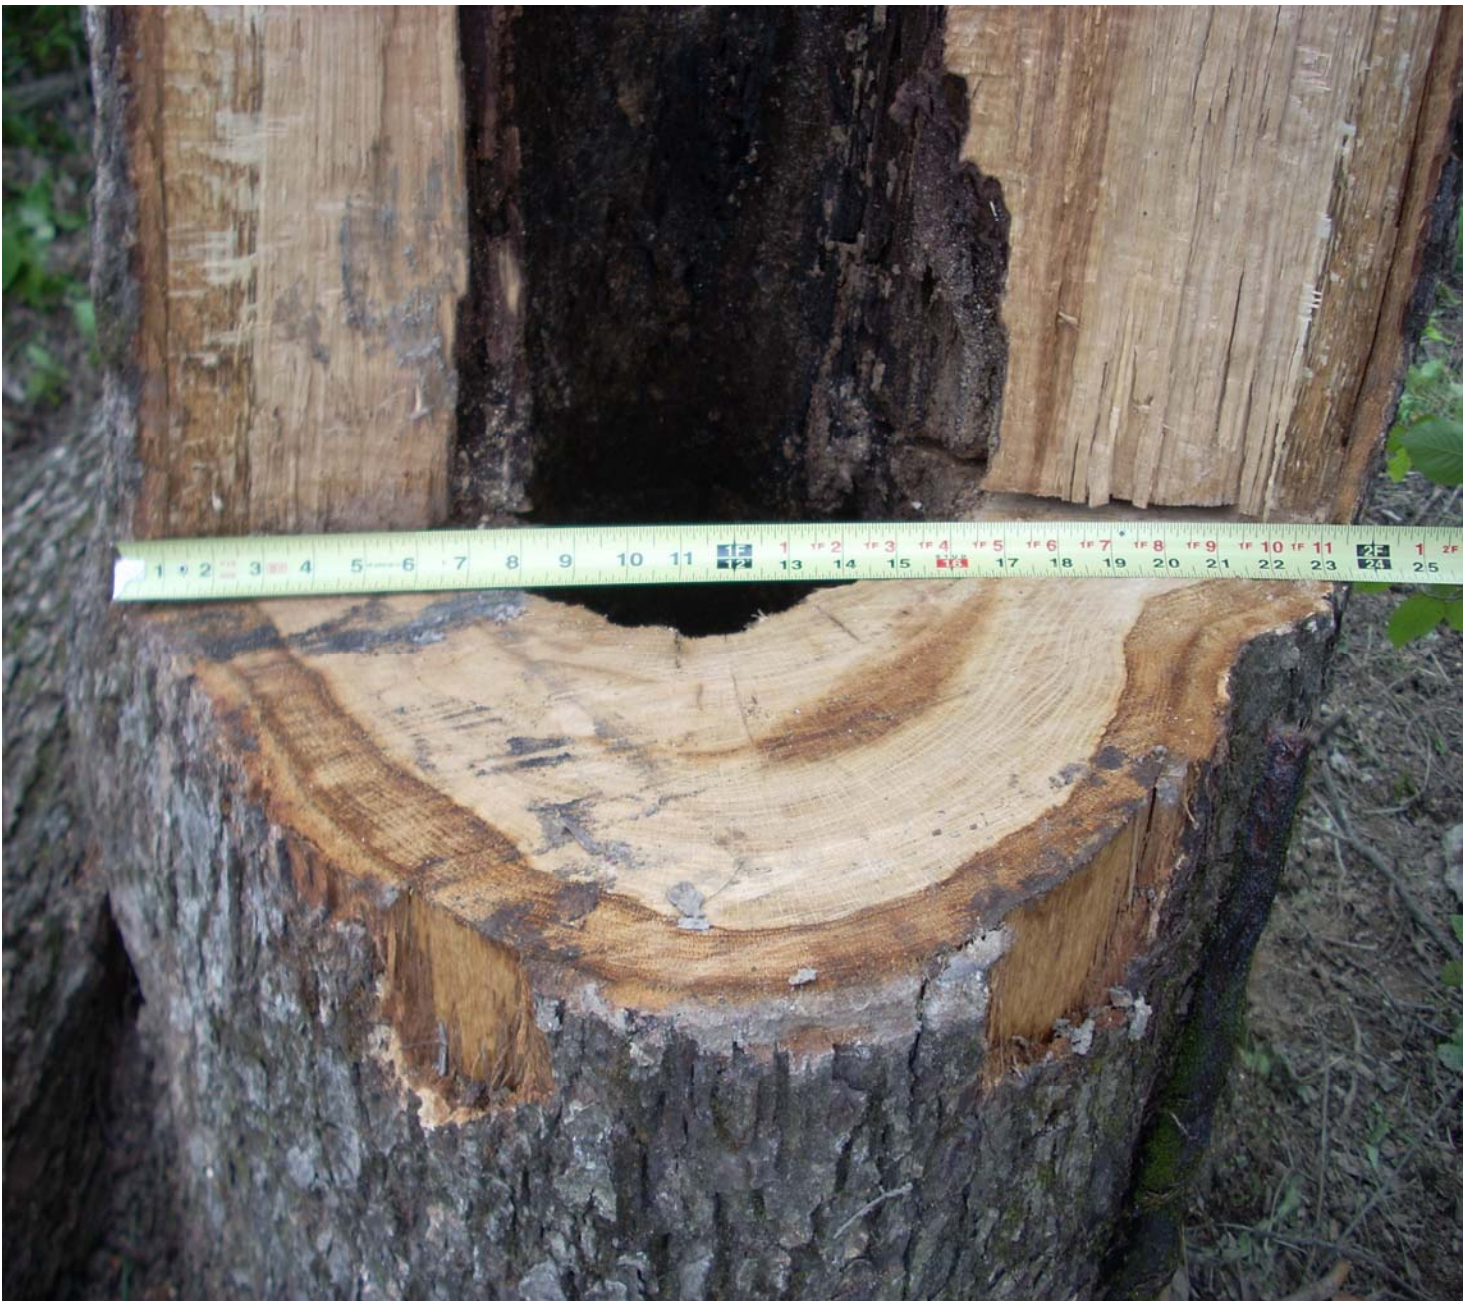
**Photo 5 Dimensions of tree diameter and hollow area**
