REPORT OF INVESTIGATION

Fatal Powered Haulage Accident July 17, 2008

Butcher Branch Mine Century Operations LLC Beverly, Bell County, Kentucky MSHA ID 15-18924

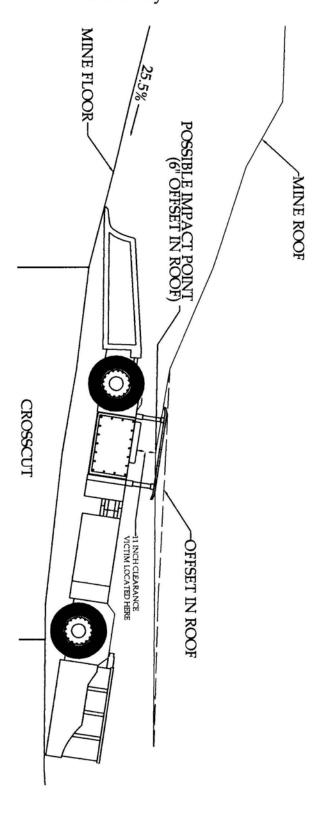
SKETCH OF ACCIDENT SITE Butcher Branch Mine At Survey Station #919

The accident occurred at Survey Station #919 in the No. 6 entry of the 001/MMU (mechanized mining unit) panel. A dip in the coal bed had occurred at this area which created a slope of approximately 25.5 % degrees. An offset brow was present in the mine roof at the bottom of the dip area. A single layer of rock dust bags, approximately 3 ½" thick, were stacked atop the scoop. The victim was riding on top of the rock dust bags. The distance between the offset brow and the layer of rock dust bags was less than eleven inches, which was not sufficient clearance.
