REPORT OF INVESTIGATION

Fatal Powered Haulage Accident  
August 22, 2008

B & L Trucking (L444)  
Varney, WV

No. 65 Mine  
Double Bonus Coal Company  
Wyoming County, WV  
ID No.46-09020

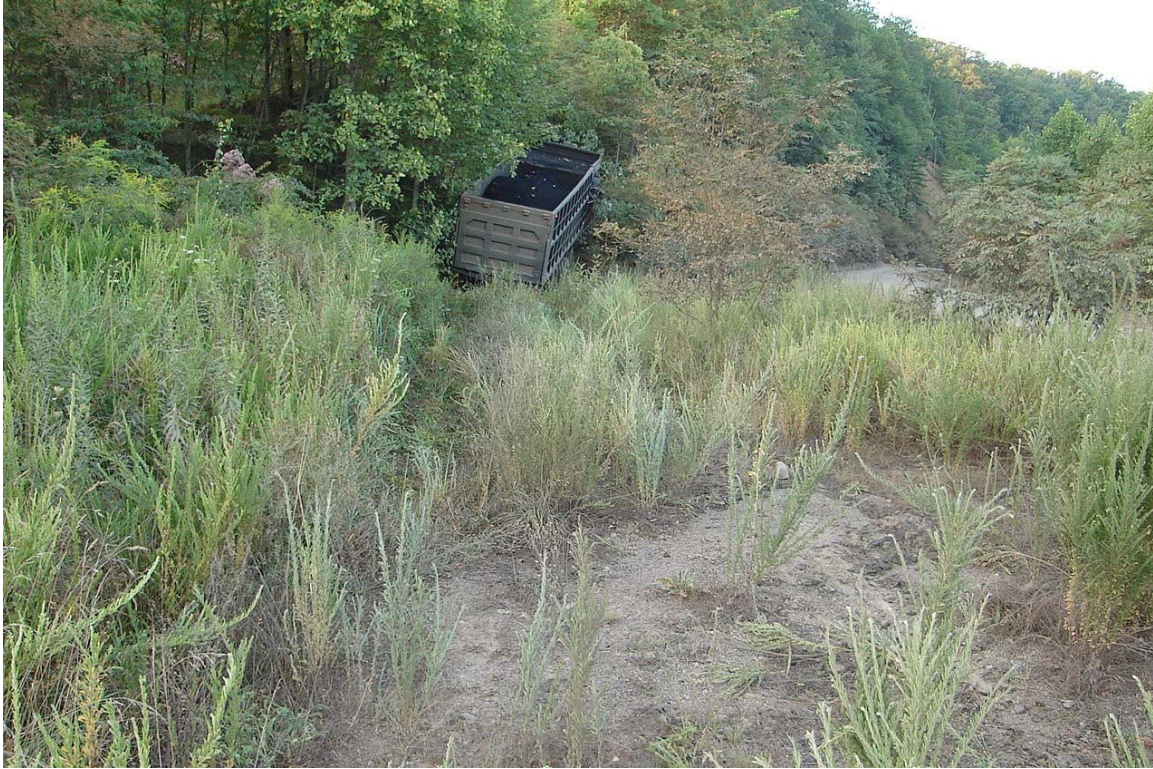
On Friday, August 22, 2008, at approximately 11:00 p.m., Danny L. Jones, a 38-year old truck driver was fatally injured when he exited the coal haulage truck he was operating as it struck a berm, left the roadway, and ran over him with the rear tandem wheels.

The accident occurred because the RD 686SX Mack Coal Haulage Truck had numerous mechanical defects, the seat belt was missing, and the victim was not properly trained. The victim had three days experience operating a coal haulage truck at this site.
