**REPORT OF INVESTIGATION
(Surface Coal Mine)**

**Fatal Machinery Accident
September 19, 2008**

**East Mac & Nellie Mine
ICG Hazard, LLC
Ary, Perry County, Kentucky
I.D. No. 15-18966**

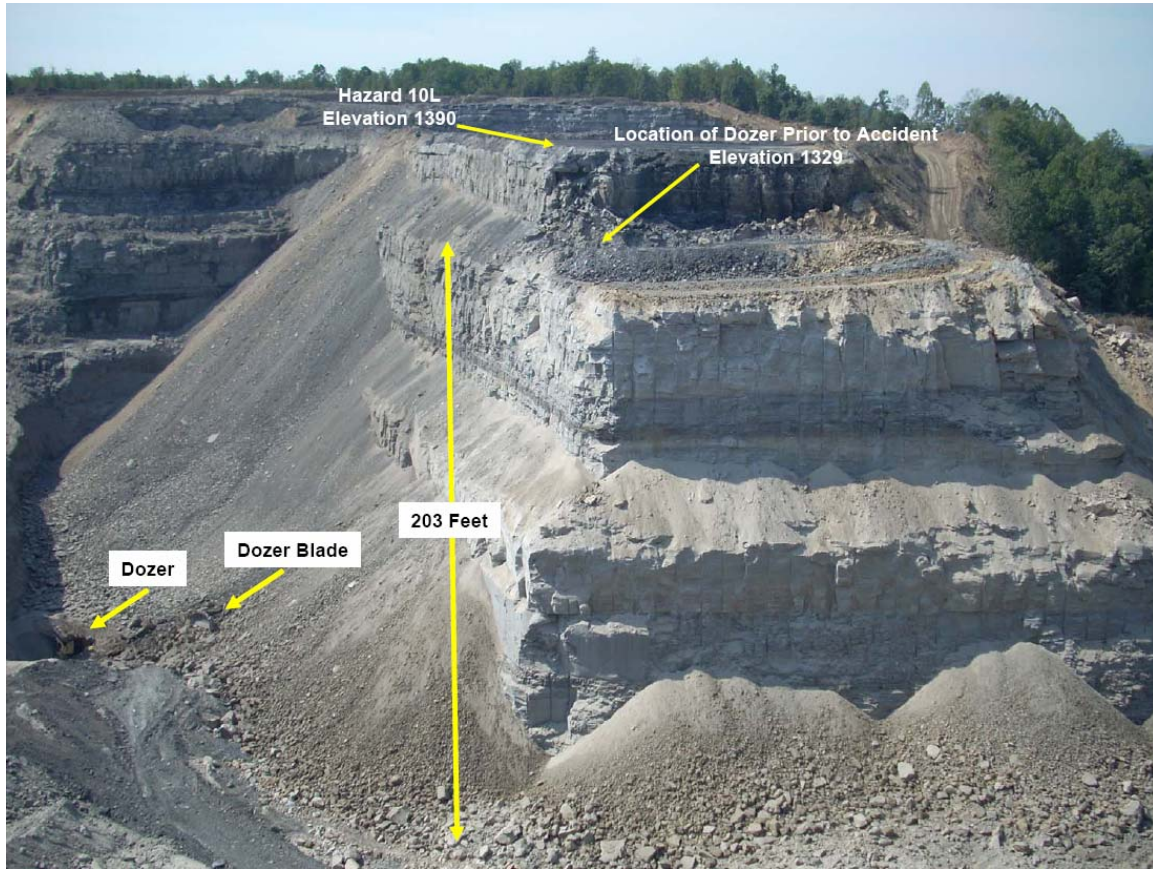
PHOTOGRAPH OF ACCIDENT SCENE

There were no eyewitnesses to the accident. It is the consensus of the investigation team that a highwall failure occurred suddenly in competent rock while the bulldozer was being operated on the top of the spoil area above the southeast highwall.

The thickness of shot overburden at the time and location where the bulldozer went over the highwall was approximately 7 feet. At the location where the bulldozer went over the highwall, an arc shaped scarp (a steep slope or cliff at the edge of a plateau or ridge) was observed within the shot rock. The arc had a length along the crest direction of the highwall of 40 feet. This length was measured using a laser range finder from the 1,329 foot Safety Bench. The depth of arc, perpendicular to the crest, was estimated to be 15 feet within the 7-foot-thick shot rock.

At the time of the accident, the bulldozer was not operating perpendicular to the southeast highwall. Due to over-break of the highwall above the 1329 foot Safety Bench, the operator had turned the bulldozer slightly around the southeast corner of the highwall. The investigation revealed that a highwall failure occurred suddenly in competent rock when the bulldozer was operating on the top of the spoil area above the southeast highwall. The track marks indicated that the bulldozer operator did not have time to react to the sudden tilt of the bulldozer since no skid marks were observed.

Corrective actions: The mine operator developed a plan to prevent a similar occurrence of this accident. The ground control plan was revised to show that equipment used to remove material over elevated highwalls will be required to use the double blade method of pushing (one blade of material will be left at the edge and pushed over with the following blade of material). This will allow the machine to remain a safe distance from the edge of the highwall at all times. The plan also requires training to be provided to the employees concerning the revised ground control plan and hazards associated with operating equipment while pushing materials over the edge of highwalls.
