COAL MINE SAFETY AND HEALTH
REPORT OF INVESTIGATION

Fatal Powered Haulage Accident
October 8, 2008

Mountaineer Labor Solution (T025)
Seth, West Virginia

Independence Coal Company
Justice No. 1 Mine
Madison (Boone County) WV
MSHA ID No. 46-07273

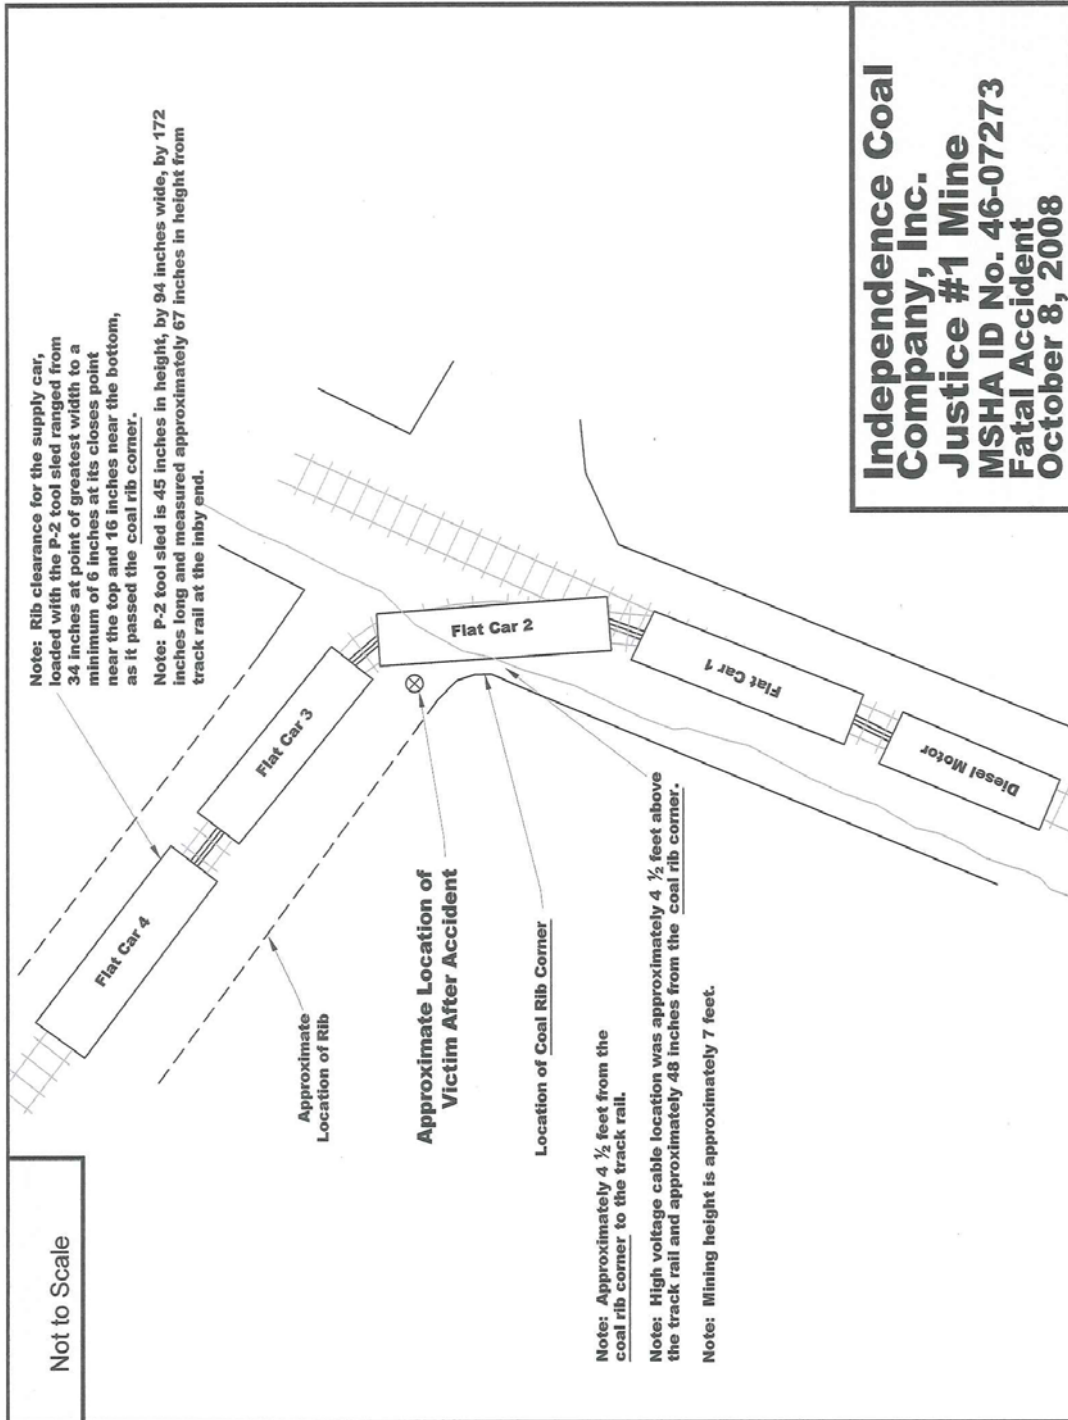
APPENDIX C

The mined height in the area of the 1 Left Switch was approximately seven feet. See Appendix C for more detail. The rib clearance for the supply car, loaded with the P-2 tool sled, ranged from 34 inches at the point of the greatest width, to 6 inches at its closest point near the top, and 16 inches near the bottom of the P-2 sled.

The outby coal rib at the corner of the side track did not show signs of being disturbed, however; the area of the inby side of the corner was observed with rock dust disturbed. Cain had crossed the track to hold up the high voltage cable to clear the supplies loaded on the cars passing underneath. As the No. 4 car with the P-2 tool sled was being pushed further into the spur, the sled came closer to the coal rib corner and struck Cain (victim). The inby end of the P-2 tool sled appears to have slid toward the off side, as the sled contacted the victim.

The P-2 tool sled was loaded on a supply car with the inby end of the sled 7½ inches higher than the outby end. The distance between the sled and the coal rib ranged from 16 inches on the bottom to 6 inches at the top. Scratch marks, observed on the side of the P-2 tool sled, were created by the victim's self-contained self rescue device (SCSR) and hammer. The coal rib corner was concaved from bottom to top, with the least amount of opening at or near the top.

Root Cause: Adequate clearance was not provided along the 1 Left spur and the supplies located on the supply cars. The supplies also hindered the motor operator's visibility.

Corrective Actions: A Safeguard Notice was issued, requiring clearance for all materials on flat cars on the tight or close side of the track, both to the side and to the top.

This is a notice to provide a safeguard, requiring clearance of 24 inches be provided on the walkway side and 12 inches above and along the tight side of all materials loaded on a flat car for transportation into or out of the mine.
