REPORT OF INVESTIGATION

Fatal Machinery Accident  
September 19, 2008

Battlecreek Corporation, dba  
Battlecreek-Tri-Mountain Corporation (R542)  
Summersville, West Virginia

Alex Energy Incorporated  
No.1 Surface Mine  
Drennen, Nicholas County, West Virginia  
46-06870

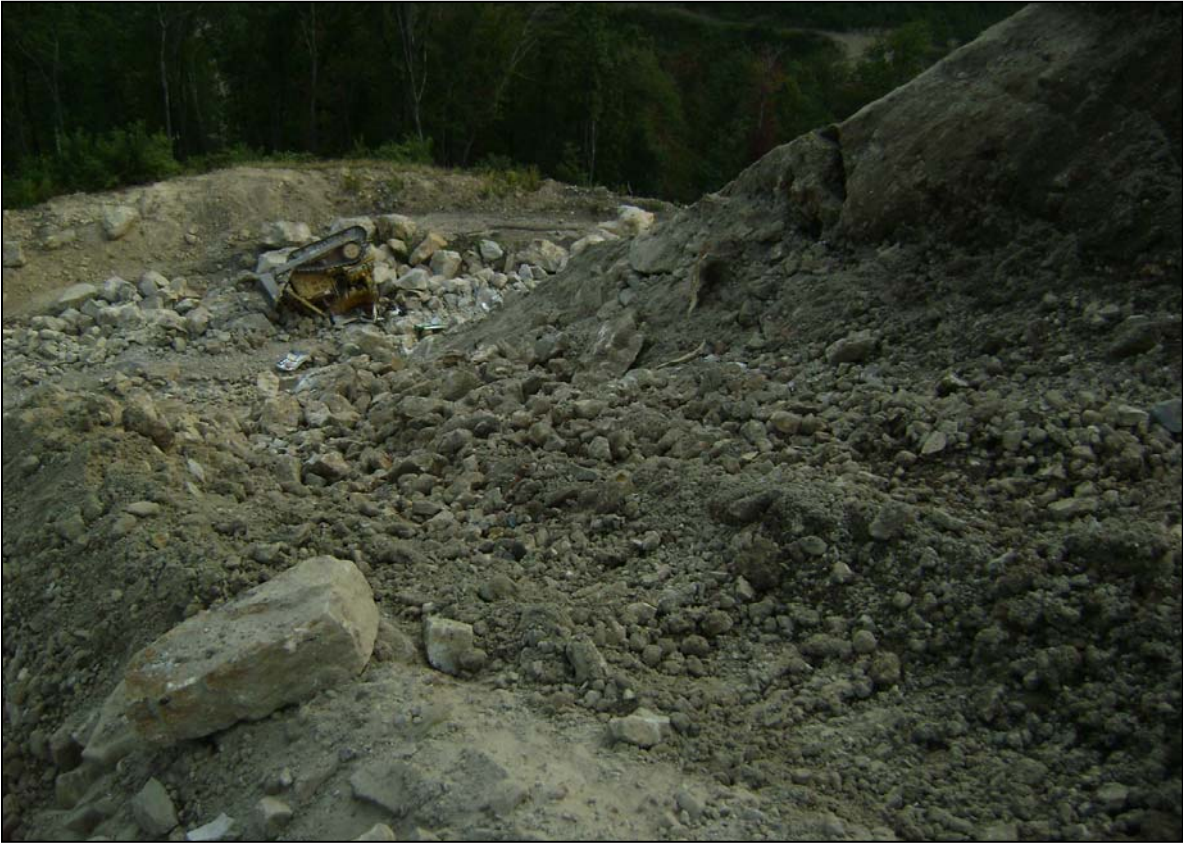
Loose, layered rocks, ranging from 4 inches to 12 inches in thickness, were present on the slope for a distance of approximately 30 feet just above the rock outcrop (photo). The layered rocks were approximately 15 feet wide and had apparently rolled down with each dozer pass. There were Grouser traction tracks leading up to the rocks, but no sign of track traction on these rocks. Rocks, unobserved by the dozer operator on the steep slope, acted as layered ball bearings, causing sudden speeding up or loss of directional control (#2 and #4 points above). This sudden loss of control and turn to the left occurred just above an approximate 18 inch high outcrop of the original highwall. When the right track slipped over the outcrop it dropped, causing the dozer to tilt and begin rolling down grade.

Root Cause: The dozer operator failed to maintain full control of the equipment he was operating on extreme slope conditions.

The accident occurred because the equipment operator was unaware of the slope conditions on which he was operating and failed to maintain full control of the equipment.

Corrective Action: Equipment operators will be trained to identify extreme conditions, operate equipment safely in extreme conditions, and recognize the limitations of equipment in extreme conditions.

Corrective Action: Persons designated by the operator to perform on shift inspections will be trained in identifying extreme operating conditions, operating and machinery limitations, and written company policy.
