REPORT OF INVESTIGATION

Fatal Powered Haulage Accident
October 19, 2008

McElroy Mine
McElroy Coal Company
Glen Easton, Marshall County, West Virginia
I.D. No. 46-01437

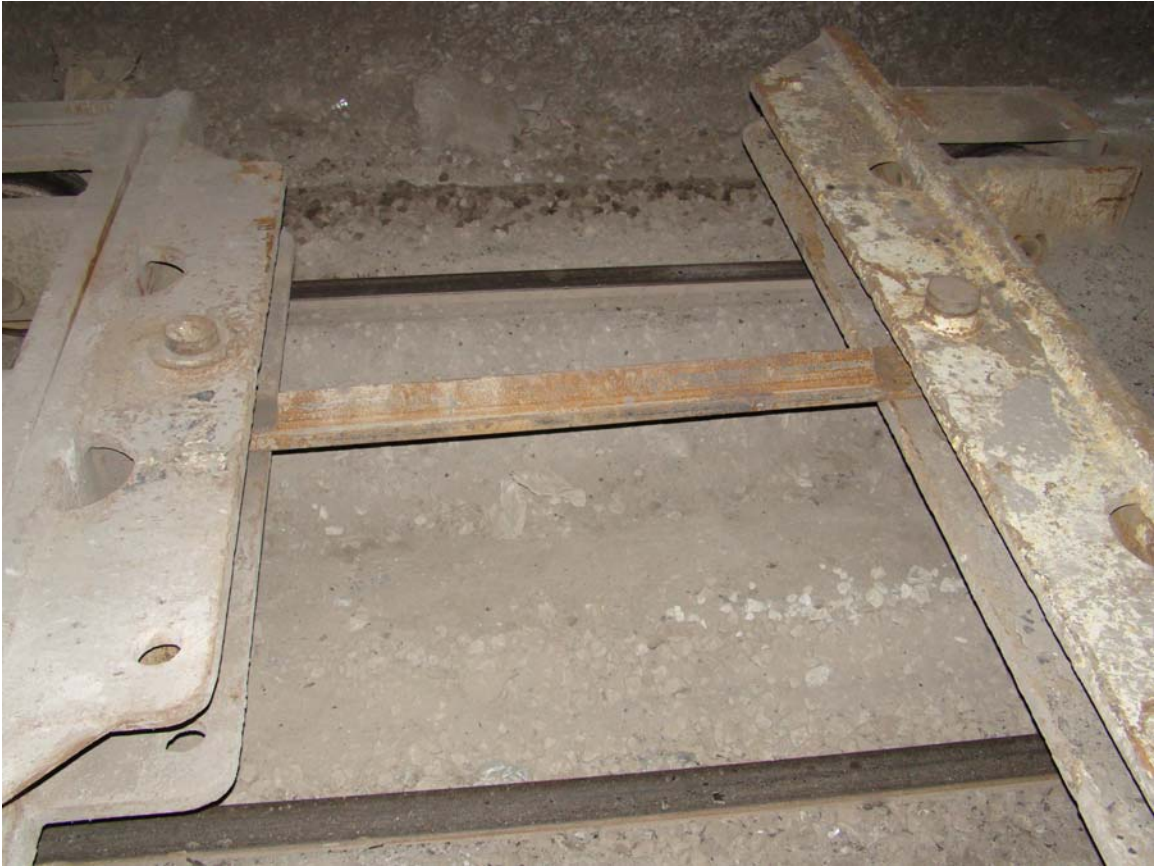
PHOTO OF ACCIDENT SCENE

The dollies were stopped within approximately 75 feet of a turn in the track, where the visibility of the No. 47 locomotive operator was limited. The dollies were stopped in this location because there was a dip in the track where the dollies could settle after being uncoupled from the locomotive.

The trailing (inby) end of the dollies was provided with two red reflective streamers. The streamers would have been difficult to see because the lights of the locomotive were off and the dolly height was approximately eight inches off of the mine floor. It was management's policy to use streamers to mark the ends of supply-carrying equipment that were not attached to trail locomotives. The streamers did not give a sufficient visual warning as to the location of equipment that was stopped or parked on the track

The lead motormen stopped the trip at a location that could not be seen until the trail locomotive was approximately 75 feet inby the parked dollies. A streamer was positioned on each inby corner of the dolly. In these positions, the streamers are difficult to see because the dolly is far below the operator's compartment of a 27 ton locomotive. The victim began disconnecting the trip of dollies from the lead locomotive before he knew exactly where the trail locomotive was located.

Corrective Action: A Notice to Provide a Safeguard was issued requiring a light attached to the trip within 3 feet of the end of the dolly, supply car, or coal car not attached to a locomotive. If the farthest projection on the end of the trip not attached to a motor is due to overhanging equipment or supplies, the light will be placed within 3 feet of the end of the overhanging equipment or supplies.
