UNITED STATES  
DEPARTMENT OF LABOR  
MINE SAFETY AND HEALTH ADMINISTRATION  
COAL MINE SAFETY AND HEALTH

REPORT OF INVESTIGATION  
Surface Coal Mine

MACHINERY ACCIDENT  
October 22, 2008

AM&E Coal Incorporated Mine #1  
AM&E Coal Incorporated  
Cornettsville, Perry County, Kentucky  
ID No. 15-19283

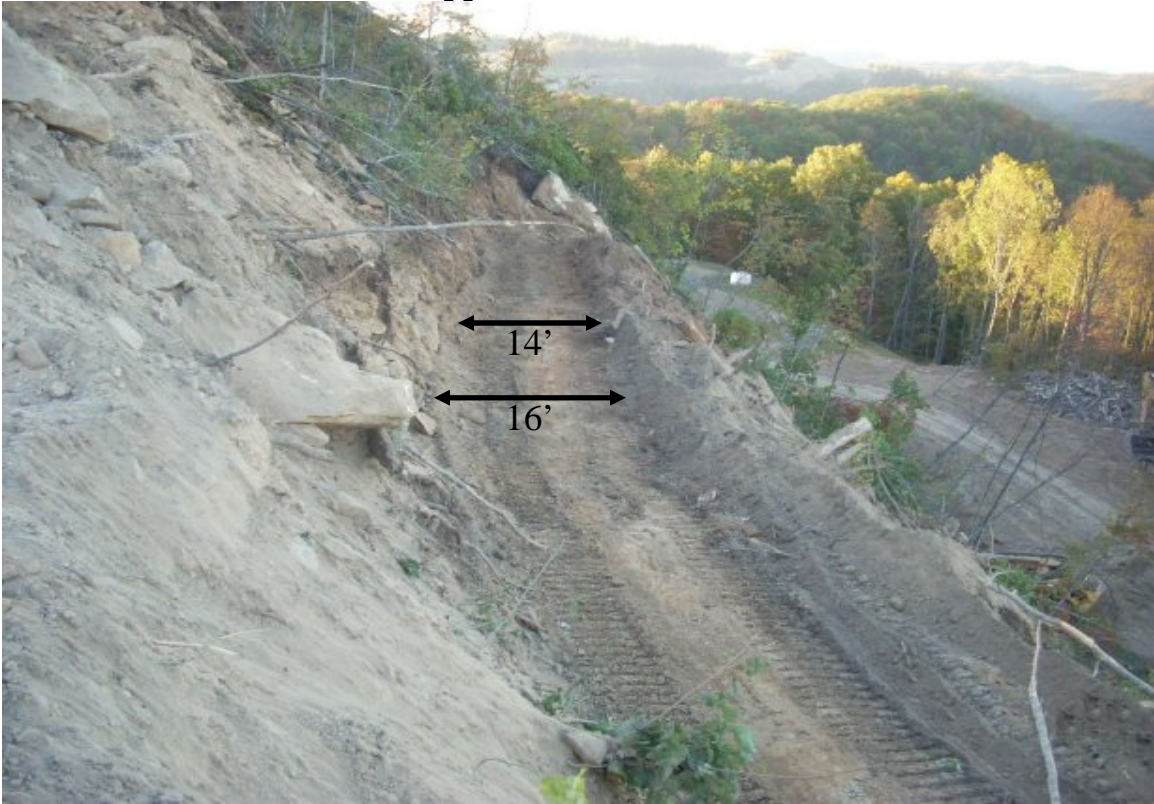
The accident occurred while Blevins was constructing a bench along a steep hillside. Blevins had completed approximately 200 feet of bench with a berm. Although a berm was present, it was marginal as it was constructed on roots, small trees and brush. Approximately 30 feet beyond this constructed bench, Blevins encountered a large rock, approximately 17 feet long, 6 ½ feet wide and 5 feet thick. While attempting to dislodge this rock, a segment of the improperly constructed berm (approximately 30 feet long and 8 feet thick) failed, allowing the D8R dozer to slide toward the right. The D8R dozer slid down the steep embankment approximately 55 feet before rolling over, making a complete revolution, and coming to rest on its left side. Blevins was ejected and was found lying in a prone position beside the D8R dozer.

**BENCH UNDER CONSTRUCTION**

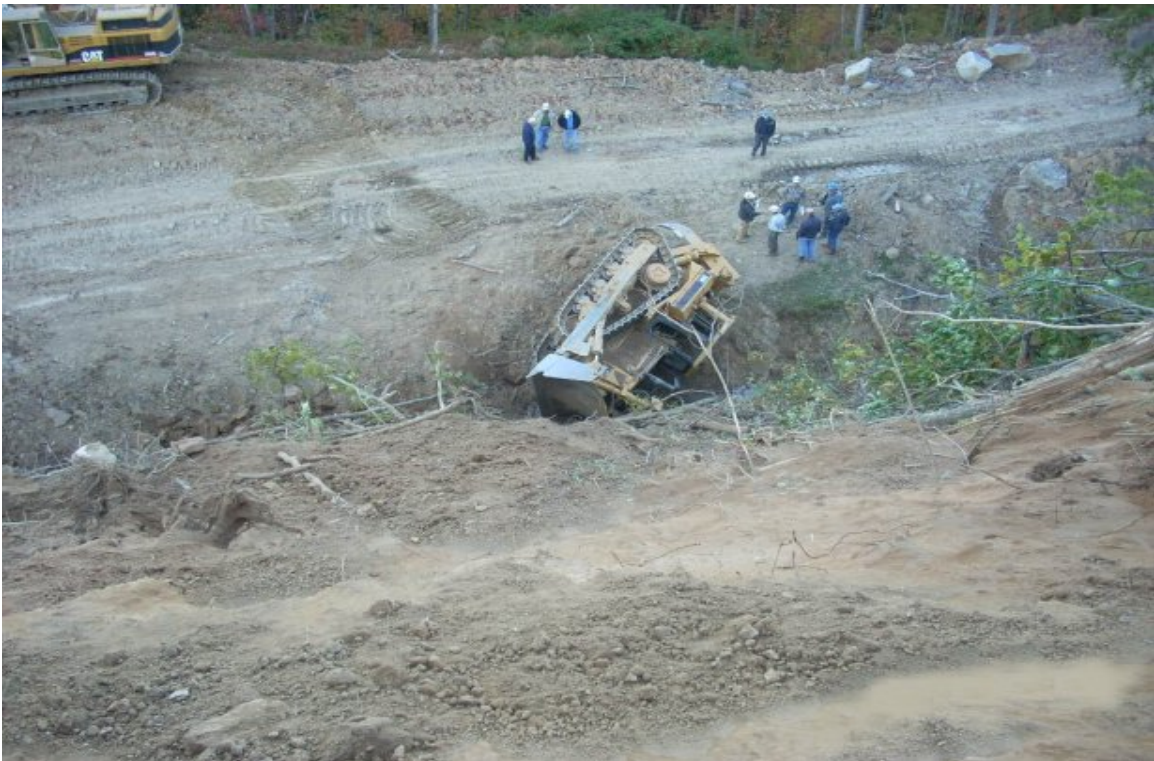
**DISTANCE FROM BENCH/BERM TO OVERTURNED D8R  
APPROXIMATELY 85 FEET**
