**UNITED STATES
DEPARTMENT OF LABOR
MINE SAFETY AND HEALTH ADMINISTRATION
COAL MINE SAFETY AND HEALTH**

**REPORT OF INVESTIGATION
Surface Coal Mine
Fatal Powered Haulage Accident
October 28, 2008
Wyodak Mine
Wyodak Resources Development Company
Gillette, Campbell County, Wyoming
ID No. 48-00083
Accident Investigators
Art C. Gore
Accident Investigator/Coal Mine Safety and Health Inspector**

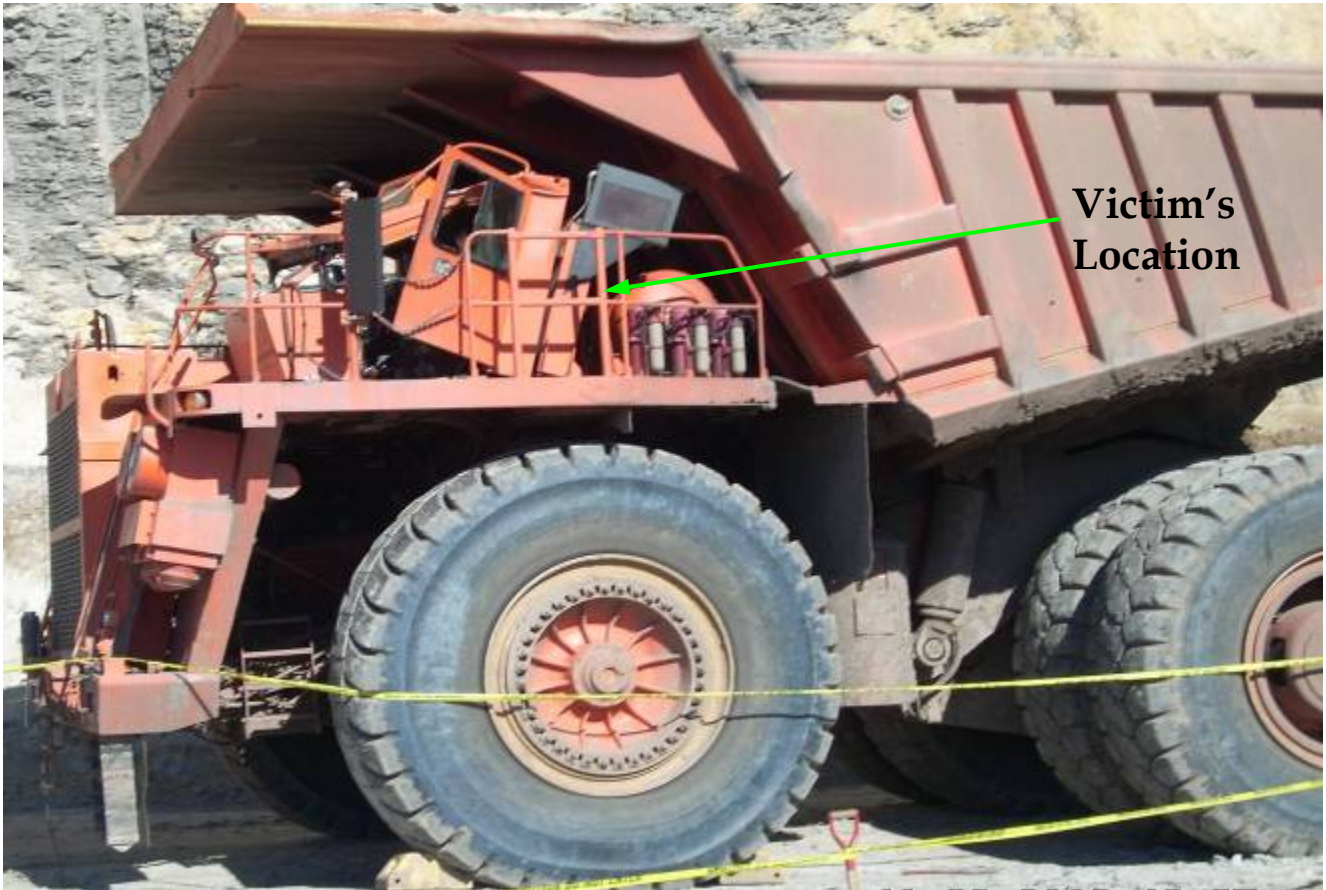
PHOTO OF ACCIDENT SCENE

DRESSER HAULPAK - MODEL 685E

Location of Kempf on Truck

After the accident, Kempf was found pinned behind the operator's cab of truck No. 212 between the brake accumulator cabinet and the air receiver tank. He reportedly had gone to that area to relieve himself. WRDC had provided portable toilets along the haul road for the employees to use. Management expected employees to use the portable toilets and not relieve themselves at/on equipment. After the accident, a written policy was adopted to strictly prohibit this practice.

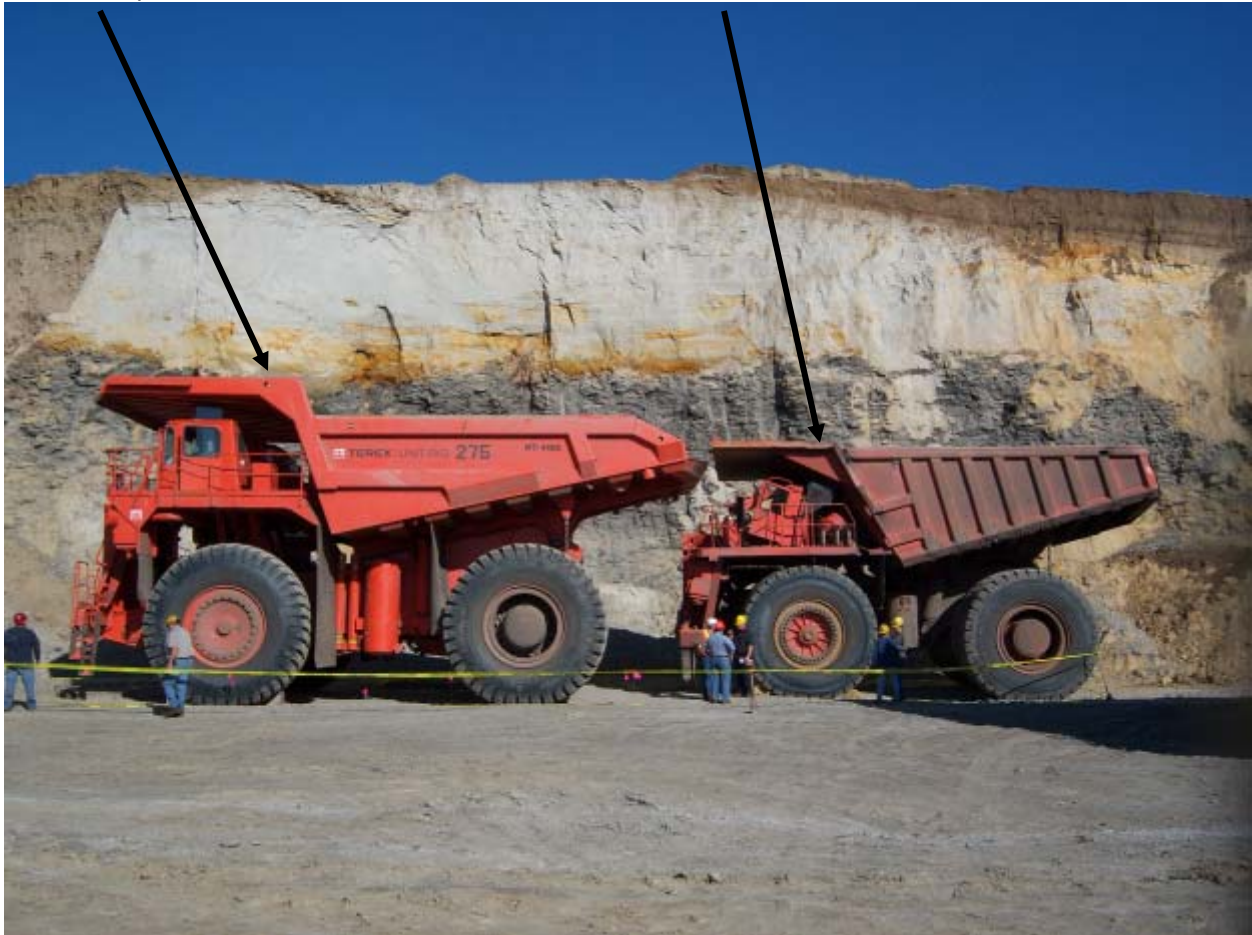
PICTURE OF TRUCKS AT ACCIDENT SCENE

Kempf operated a Dresser Haulpak 685E, 190-ton, end-dump haul truck, Serial Number CF31516AFE43-D, Company Number 212. This vehicle was approximately 22 feet high and 39 feet long. It was 23 feet 1 inch wide. The vehicle that backed into Kempf's truck was a Terex/Unit Rig MT4400, 240-ton, end-dump haul truck, Serial Number MH334,

Company Number 275. This truck was approximately 24 feet high and 46 feet long. It was 24 feet 10 inches wide. Kempf's truck was estimated to have been parked approximately 30 feet behind and within the blind spot of truck No. 275. This distance was estimated as truck No. 275 was moved after the accident to facilitate the rescue operation. Both the operator and the trainee in truck No. 275 stated that they looked in the mirrors prior to backing up the truck and did not see truck No. 212 behind them.

TEREX/UNIT RIG, MT 4400

DRESSER HAULPAK, 685E

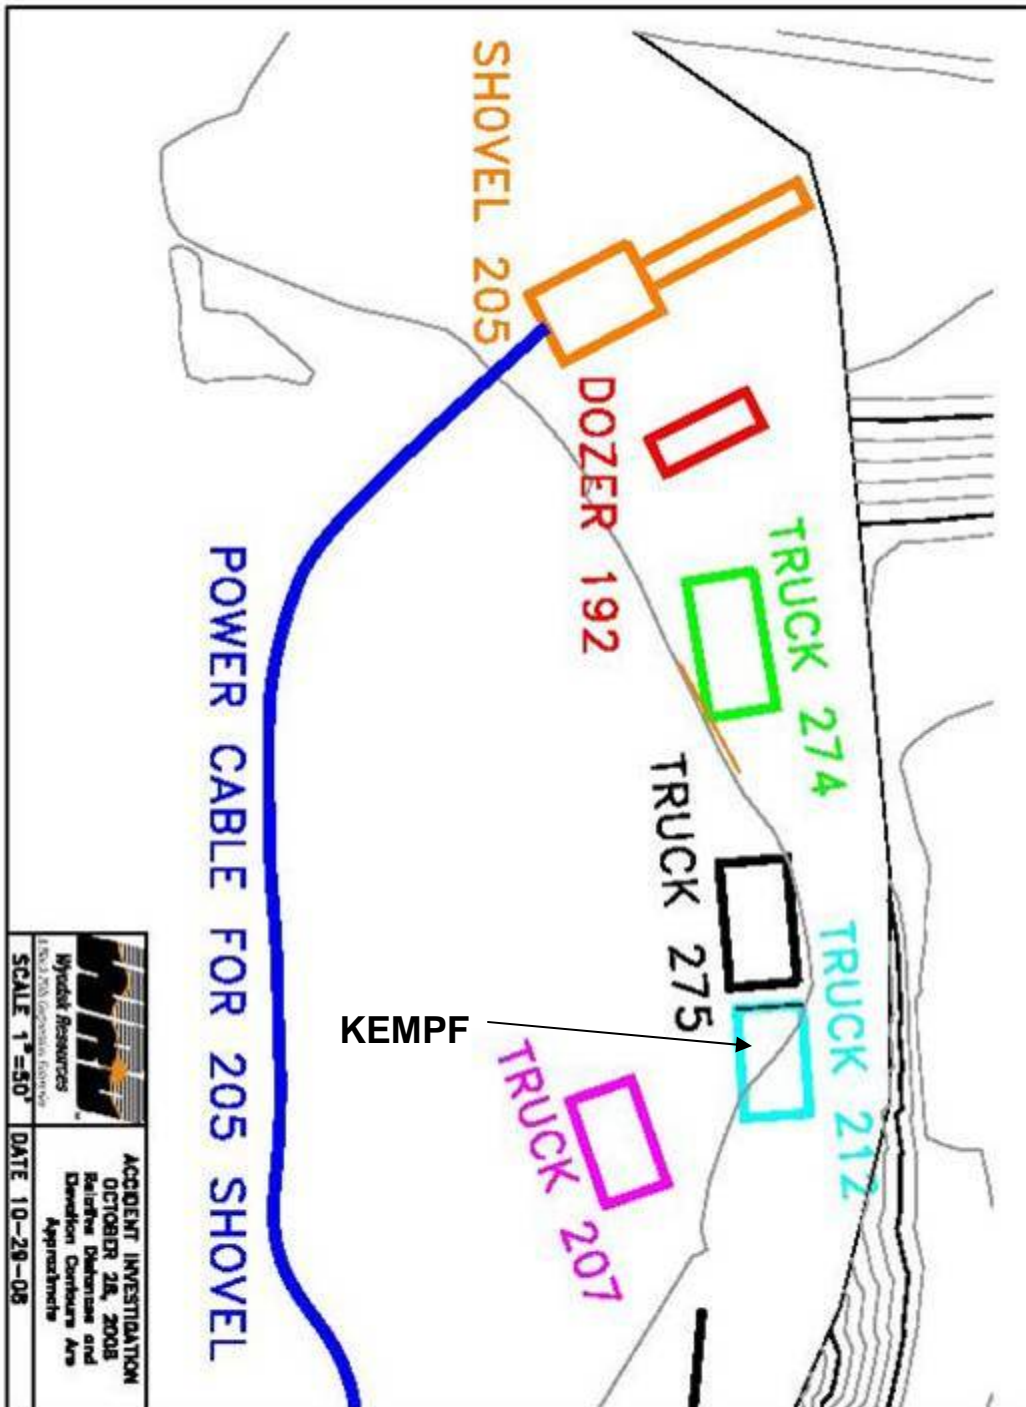
SKETCH OF ACCIDENT SCENE

Just prior to the accident, haul truck Nos. 274, 275, and 212 were waiting in line to be loaded at No. 205 overburden shovel on bench No. 3 in the Clovis Pit (see Appendix C). Truck No. 274, operated by Cody Holbrook, was first in line. Truck No. 275, operated by Vicki Wieseler, was in the middle and Kempf's No. 212 truck was last in line. A trainee, Keith Garrigan, was in the cab with Wieseler. Truck Nos. 274 and 275 were Terex/Unit Rig, 240-ton, end-dump haul trucks.

The accident occurred in the Clovis pit at the northwest corner of the No. 205 shovel overburden bench.
