REPORT OF INVESTIGATION

Surface Mine Facility

Slip and Fall Accident March 9, 2008 Resulting Death April 4, 2008 Chargeable as of November 24, 2008

Warrior Preparation Plant Warrior Coal, LLC Madisonville, Hopkins County, KY ID No. 15-14335

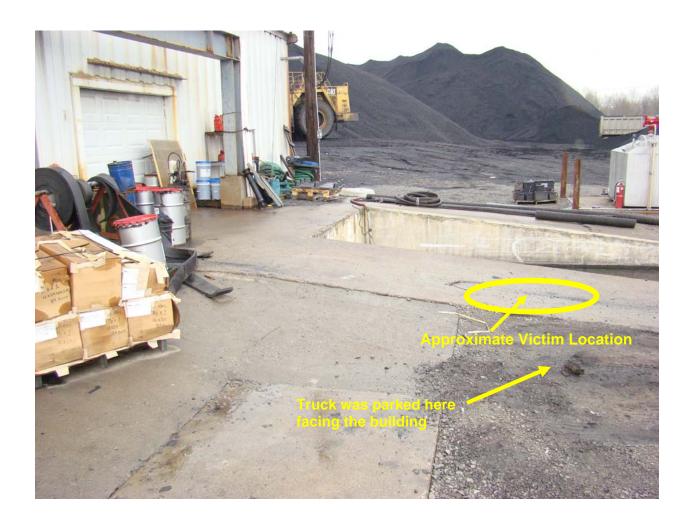
Appendix B Accident Site

The weather was cold with icing conditions. It had snowed a couple days prior to the accident. According to Roberts, the snow had melted on portions of the walkway and had frozen during the night, causing "black ice." The walkway was slightly inclined adjacent to a loading dock. No snow or ice had been removed prior to the miners traveling this area.

1. *Root cause:* An effective policy was not in place and implemented to ensure that the designated walkway was kept free of ice and snow.

Corrective Action: Warrior Coal, LLC, Warrior Preparation Plant, shall update their safety program with procedures for maintaining regularly traveled walkways in safe condition during inclement weather conditions such as freezing rain, snow, and ice, prior to miners accessing these areas. A copy of the instructions will be given to all company and contractor employees and posted at the mine site.
