REPORT OF INVESTIGATION

Surface Mine Facility

Machinery Accident
December 11, 2008

Warrior Preparation Plant
Warrior Coal, LLC
Madisonville, Hopkins County, KY
ID No. 15-14335

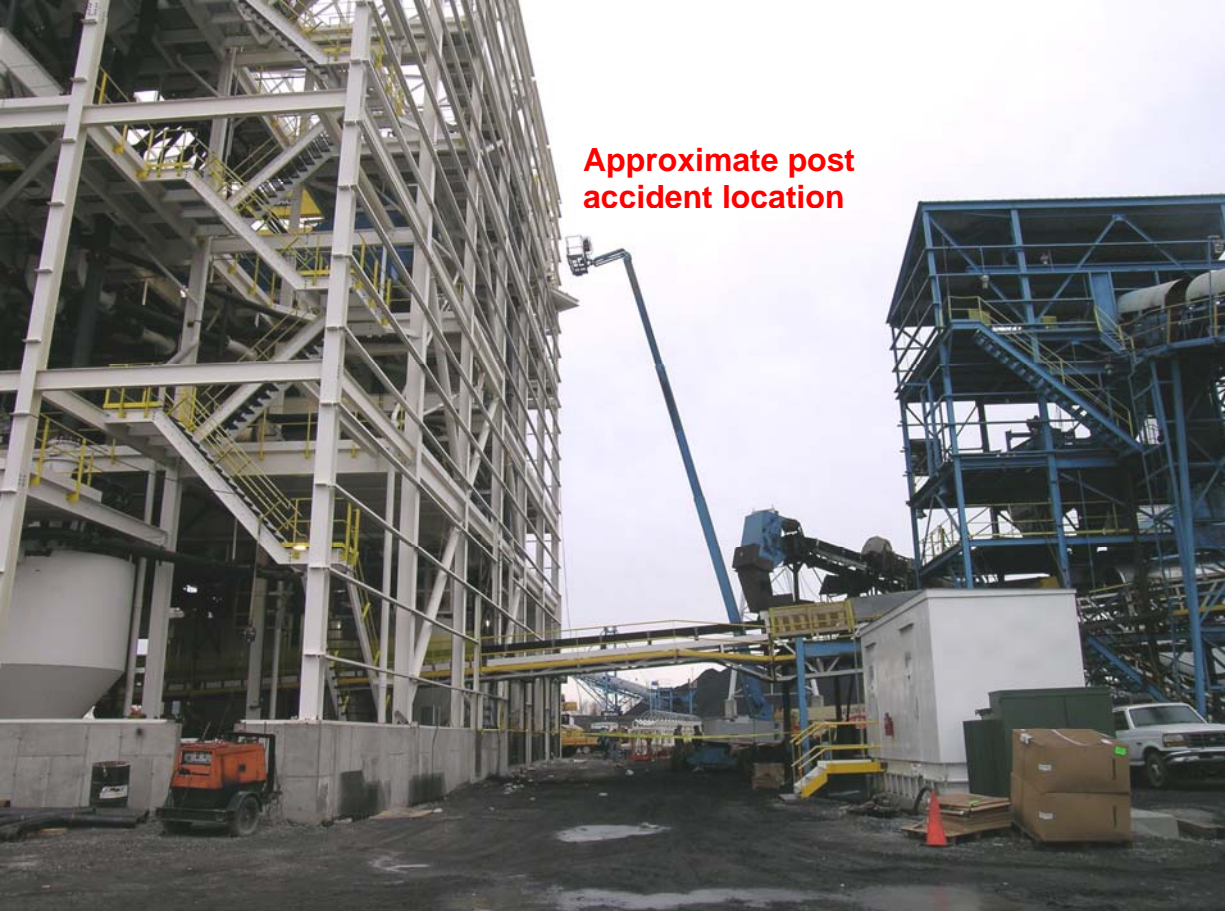
Overview of Accident Site

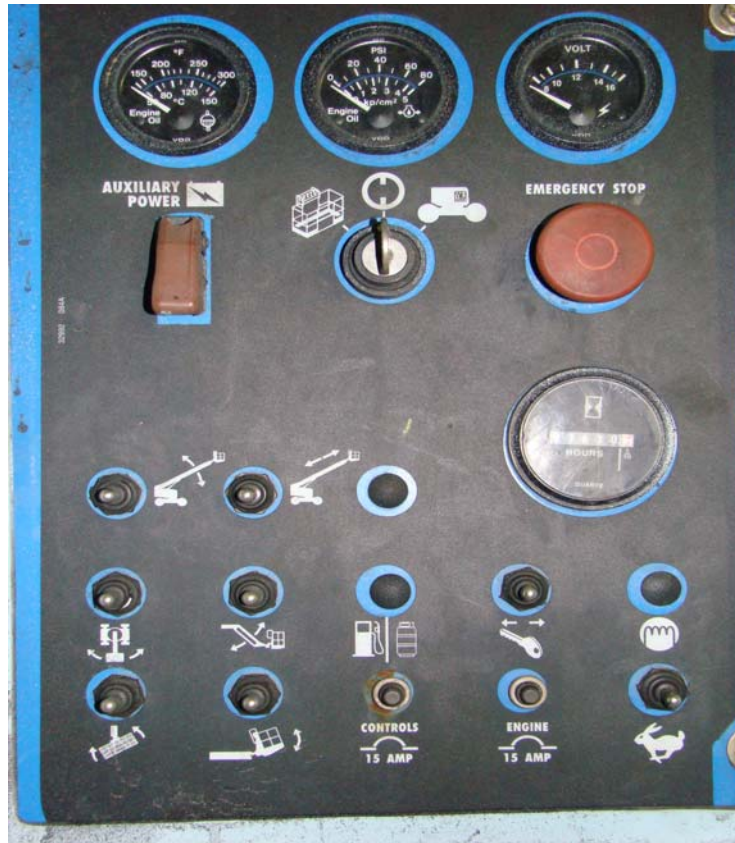
Appendix B Machine Controls

The turntable control console included switches that controlled turntable rotate, main boom up/down and the main boom extend/retract. Control switches were also provided to use the jib boom up/down, platform level, and platform rotate to allow an operator to maneuver the platform into locations that would not be possible using turntable and main boom controls only. Before these controls for the platform movements would operate, the function enable switch located on the bottom left corner of the turntable console has to be pushed to the right or left.

After the accident, the turntable controls were used to lower the platform to the ground in order to remove the victim. During the accident investigation, an experienced operator stood on the ground and used the turntable controls to raise the platform back to the location of the accident (between the third and fourth floors of the plant). As the platform was raised, the controls operated smoothly and no problems were discovered. As the platform was being lowered, a further check was made of all the controls on the turntable console and they all operated smoothly. These controls were checked with the engine running and with auxiliary power and they operated properly in both situations.

The emergency stop button on the turntable control console was also tested. The emergency stop button was pushed to the "off" position and the engine stopped. With the emergency stop button in the off position, the engine would not start and none of the console controlled functions would operate.

Turntable Controls

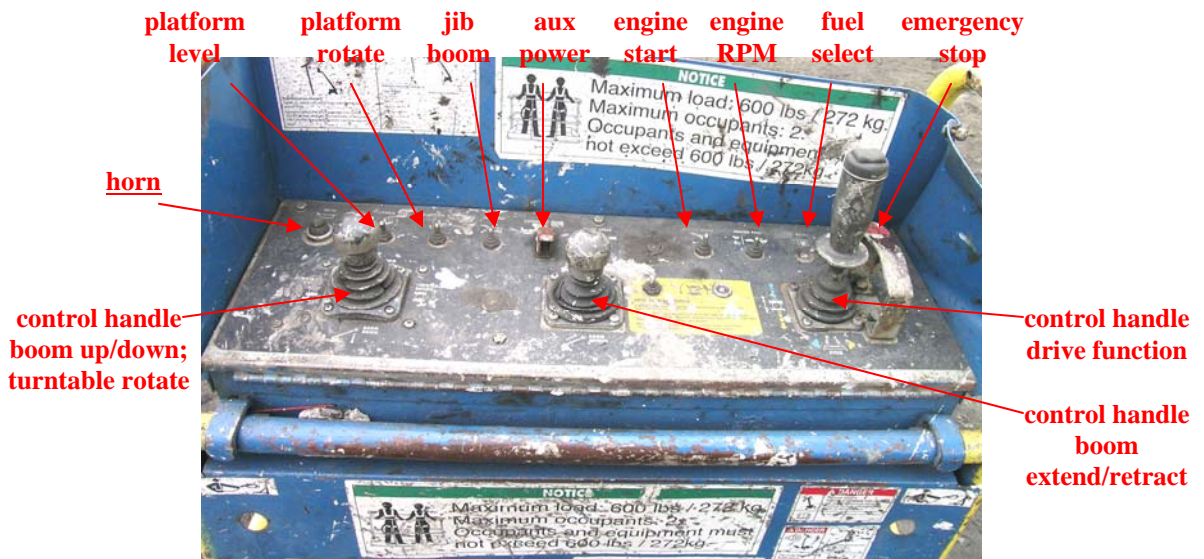
The platform control console also had two joysticks in the lower left corner to control the movements of the main boom and the turntable rotate. These joysticks were proportional, which allowed the operator to control the speed of the movements by the amount of joystick movement. The left joystick controlled the turntable rotate and the up and down movement of the boom. The right joystick controlled the boom extension and retraction. The platform control panel had additional toggle switch controls that could be used in repositioning the platform which included platform level, platform rotate and jib boom controls.

During the accident investigation, an experienced operator used the controls on the platform console to check each of the functions used in moving the platform. The functions operated smoothly and acted as expected with the exception of the main boom up and down function. When moving up or down, the main boom would continue to travel for several inches after the operator would release the joystick when the boom was traveling at full speed. Man-lift manufacturer representatives stated that the amount of boom travel was controlled by adjustments in the electrical control circuit for the main boom hydraulic controls. These adjustments could be used to set the time allowed from when the joystick was released until the boom movement would stop. These adjustments also change the distance the boom travels after the joystick is released. Man-lift manufacturer representatives indicated that they did not require a specific time for the boom to stop moving, but allowed the man-lift owners to set that time according to their preference. The representatives stated, that in close quarters, the man-lift operator should use the proportional joystick to slow the speed of the boom travel and thus control the distance the boom travels after release of the joystick. During the investigation an operator was able to use the proportional joystick to slow the up and down movement of the boom and thus limit the distance of boom travel when the joystick control was released.

Platform Controls

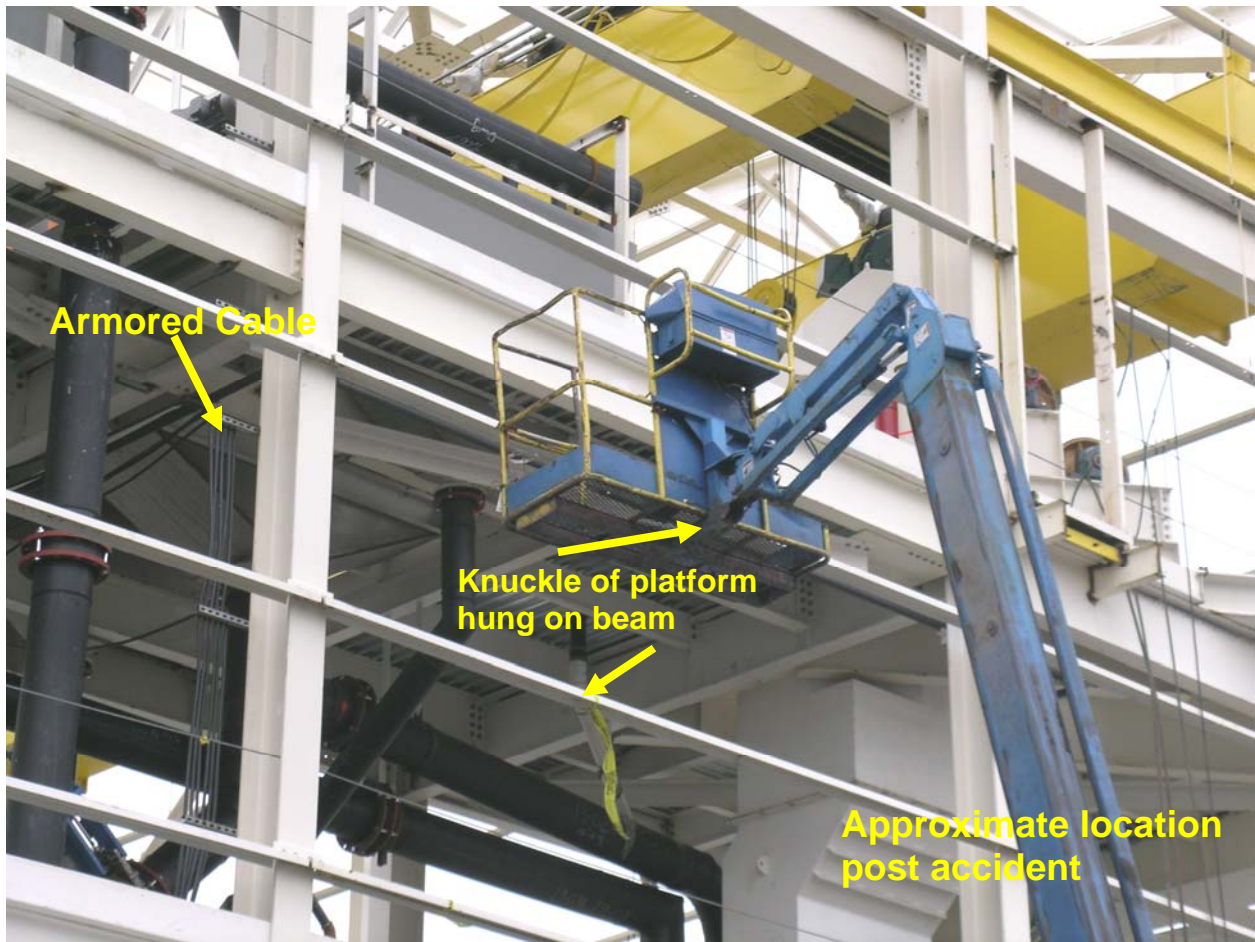
Appendix C
Accident Site

The accident occurred on the north face of the building between the 3rd and 4th floor, approximately 75 feet above ground level. The plant structure was near completion and the clean coal belt which is located on the ground floor of the structure was in operation (see Appendix C).

Photograph depicts approximate post accident location of the platform

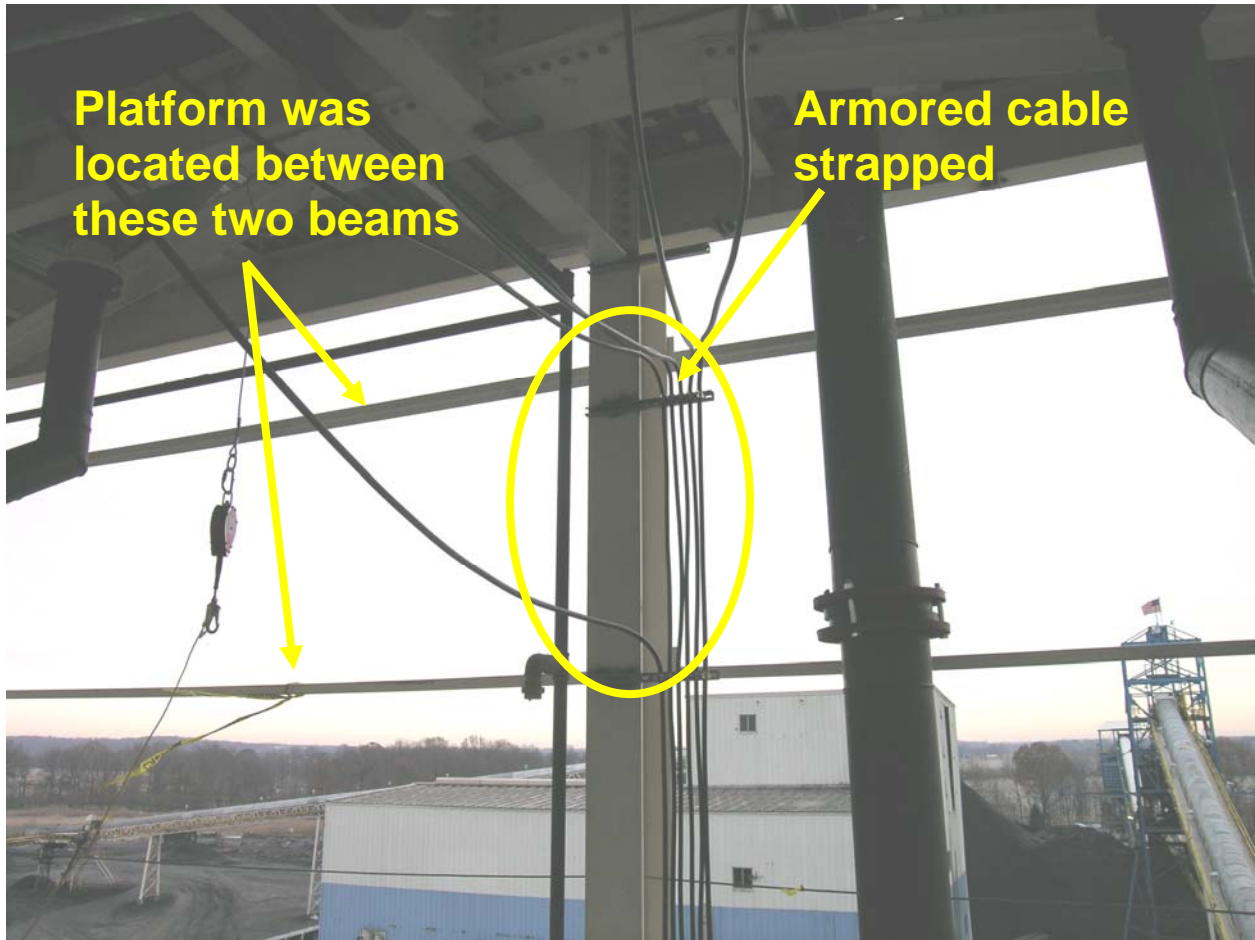
Appendix D
Accident Site

Photograph depicts the immediate work area

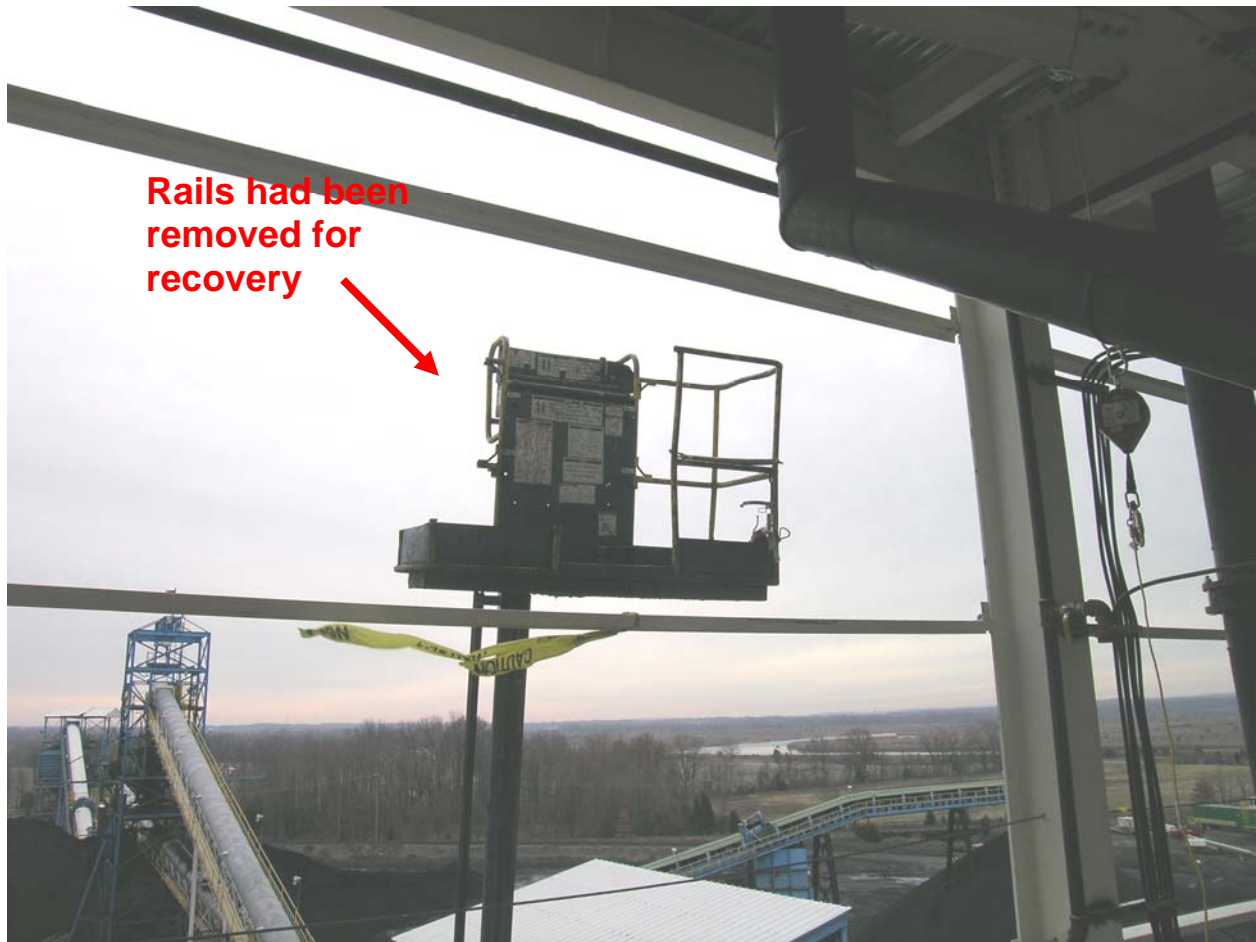
Appendix E
Accident Site

View from inside of the plant approximate post accident position of platform.

The total height of the platform from the knuckle to the top of the platform measured 54 inches. The vertical opening between the beams measured 58 inches.

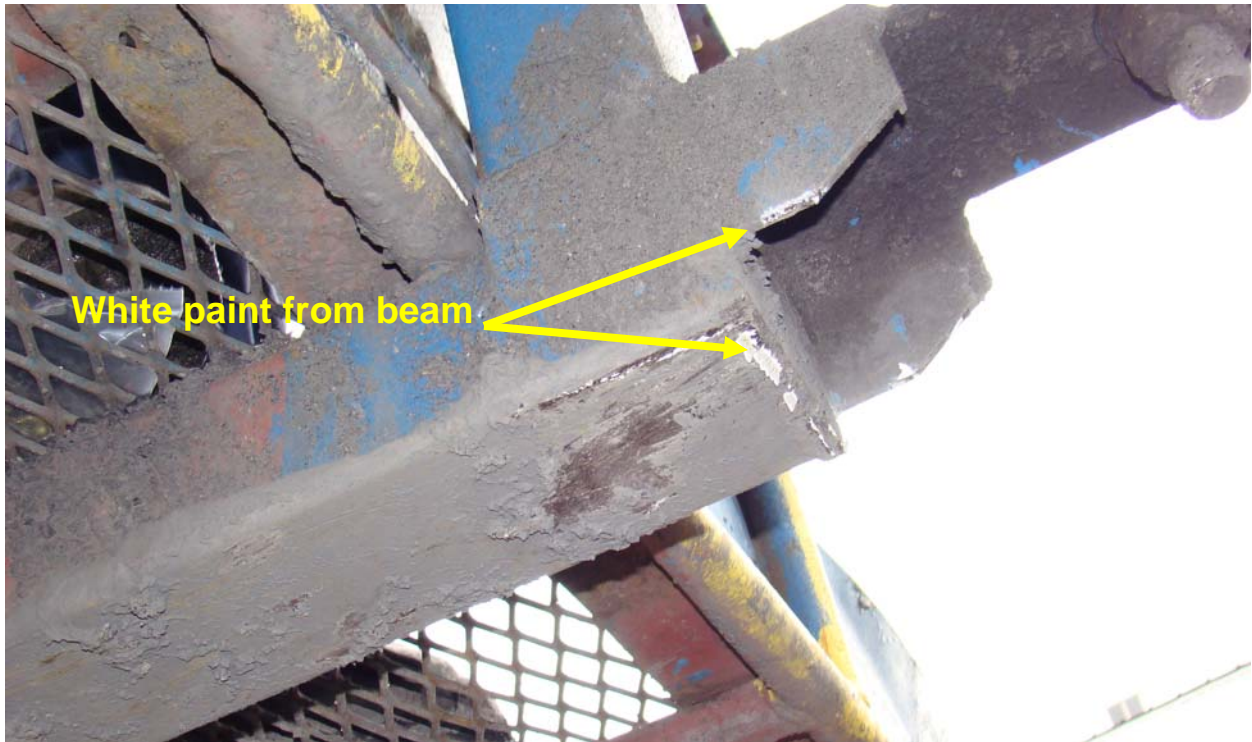
Appendix F
Accident Site

Prior to the accident, Albright had used the extra maneuverability allowed by the jib boom to maneuver the platform inside the outside wall of the preparation plant to do work between the 3rd and 4th floors. In order to place the platform in the location that the work was being performed, the platform had to be maneuvered between two lateral beams located on the outside wall of the preparation plant. While relocating the platform from the work location to the outside of the preparation plant, the platform became wedged against the lateral beams. After the platform became wedged, the operator remained on the platform and attempted to use the platform controls to loosen the platform. This method of freeing the platform is contrary to the method that is specified by the manufacturer of the man-lift. As the platform was being maneuvered to try and loosen it from the beams, the boom arm was deflected. The deflection caused a considerable amount of energy to be stored in the boom arm. When the platform was freed from the beams, the stored energy caused it to straighten with a violent and sudden movement.

Photograph depicts white paint from the beam on the knuckle of the platform

Corrective Action: All company and contractor employees that are subject to operate the man-lifts were trained on December 18, 2008 in the safe operating procedures to be followed in the event the platform becomes entangled or caught on an adjacent structure.
