REPORT OF INVESTIGATION

Surface River Coal River Loading Facility

Drowning Accident

**Ireland River Loading Facility
Consolidation Coal Company
Moundsville, Marshall County, West Virginia
MSHA ID No. 46-01438**

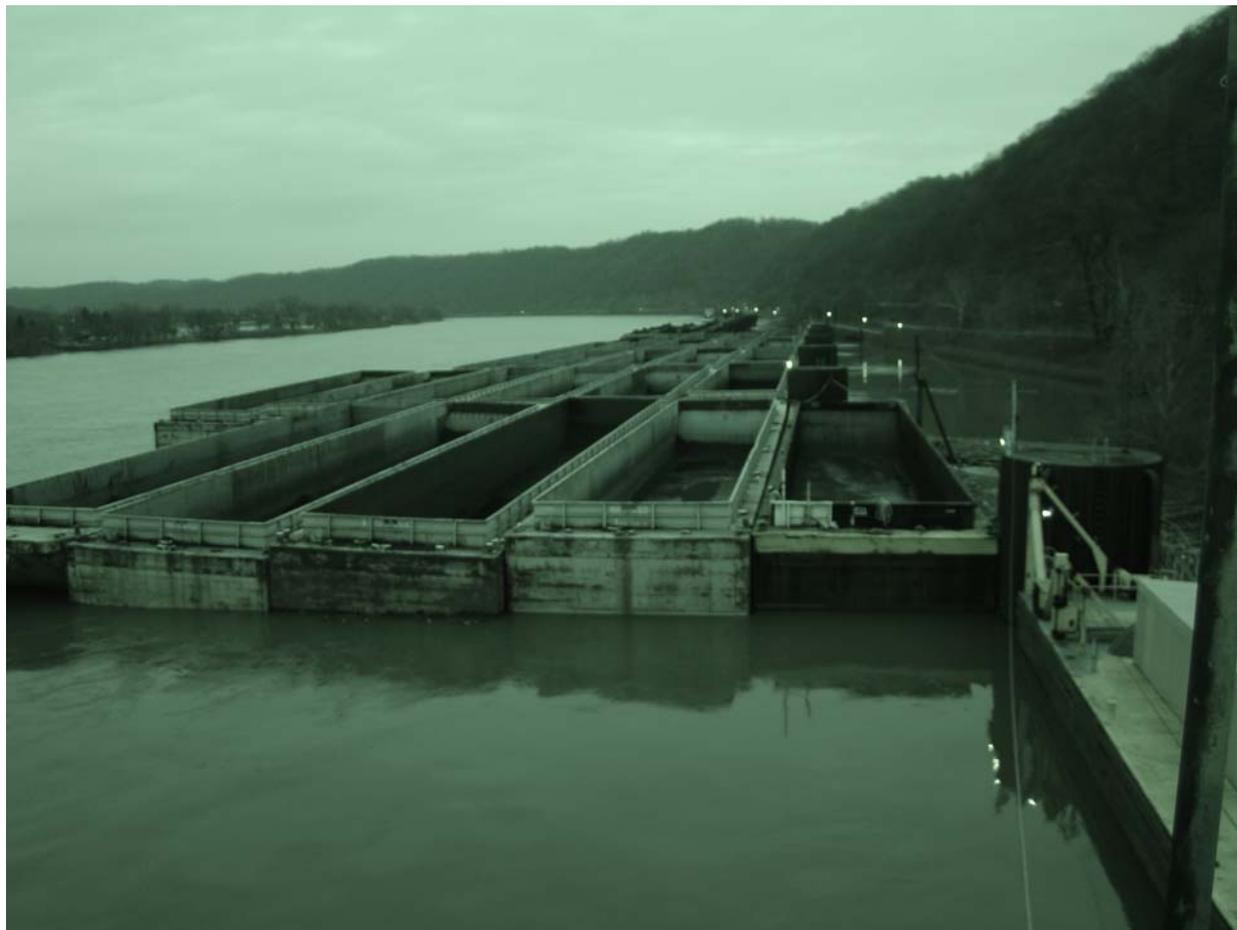
PHOTO OF ACCIDENT SCENE

* after the recovery operation had taken place

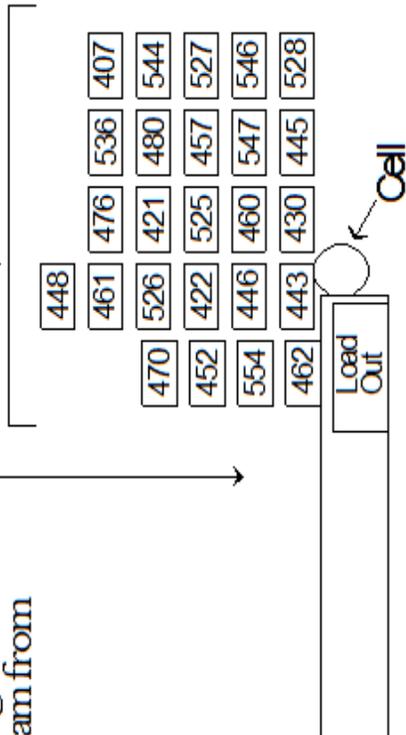
Location of Barges after Recovery

The Tugboat Quarto moved the 554 barge upstream and secured it. Then the Tugboat Champion moved the 452 barge up. Then the Tugboat Kimberly moved the 470 barge out, the victim was observed floating between the remaining barges and he was removed from the river by the crew on board the Tugboat Quarto that positioned just downstream from the Kimberly.
