REPORT OF INVESTIGATION

Fatal Hoisting Accident
October 27, 2009

Eagle Mine
Newtown Energy, Inc.
Comfort, Kanawha County, West Virginia
I.D. No. 46-08759

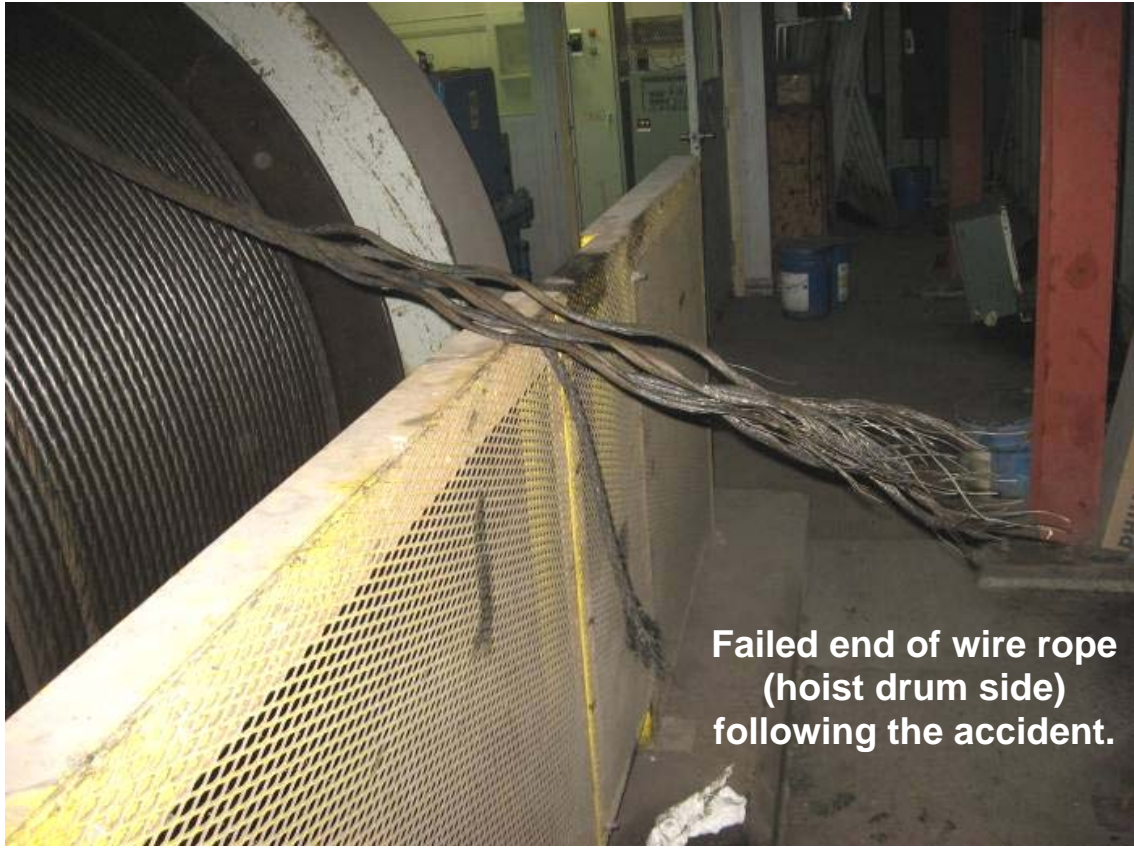
**Failed end of wire rope
(hoist drum side)
following the accident.**

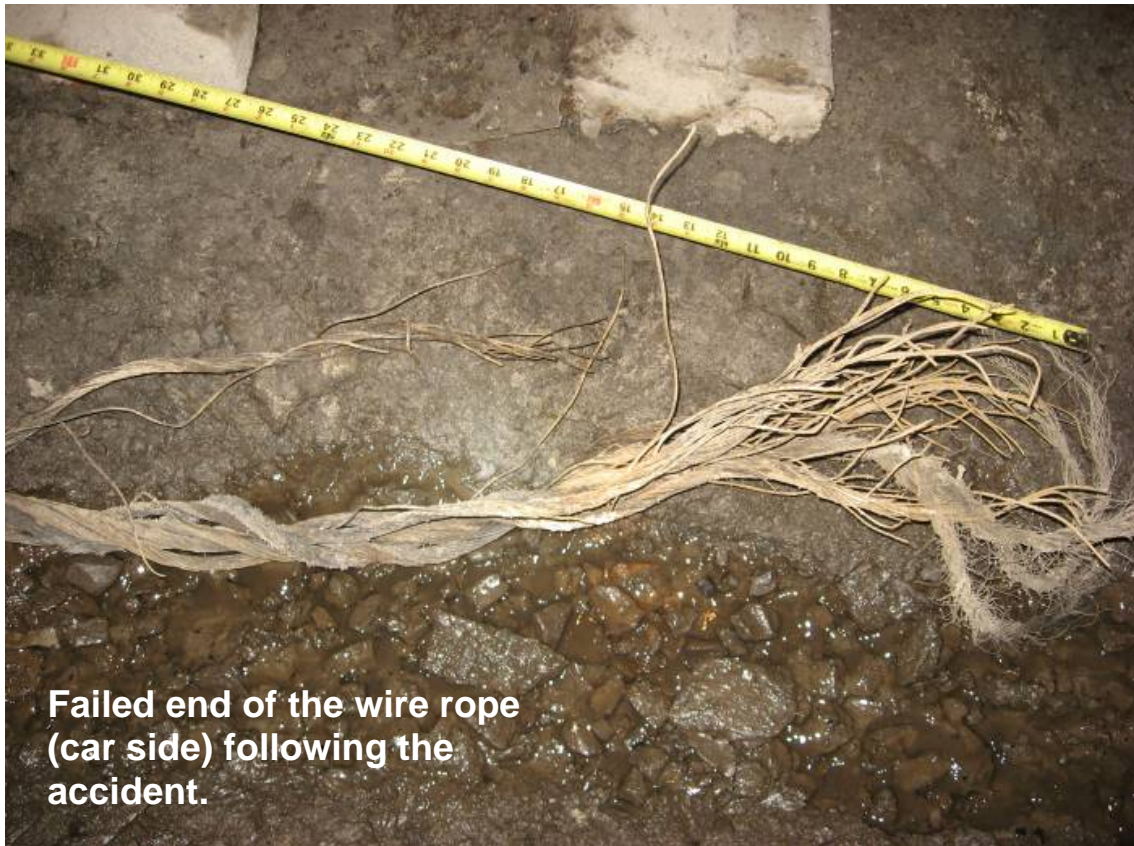
**Failed end of the wire rope
(car side) following the
accident.**

The car side of the failure was examined in the mine the day following the accident. Approximately 575 feet of the hoist rope extended from the load termination at the brakeman car up the slope. The failed end had traveled uncontrolled down the slope after it broke. There was dirt and debris on the outer portion of the rope and there did not appear to be any lubricant present in the vicinity of the car side failure. The wires at the car side of the failure were examined and showed evidence of wear and pitting corrosion.

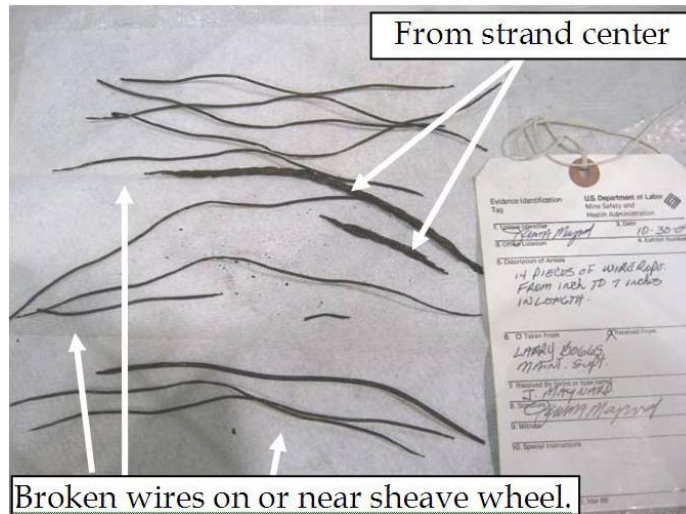
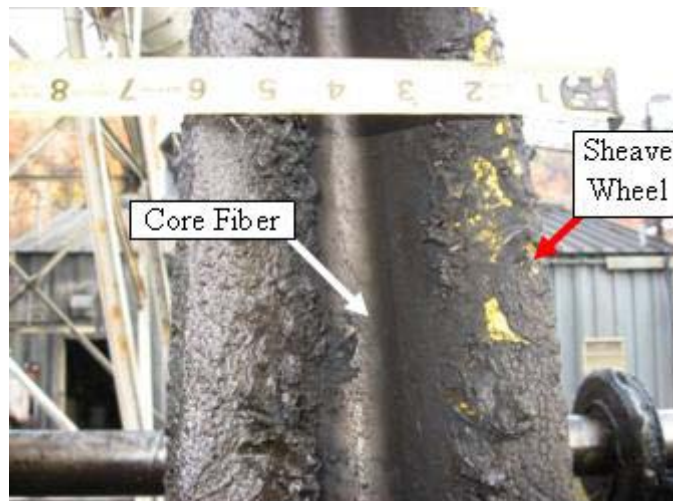
The wire rope failed at a point approximately 575 feet from the load attachment on the brakeman car as the trip was being pulled to the surface. The failure point occurred as the rope traveled over the sheave wheel located outside the hoist house. This was indicated by the number of broken wires found under the sheave wheel, the presence of core fibers, and small wire segments embedded in the lubricant on the sheave wheel, and the length of rope remaining on the hoist drum. Broken wires were gathered from the grease on the sheave and on the ground just below the sheave wheel. They included center strand pieces along with individual wires.

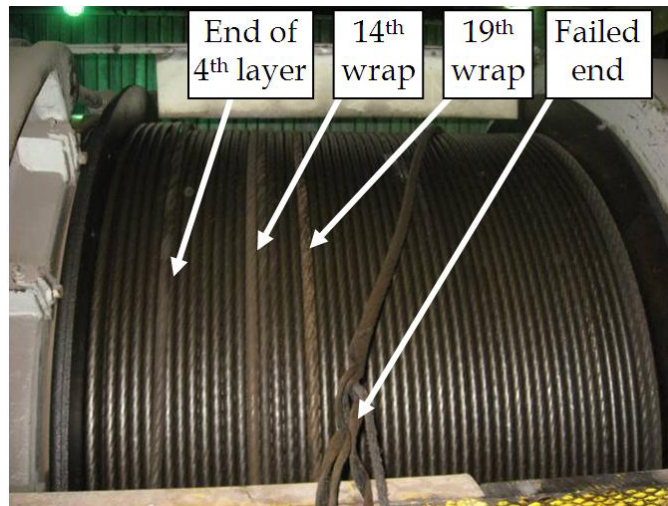
The outer wires of each strand of the failed end were worn. Many of the wires were no longer round due to wear, abrasion, and corrosion.

Matco Services Inc. (Matco) was contracted to provide a failure examination of the hoist rope. A laboratory evaluation was conducted December 1, 2009, on the hoist side portion of the failure and the additional wires (14 pieces) recovered from the mine. The car side of the portion of the failure was photographed at Matco. A detailed examination of the wire failures on the car side portion of the rope failure was not conducted. No laboratory examination was conducted because the end of this portion of rope connected to the car traveled uncontrolled down the slope, leaving behind a considerable number of broken wires along the slope. The Matco report summary describes that the wire rope failure was due to significant wire corrosion and wear.

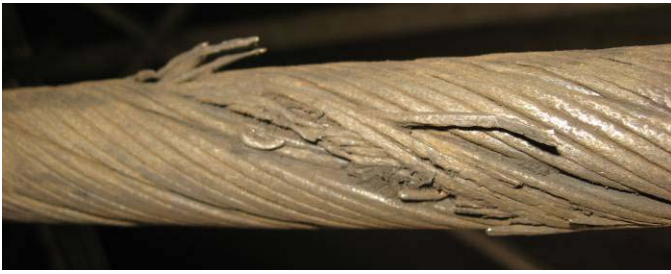
The worst portion identified by the MSHA NDT is the dry section of rope located 14 wraps into the third layer of rope on the drum. At the worst portion of rope identified by MSHA NDT, approximately 13 feet of rope was dry and not lubricated.

The outer wires of the rope were worn. Caliper measurement taken on the dry section of rope indicated diameters of 1.079, 1.084, 1.052, 1.047, and 1.066 inches. These caliper measurements were taken with the rope in an unloaded condition. Under a loaded condition (i.e. the brakeman car attached to the rope), the rope diameter measurements likely would have shown a smaller diameter.

Worst portion of rope identified by MSHA. No lubricant identified, broken wires and severe pitting corrosion.

In the worst portion of the rope, one of the strands was visibly damaged and the strand center was exposed. This center strand had no visible lubricant and exhibited broken wires and severe pitting corrosion. The outer wires of the rope, throughout this dry area, showed visible signs of pitting corrosion. Based on the MSHA NDT evaluation, caliper measurement, and visual examination, the worst portion of the hoist rope identified by MSHA NDT exceeded the retirement criteria listed in Title 30 CFR Part 75.1434(a)(1), (a)(2), (d), (g), and (h).

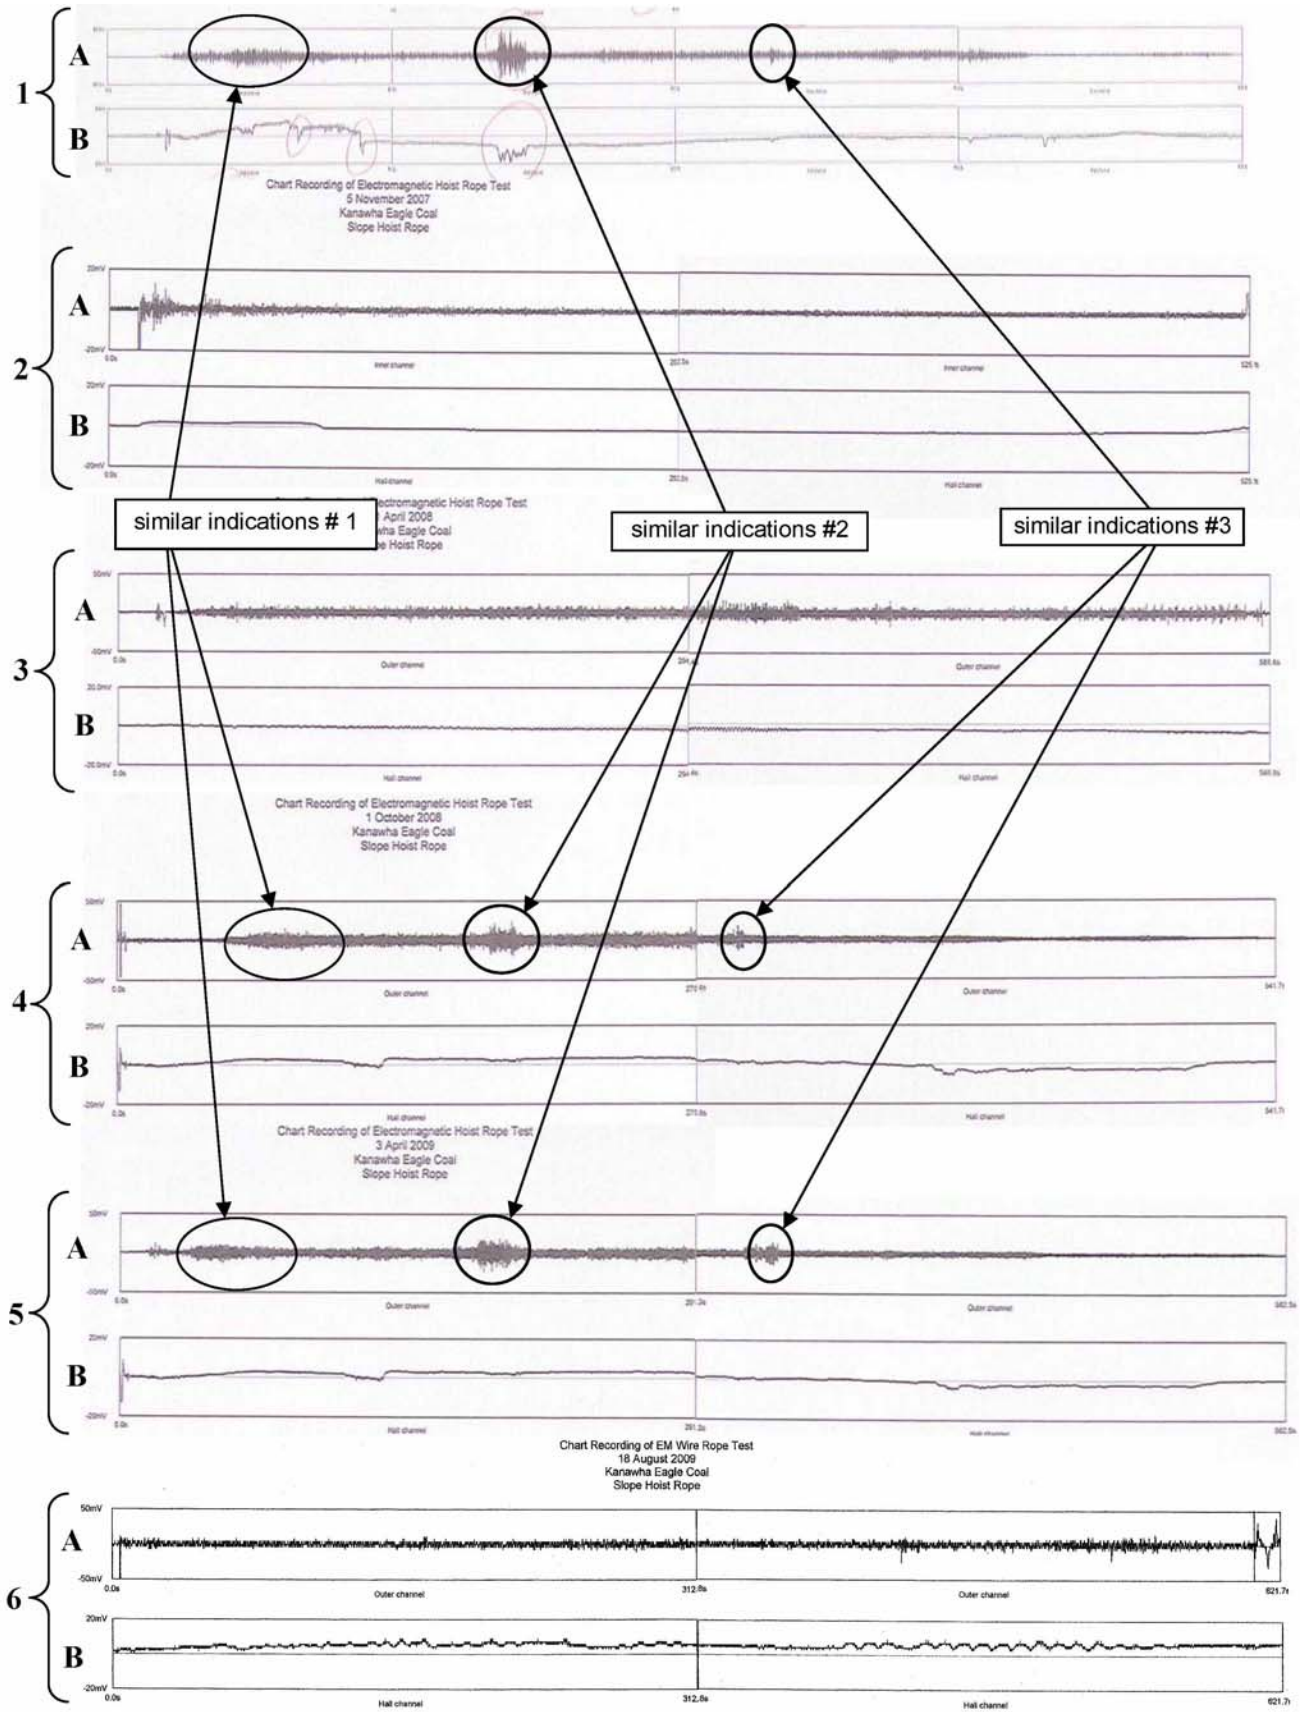
APPENDIX B Certified NDT Strip Charts

Tests 2 and 3 were the first tests performed on the new wire rope and don’t indicate significant damage or deterioration. Significant and similar damage and deterioration are identified in tests 1, 4, and 5. See “similar indications #1, #2, and #3” on Appendix B. These similarities show that the environmental conditions that caused deterioration to both wire ropes did not change. These environmental conditions included: water dripping onto the wire rope at the 1,180 to 1,227 foot mark in the slope, and water dripping on the wire rope at the 740 foot mark in the slope.

Test 6, the last test performed, does not show a progression of the damage or deterioration from tests 4 and 5. Rather, it shows practically no damage or deterioration. Test 6 resembles tests 2 and 3, the first tests on the new wire rope. Even though it was obvious that the charts from test 6 did not reflect the damage

and deterioration in the wire rope identified in the charts for the previous two tests, Certified NDT did not investigate the cause of this discrepancy, nor did it report this anomaly to the mine operator. Certified NDT failed to take action regarding the charts for test 6 that were obviously incorrect, inconsistent with previous tests, and showed that the condition of the wire rope improved.

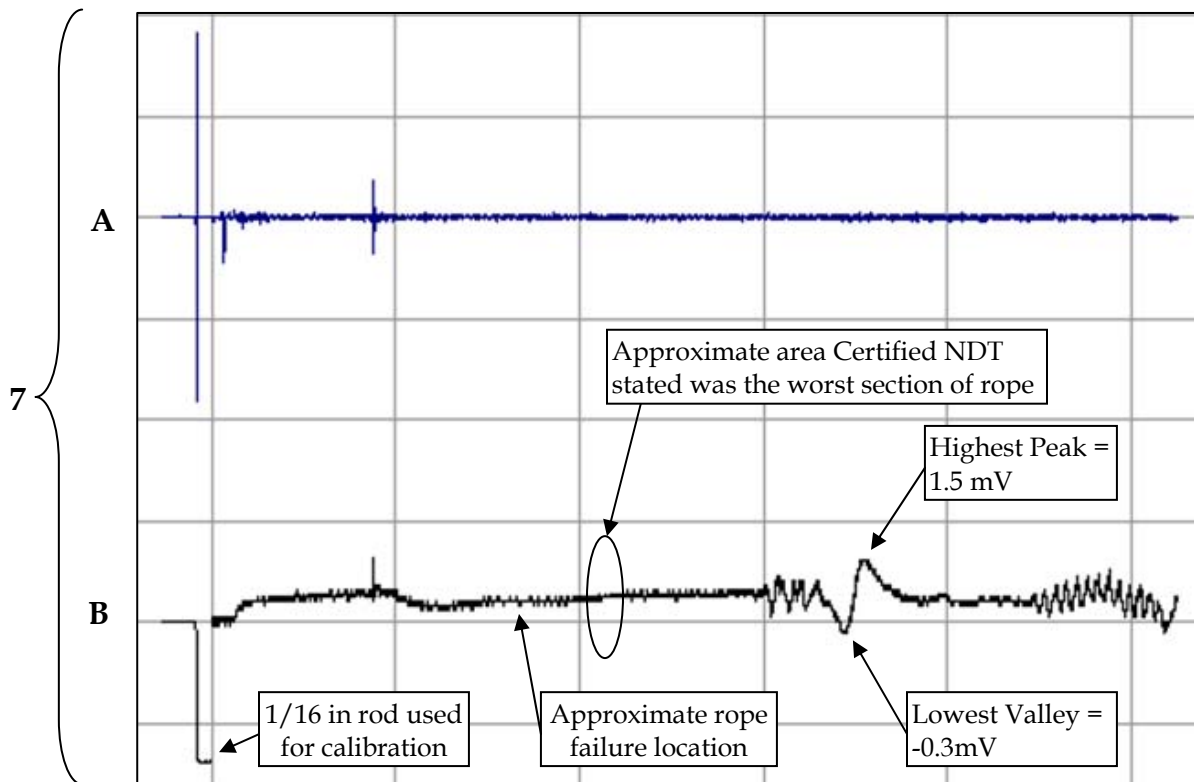
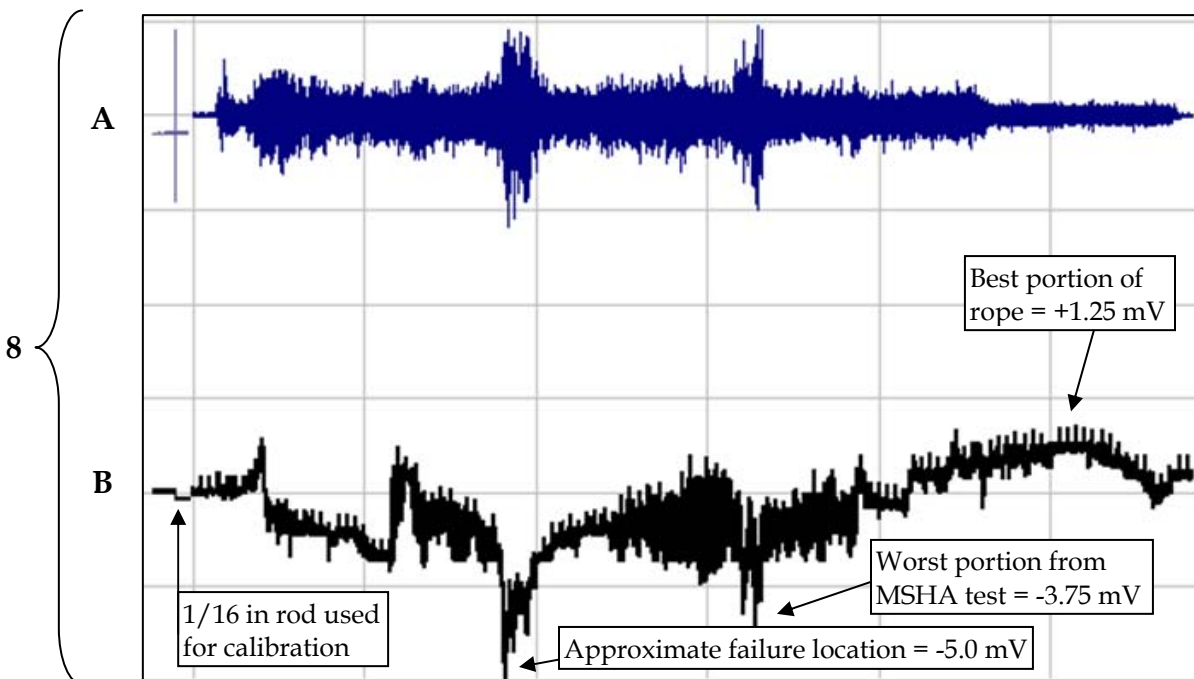
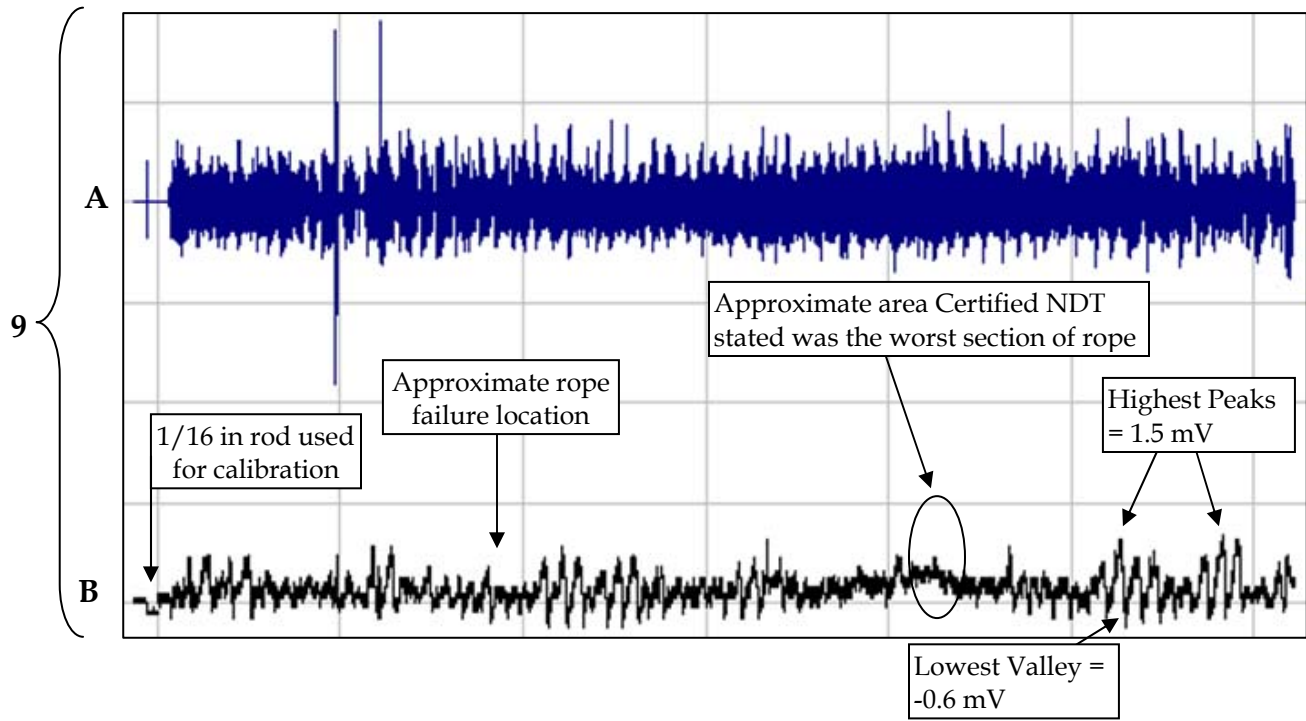
APPENDIX C
Certified NDT Electronic Data Charts

For test 5, the electronic data provided for chart A was generally consistent with the test results provided to the mine operator. However, the electronic data for chart B was significantly different than the chart made by Certified NDT. This analysis of chart B shows a maximum LMA of at least 14.97% and estimated LBS of at least 17.96%. This estimated LBS exceeds the LBS retirement criterion of 10% (§ 75.1434(h)). Unfortunately, the contractor incorrectly reported a LMA of 5.12%, an estimated LBS of 6.14%, and that the wire rope was in satisfactory condition and in compliance with 30 CFR. Certified NDT did not report to the mine operator that the electronic data showed that the wire rope exceeded the retirement criterion, and not recommending that the wire rope be immediately removed from service.

For test 6, the electronic data shows a maximum LMA of 3.35% and an estimated LBS of 4.02%. This data is dramatically inconsistent with the data from the previous test, which shows a maximum LMA of 14.97% and estimated LBS of 17.96%, because it suggests that the wire rope gained a substantial amount of metal. This is a physical impossibility. Certified NDT failed to address obvious inconsistencies between the electronic data from tests 5 and 6, which should have alerted Certified NDT that its analyses were significantly flawed.
