REPORT OF INVESTIGATION

Underground Coal Mine

Fatal Injury, Other Accident
November 23, 2009

No. 7 Mine
Jim Walter Resources, Inc.
Brookwood, Tuscaloosa County, Alabama
MSHA I.D. No. 01-01401

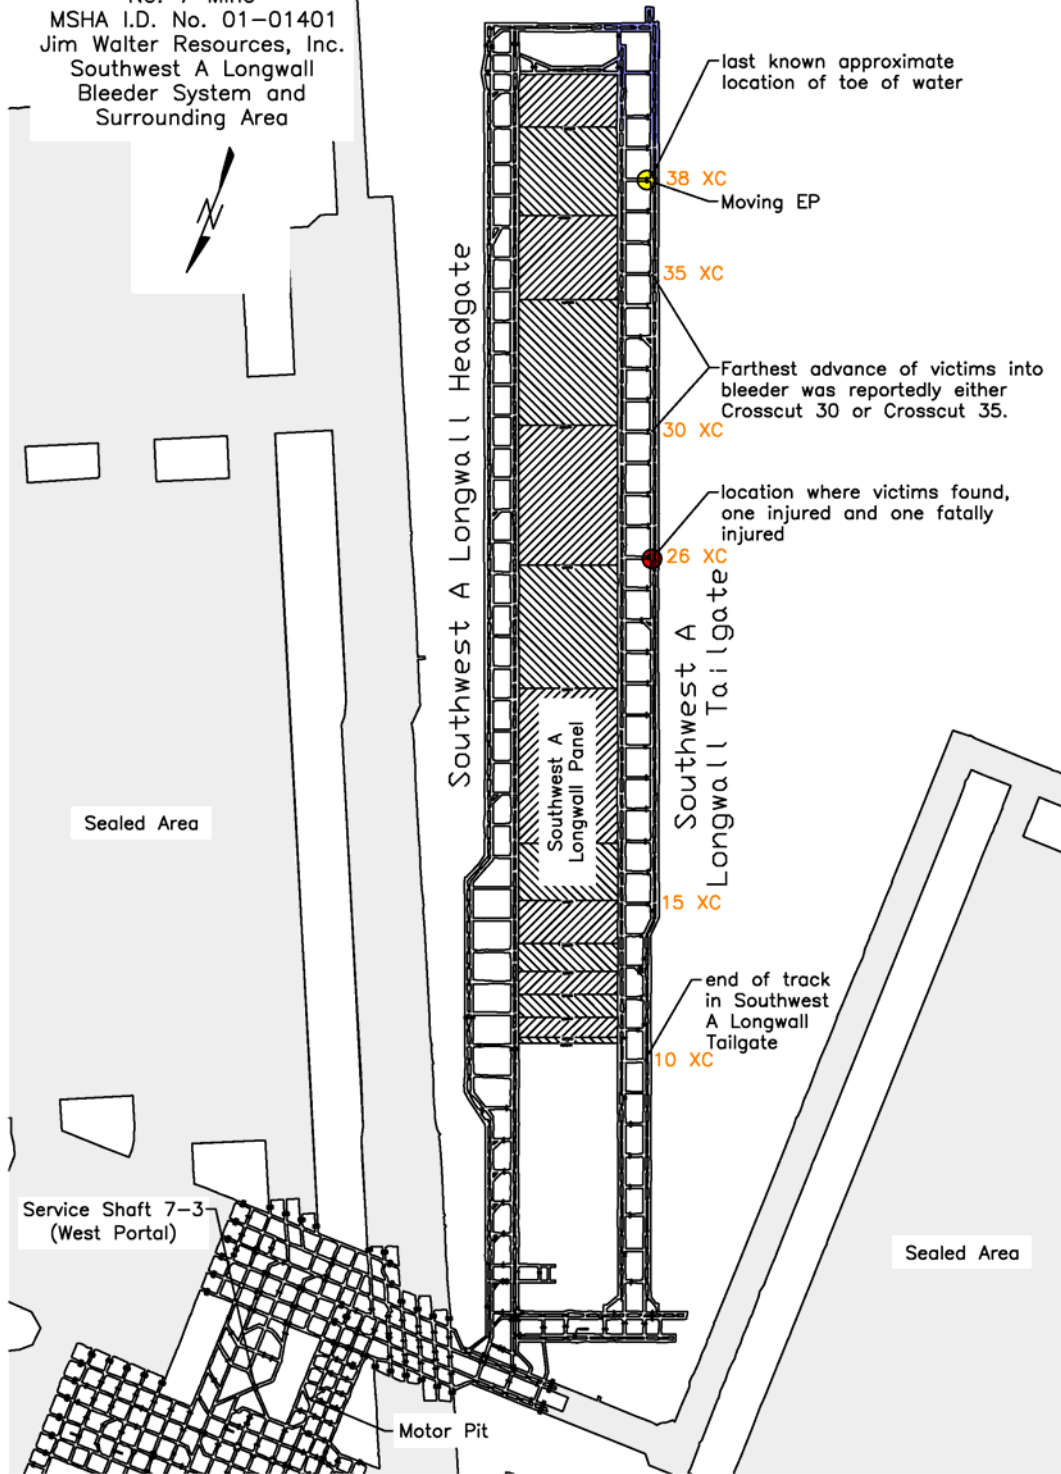
No. 7 Mine
MSHA I.D. No. 01-01401
Jim Walter Resources, Inc.
Southwest A Longwall
Bleeder System and
Surrounding Area

last known approximate location of toe of water

location where victims found, one injured and one fatally injured

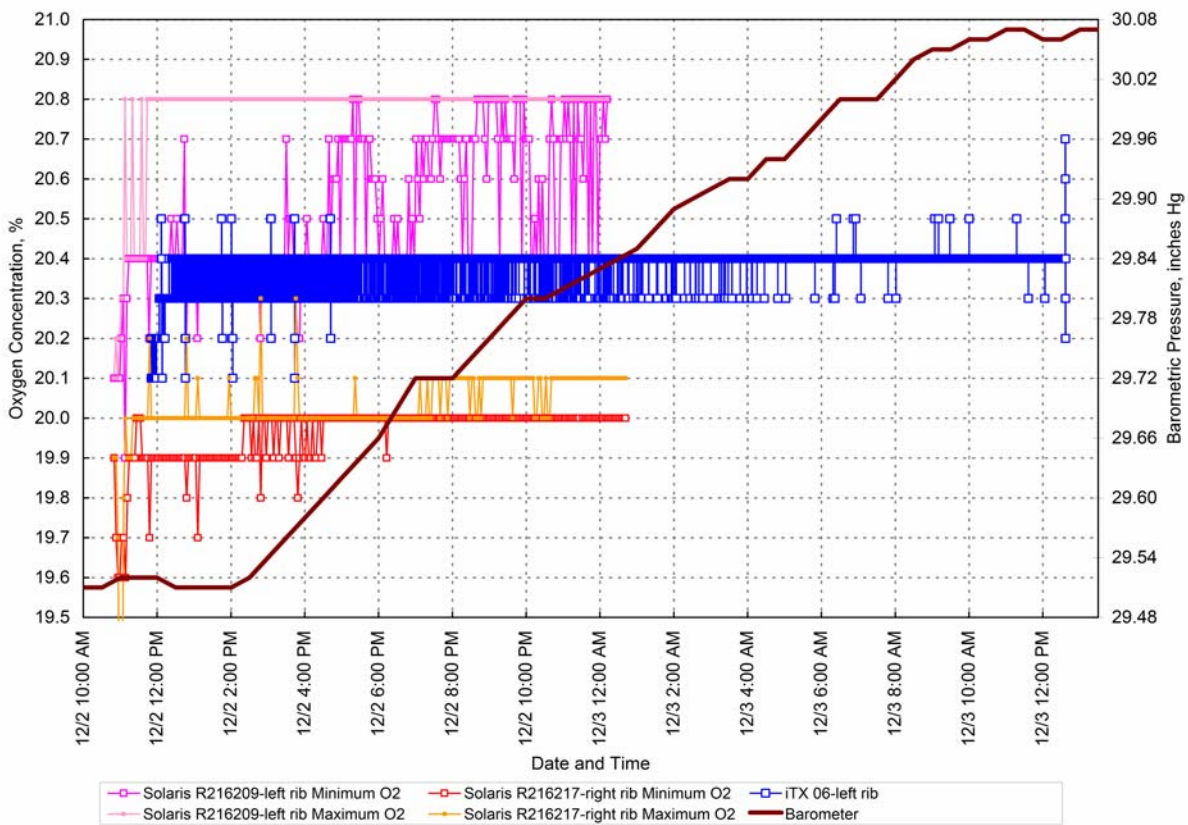
Figure 1. Comparison of Oxygen Concentrations at TG EP 5 and the Barometric Pressure During the MSHA Continuous Monitoring Study on December 2-3, 2009.

Figures 1 and 2 depict the recorded oxygen concentrations and methane concentrations, respectively, along with the barometric pressure during the study period. The data suggested increases occurred in the concentrations of oxygen and decreases occurred in the concentrations of methane in the airflow exiting the Southwest A Longwall bleeder system due to an increase in the barometric pressure. The changes observed at the monitoring location would likely have been less pronounced than that which could have occurred in airflow that ventilated the worked-out area of the Southwest A Longwall Panel deeper in the bleeder system.

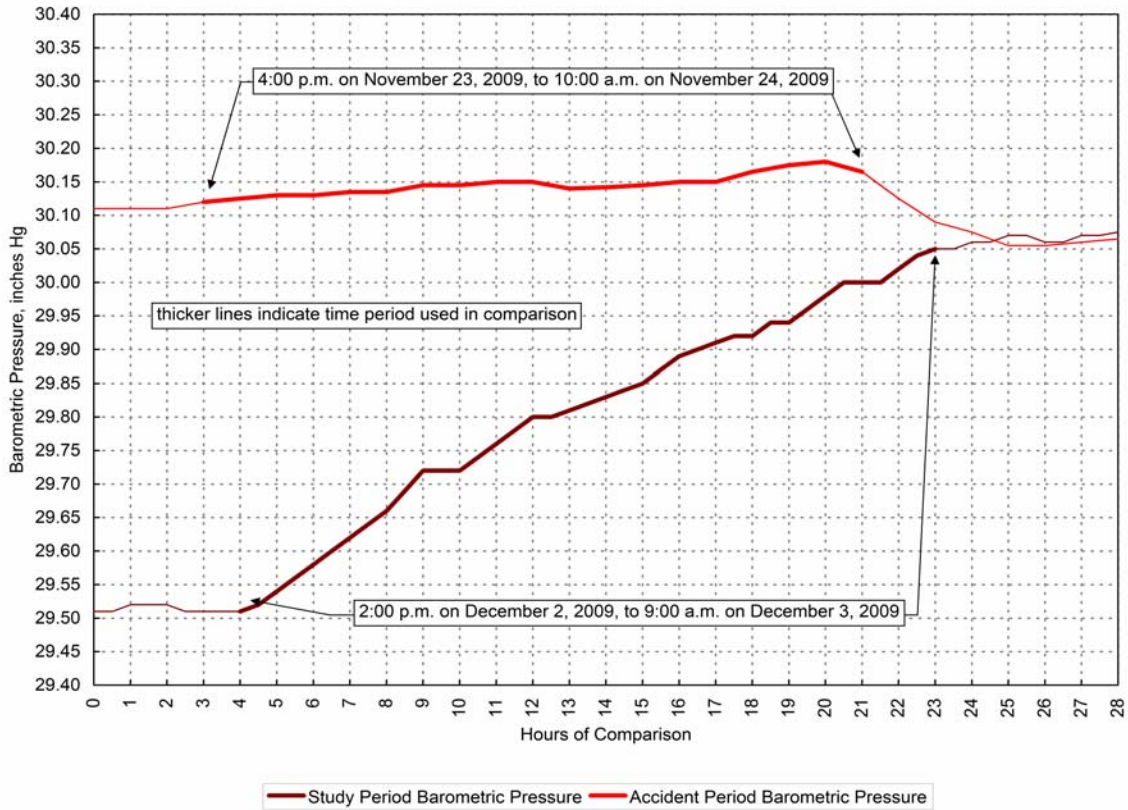
Figure 3. Comparison of Barometric Pressure During the MSHA Continuous Monitoring Study on December 2-3, 2009, and the Barometric Pressure During the Accident on November 23-24, 2009.

The comparison indicates the changes in barometric pressure that occurred during the MSHA continuous monitoring study were much greater than those that occurred during the time just before Ethridge and Chaney entered the bleeder on November 23, 2009, until the ventilation change was completed on November 24, 2009. Further, those barometric changes on November 23-24, 2009, were not severe. Investigators concluded that in a well ventilated bleeder system the barometric pressure changes that occurred on November 23-24, 2009, would not likely have contributed significantly to changes in the air quality.

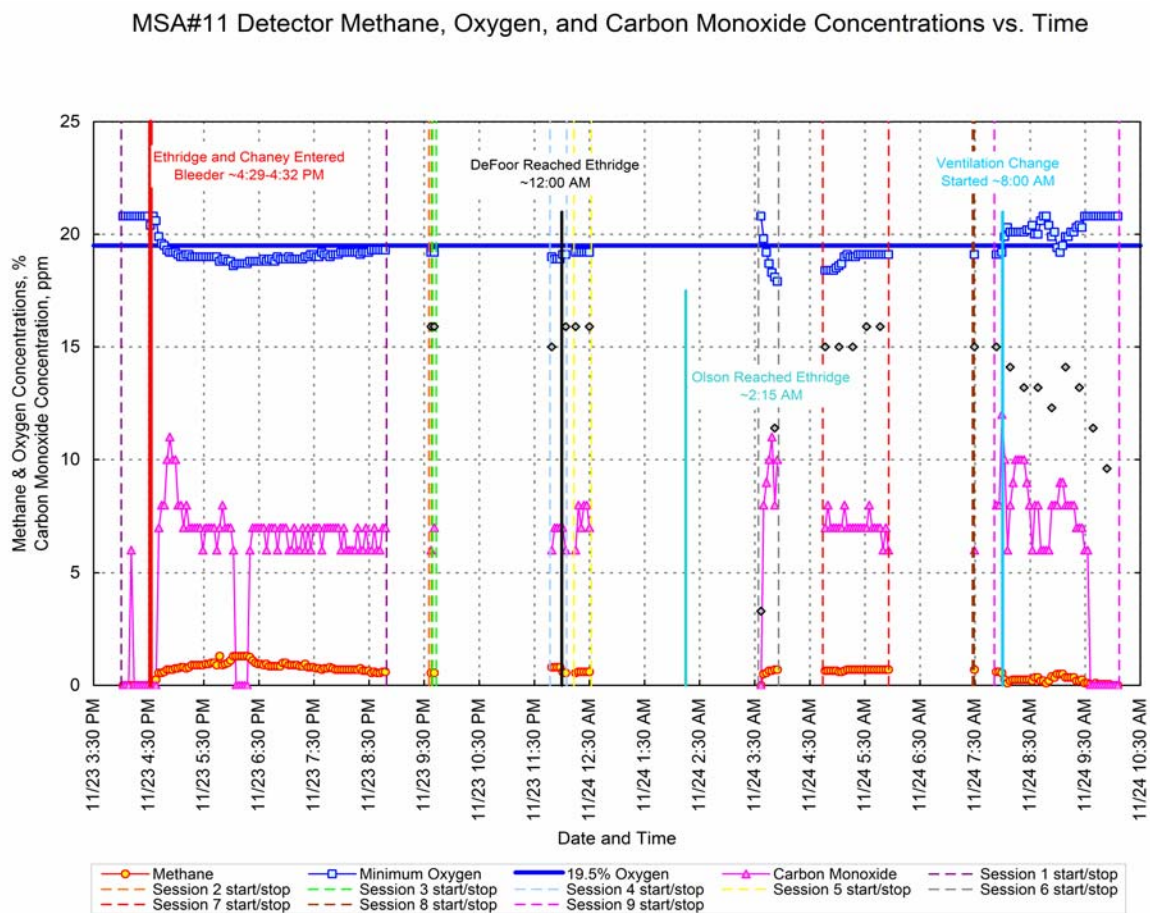
Figure 4. Ethridge's MSA#11 Detector Methane, Oxygen, and Carbon Monoxide Data from November 23-24, 2009.

Information from Ethridge's MSA#11 detector data log is contained in the figures below. The data log indicated there were nine sessions recorded between approximately 4:00 p.m. on November 23, 2009, and 10:07 a.m. on November 24, 2009. Figure 4 depicts methane, oxygen, and carbon monoxide data from these nine sessions as well as the estimated times of pertinent events that occurred while the detector was underground. These sessions are identified as Session 1 through Session 9.

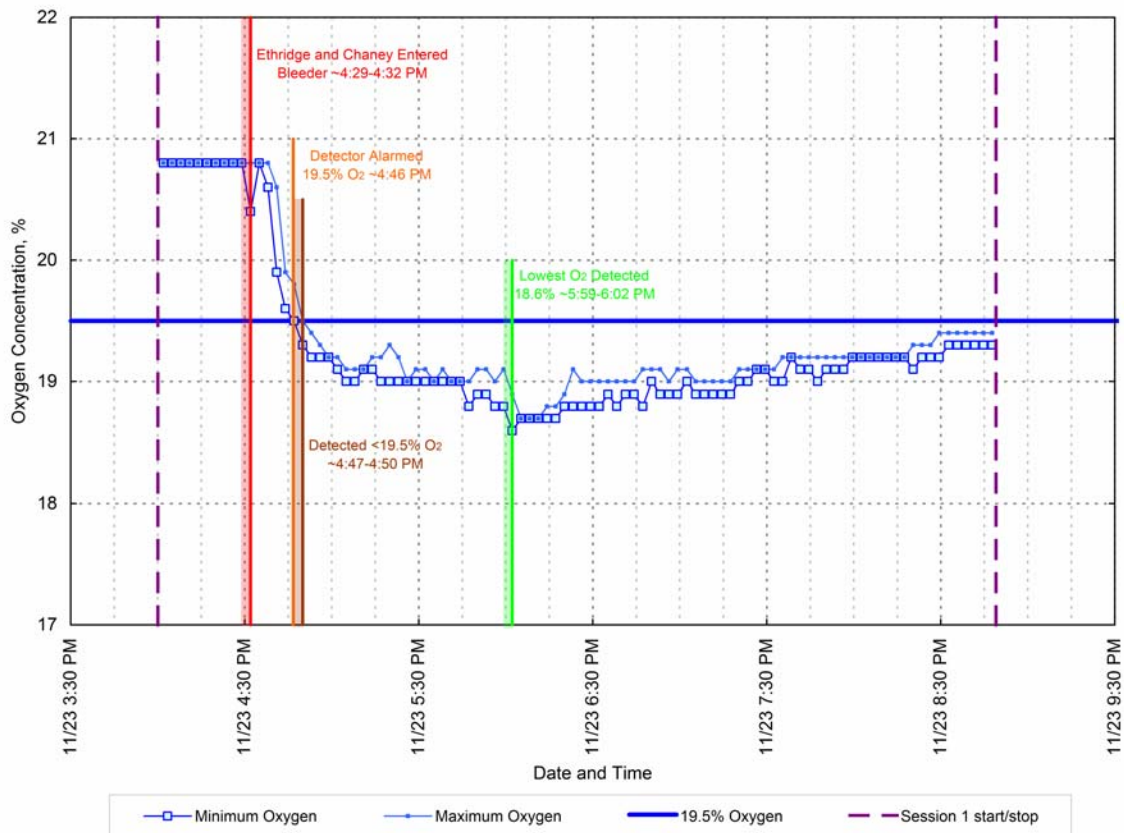
Figure 5. Ethridge’s MSA#11 Detector Session 1 Oxygen Data from November 23, 2009.

Session 1 began at approximately 4:00 p.m. and ended at approximately 8:49 p.m. on November 23, 2009. Figure 5 depicts the minimum and maximum oxygen concentrations recorded during Session 1. It was during Session 1 that Ethridge and Chaney entered the Southwest A Longwall bleeder. Estimated times of notable events

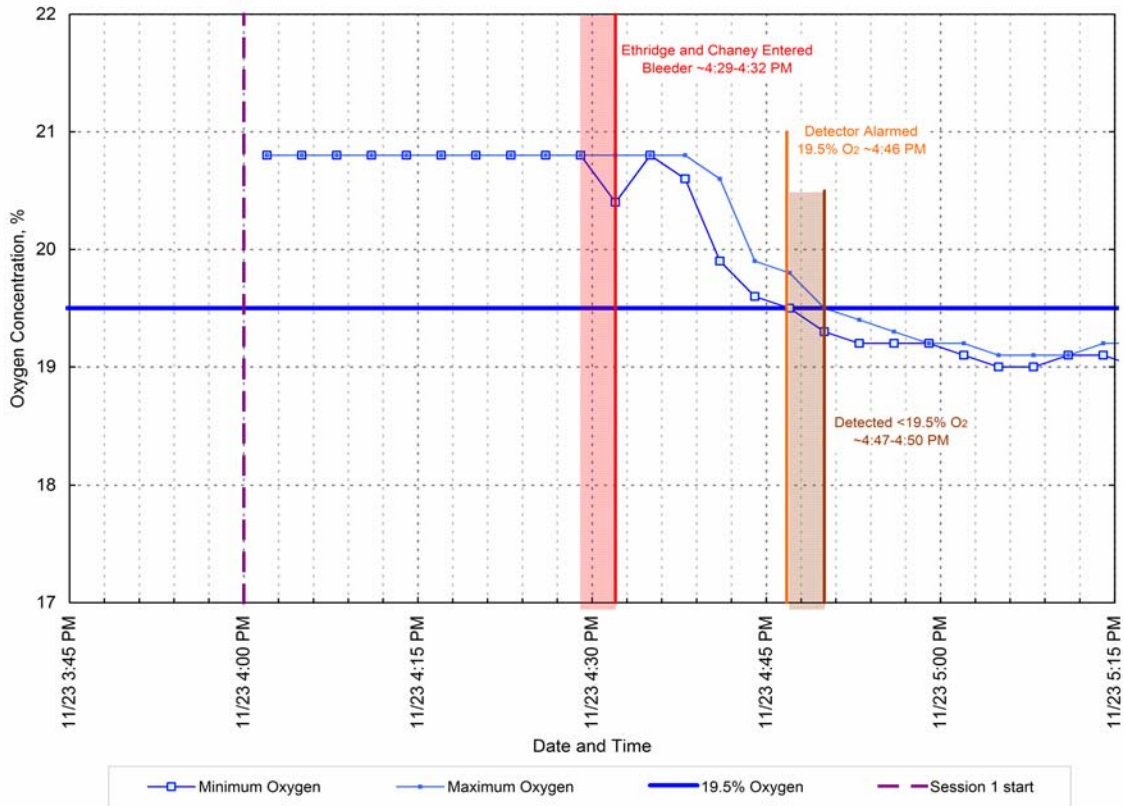
Figure 6. Ethridge’s MSA#11 Detector Session 1 Oxygen Data During Initial Travel in Southwest A Longwall Bleeder on November 23, 2009.

Figure 6 emphasizes the oxygen concentrations recorded during the first 45 minutes after Ethridge and Chaney entered the Southwest A Longwall bleeder. The minimum and maximum oxygen concentrations recorded are shown. Estimated times of notable events depicted include: the time Ethridge and Chaney entered the bleeder through the regulator located inby Crosscut 11; the time the detector first alarmed for oxygen at 19.50%; and the time the detector first recorded an oxygen concentration of less than 19.50%.

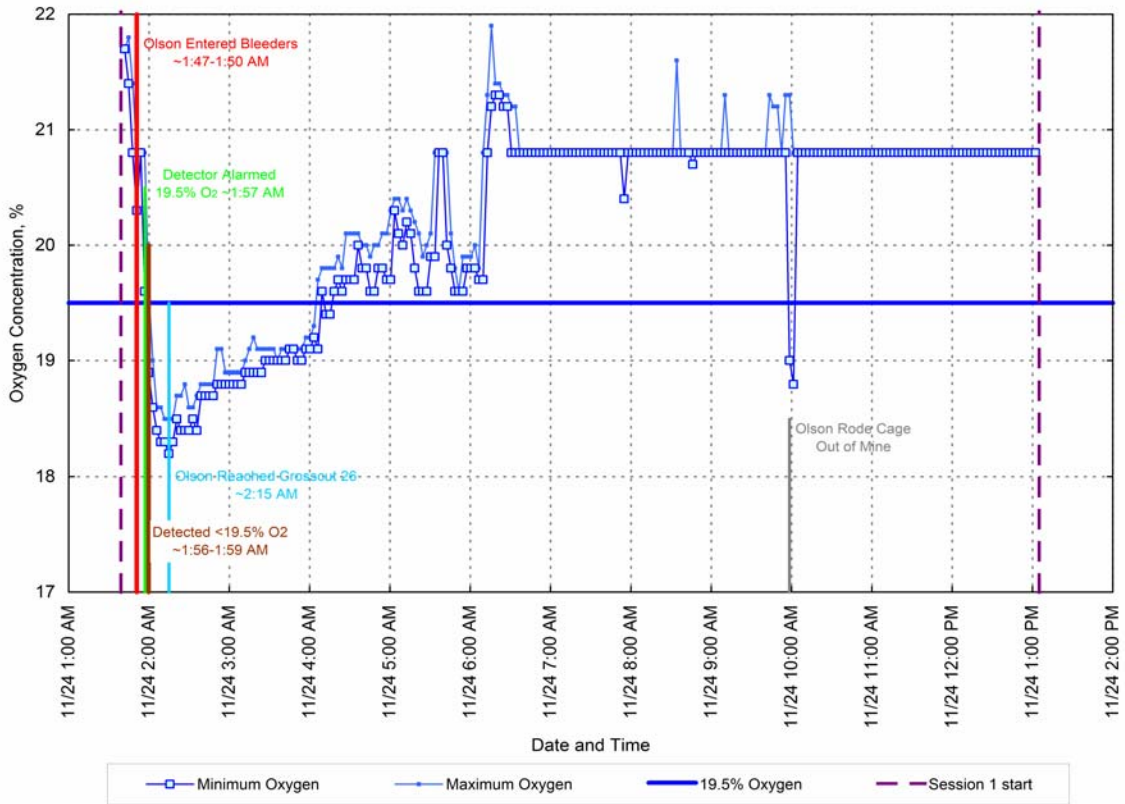
Figure 8. Olson's MSA#4 Detector Oxygen Data on November 24, 2009.

Figure 8 depicts the minimum and maximum oxygen concentrations recorded during the entire session. Figure 9 emphasizes the oxygen concentrations recorded during Olson’s initial travel to Crosscut 26. Estimated times of notable events are also depicted on these figures.

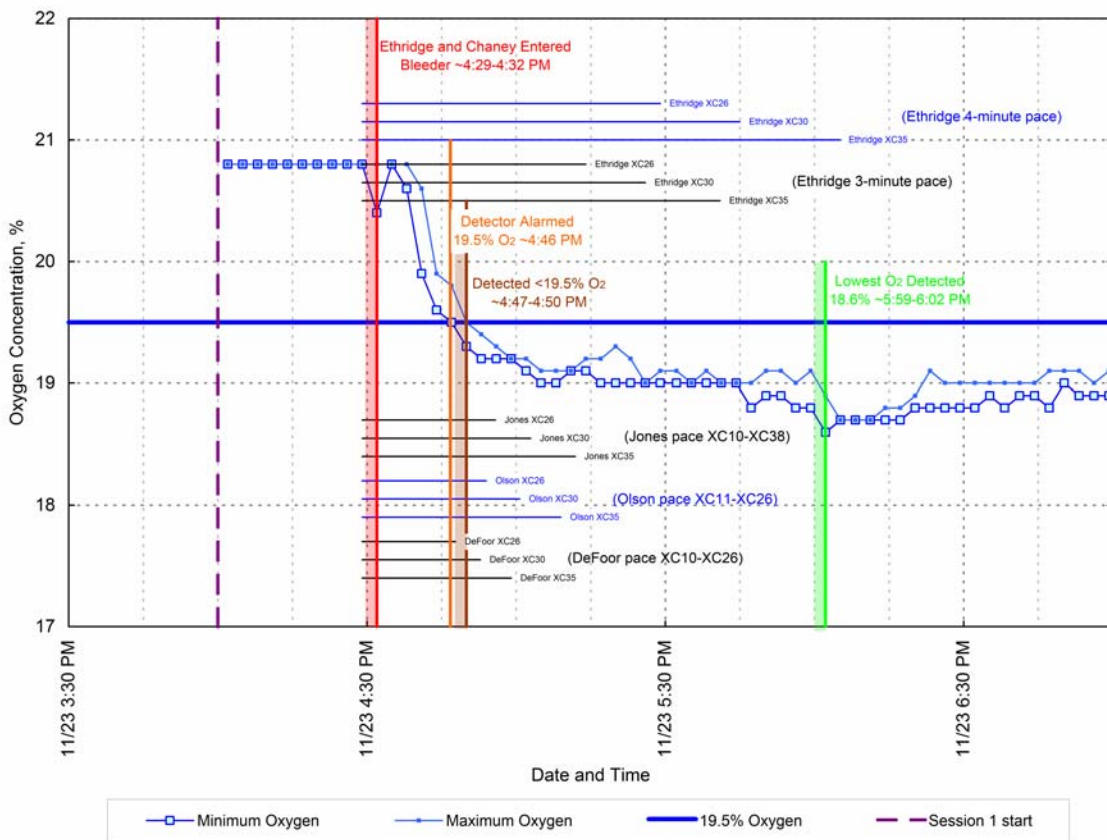
Figure 10. Comparison of Estimated Travel Times in the Southwest A Longwall Bleeder and Ethridge’s MSA#11 Detector Oxygen Data on November 23, 2009.

Ethridge indicated during interview statements that he and Chaney traveled to Crosscut 30 or to Crosscut 35 before deciding to turn around and exit the bleeder. His recollections of all the events were not clear. While they were moving Ethridge out of the bleeder, somewhere between Crosscut 25 and Crosscut 26, Olson asked him how far he and Chaney had gone and Ethridge reportedly told Olson, “This is as far as we got.” Ethridge later told Olson that they had gotten further in, possibly Crosscut 30 or

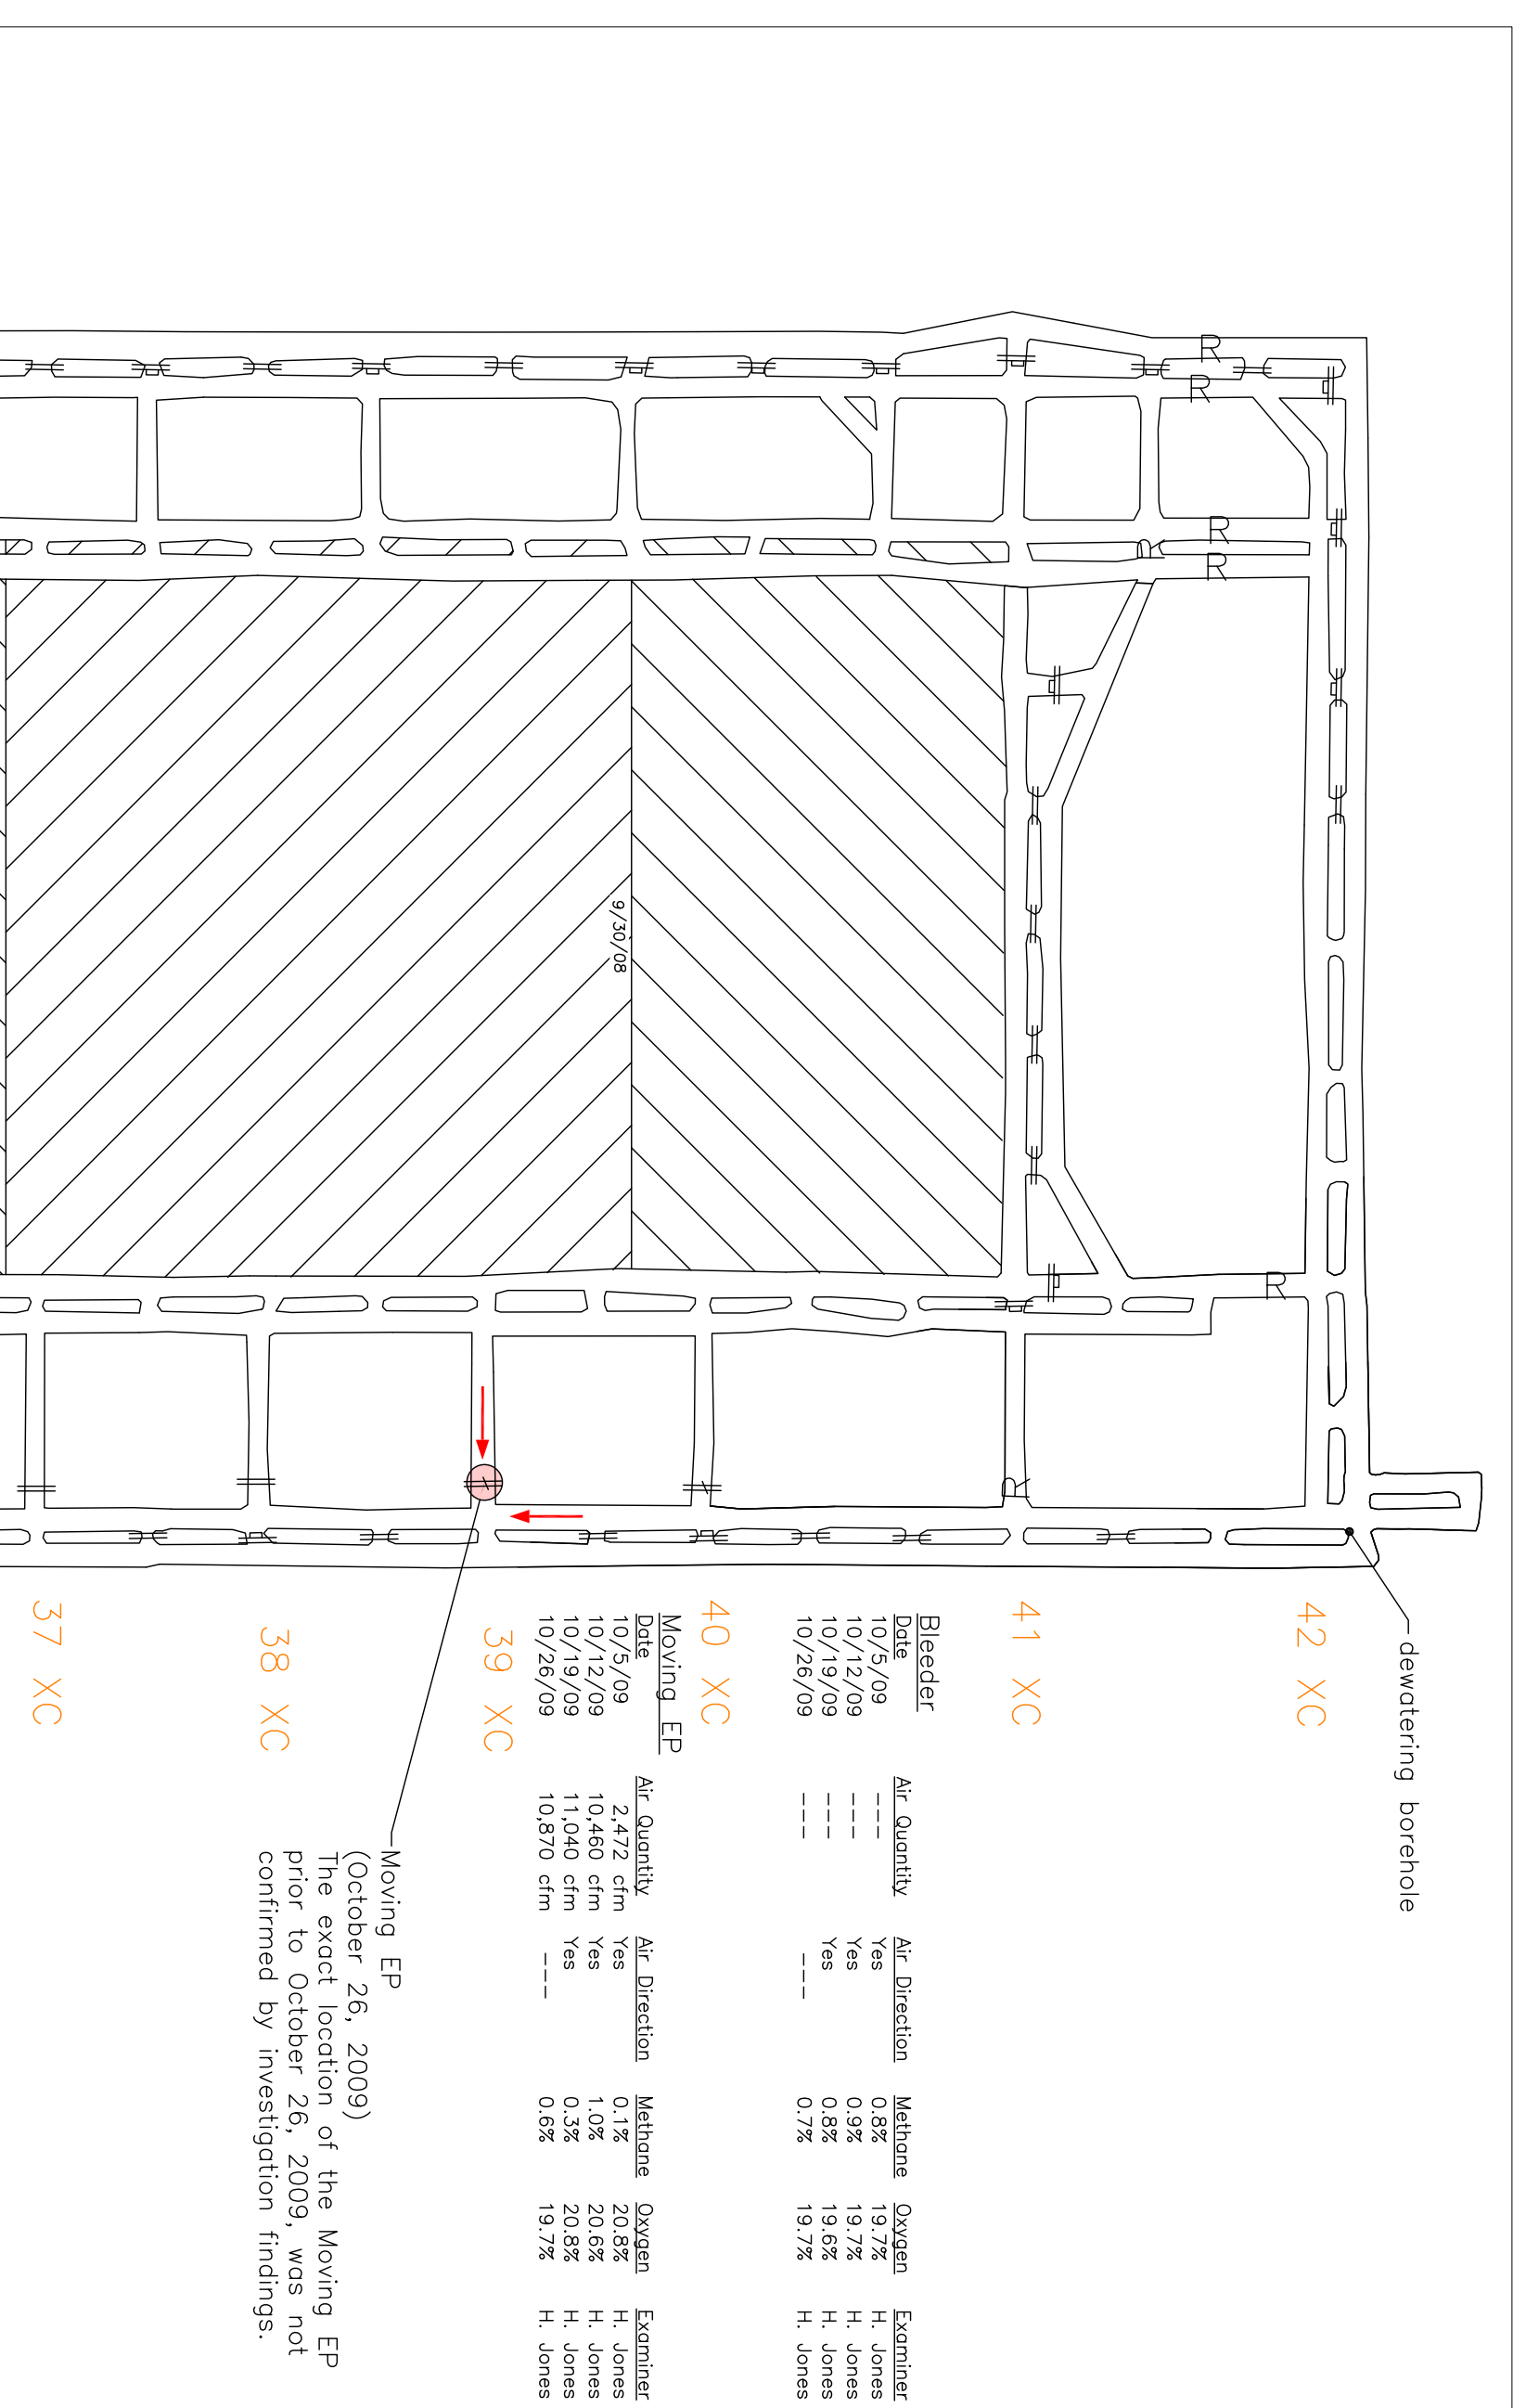
Detail 1A — Results of recorded weekly examinations performed at the Southwest A Longwall Tailgate Moving EP and the “poorest” air quality detected in the bleeder entries while the longwall face was ventilated from Headgate to Tailgate.

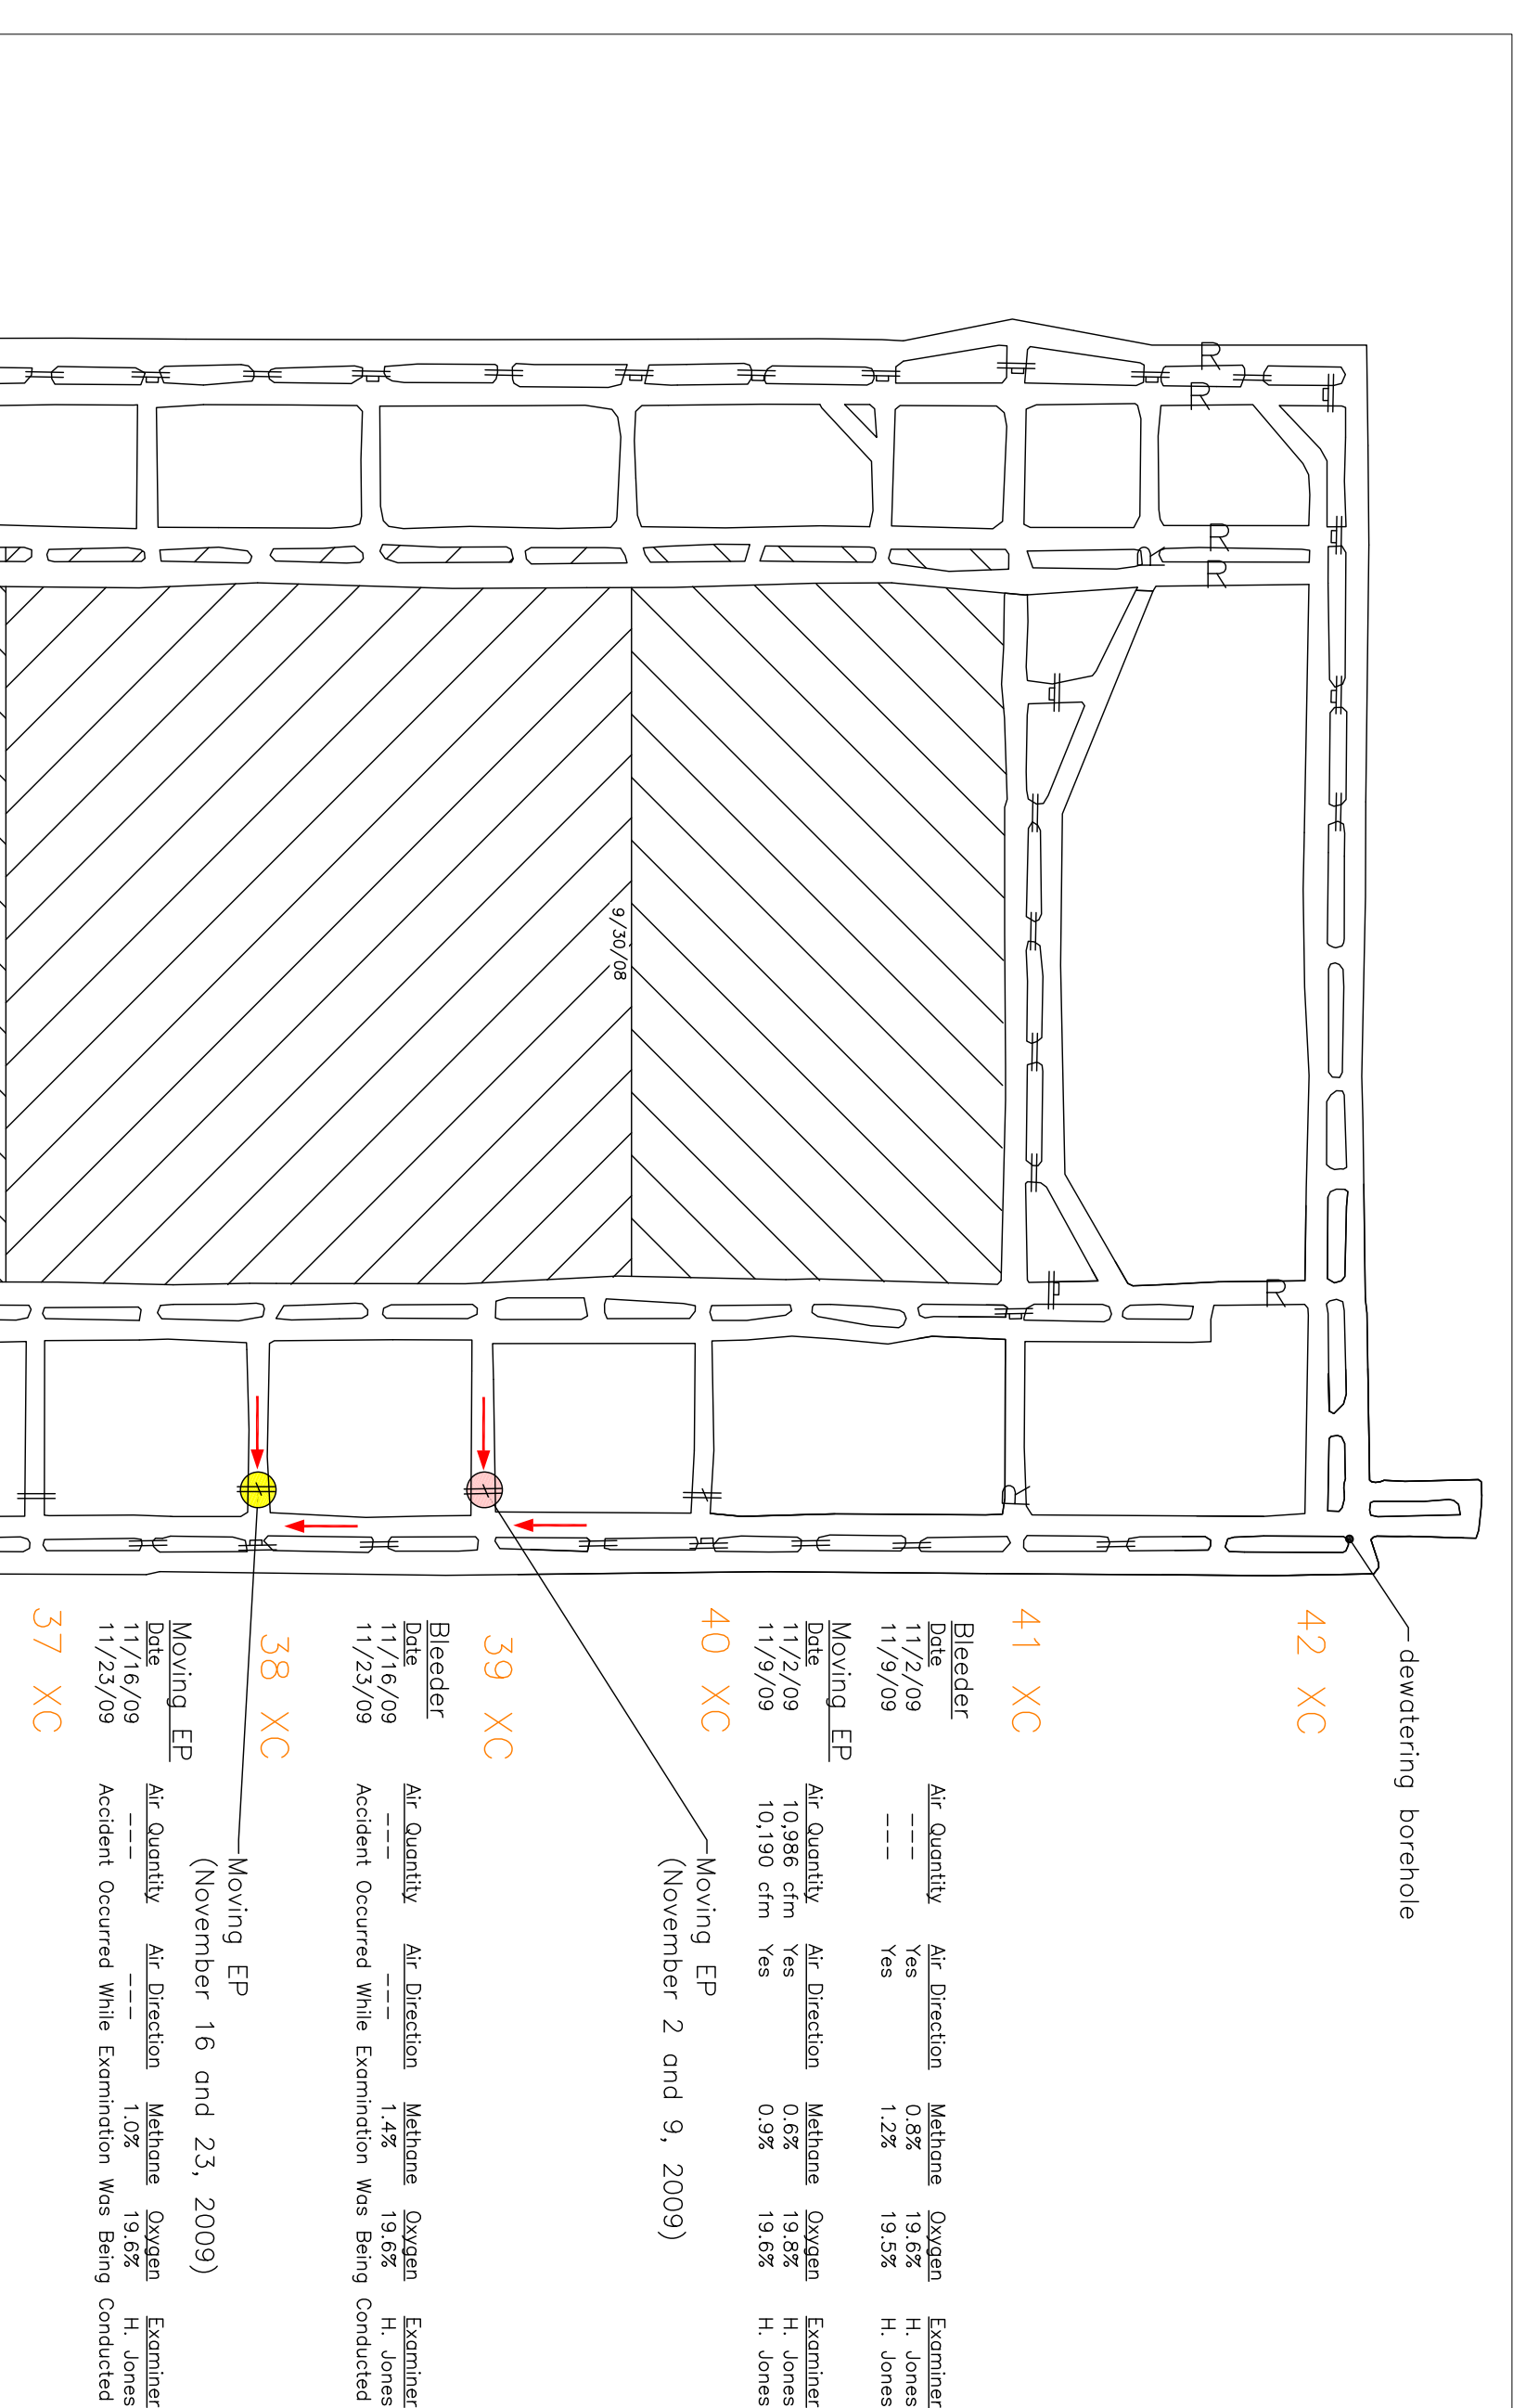
Detail 1B — Results of recorded weekly examinations performed at the Southwest A Longwall Tailgate Moving EP and the “poorest” air quality detected in the bleeder entries while the longwall face was ventilated from Tailgate to Headgate.

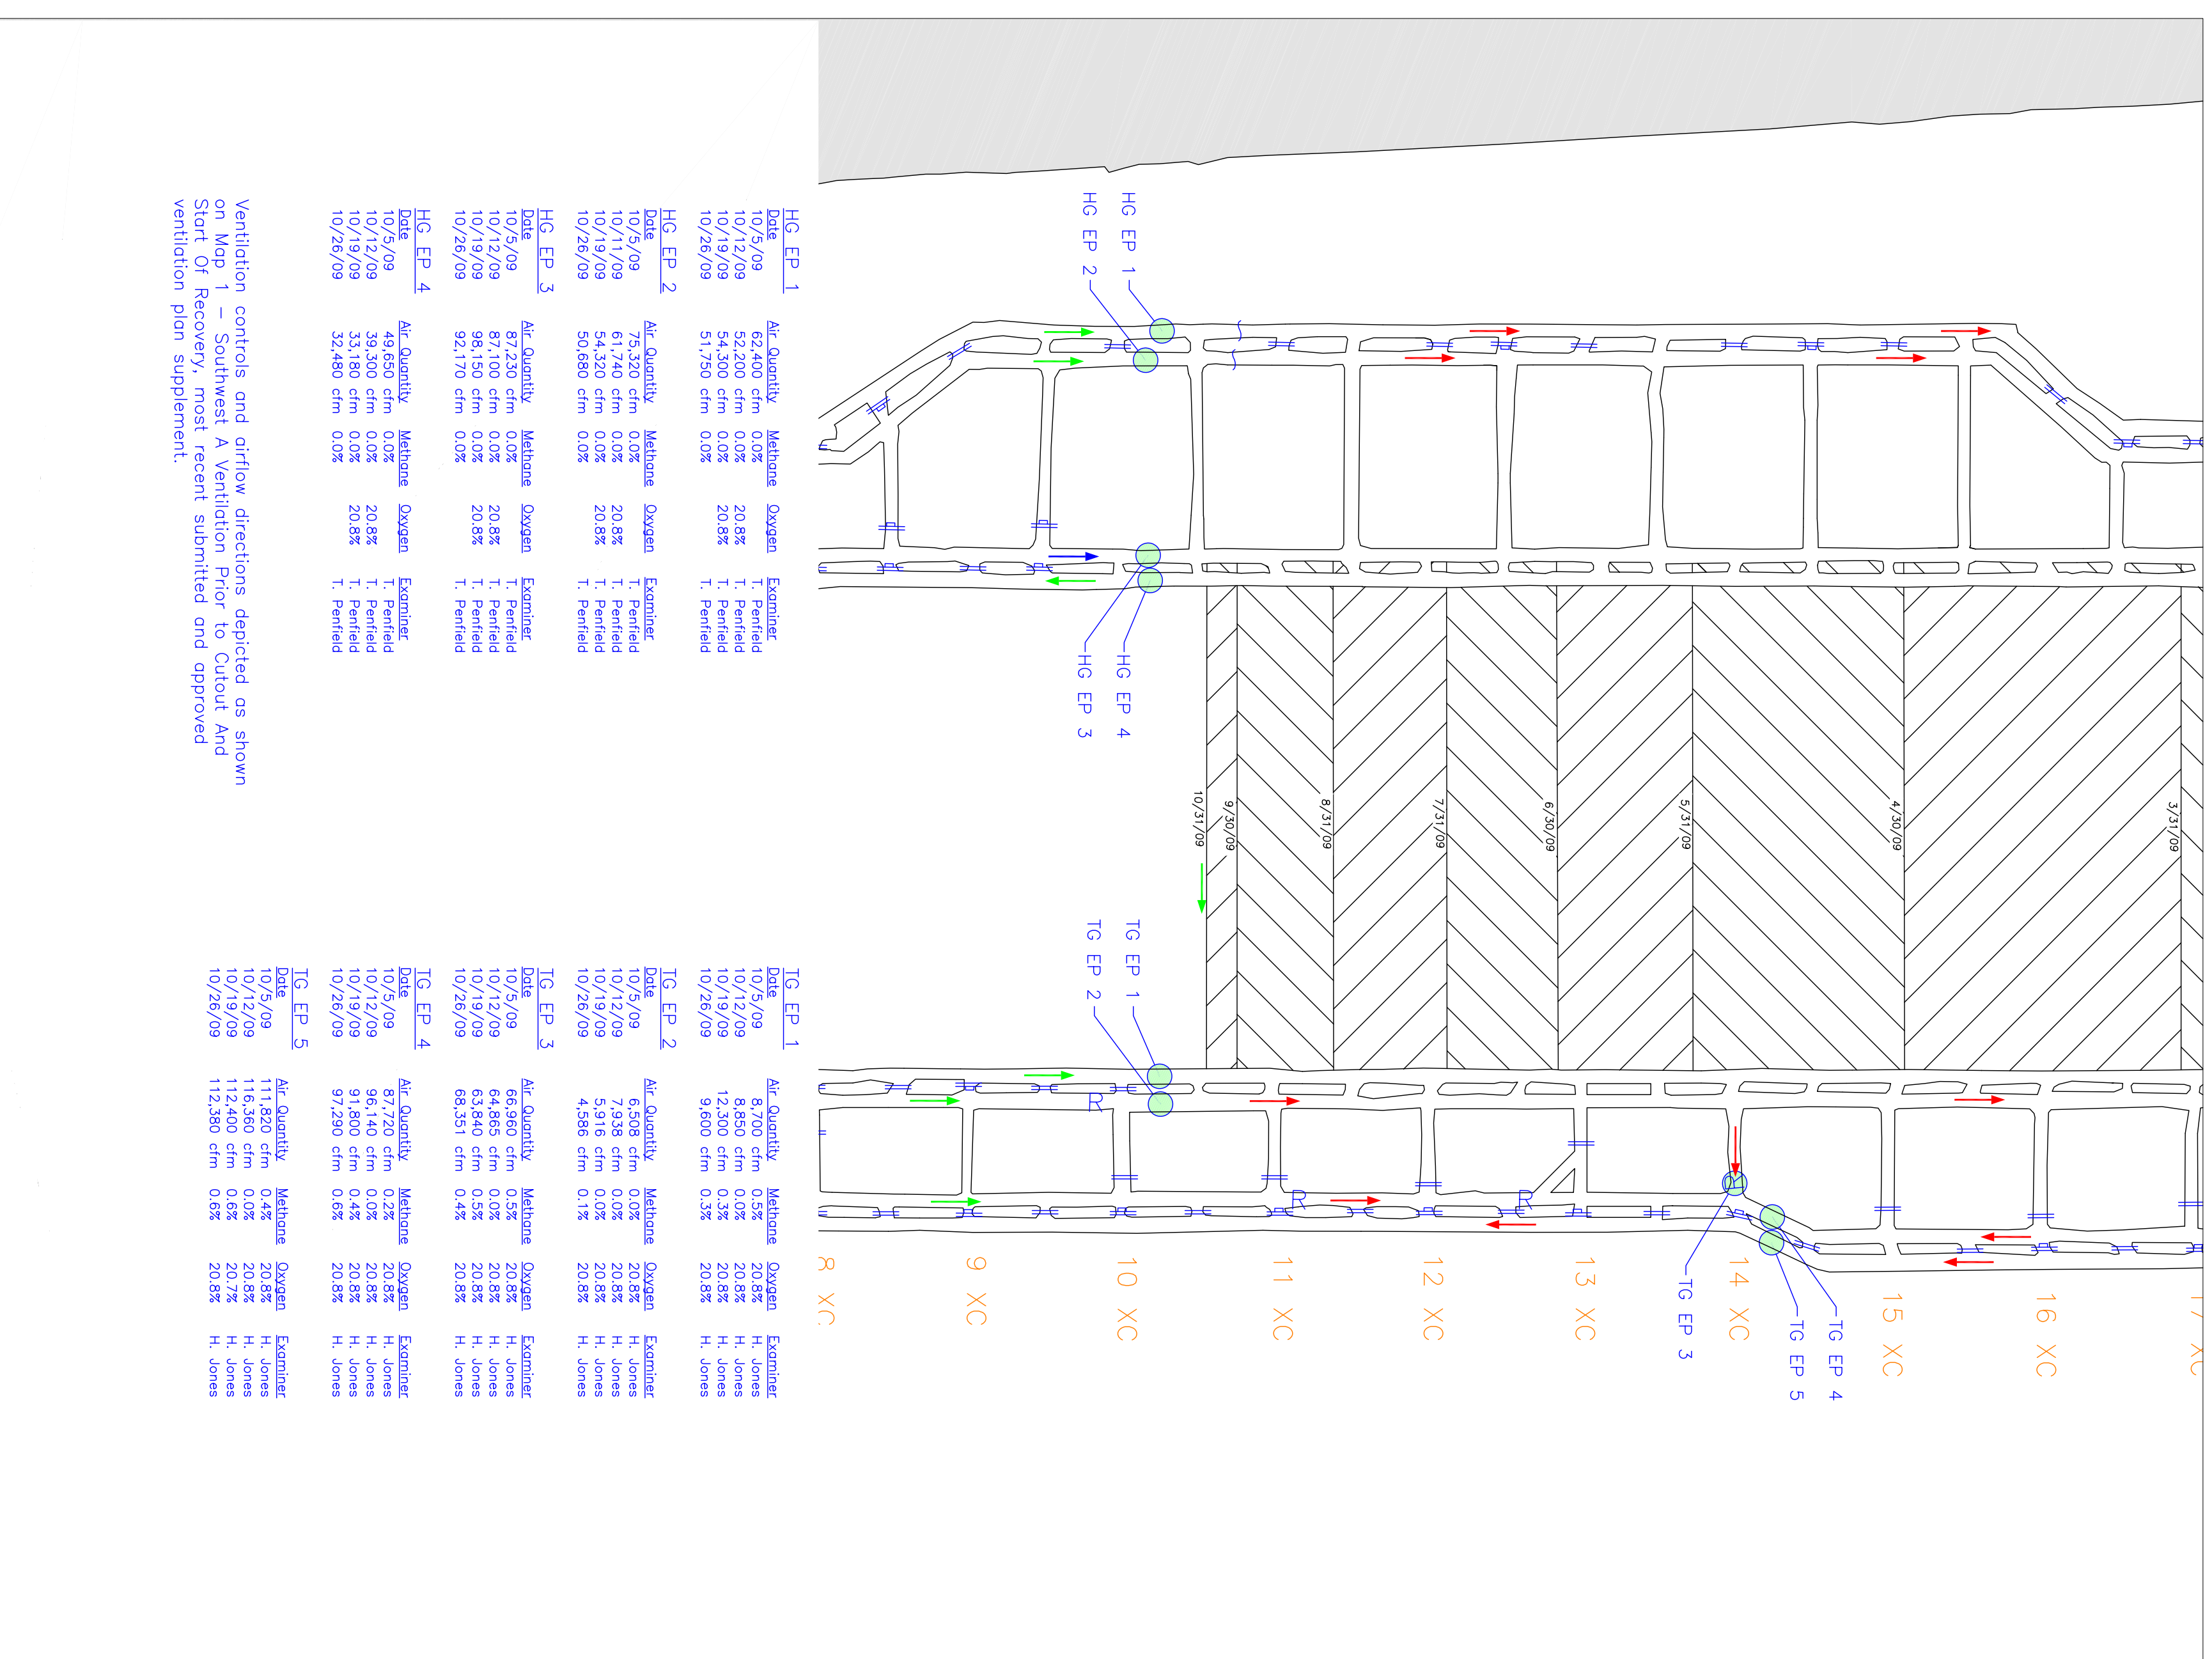
Detail 2A — Results of recorded daily examinations performed at the Southwest A Longwall Headgate and Tailgate EPs located near the longwall face while the longwall face was ventilated from Headgate to Tailgate.
