REPORT OF INVESTIGATION

Underground Coal Mine

Fatal Injury, Other Accident
November 23, 2009

No. 7 Mine
Jim Walter Resources, Inc.
Brookwood, Tuscaloosa County, Alabama
MSHA I.D. No. 01-01401

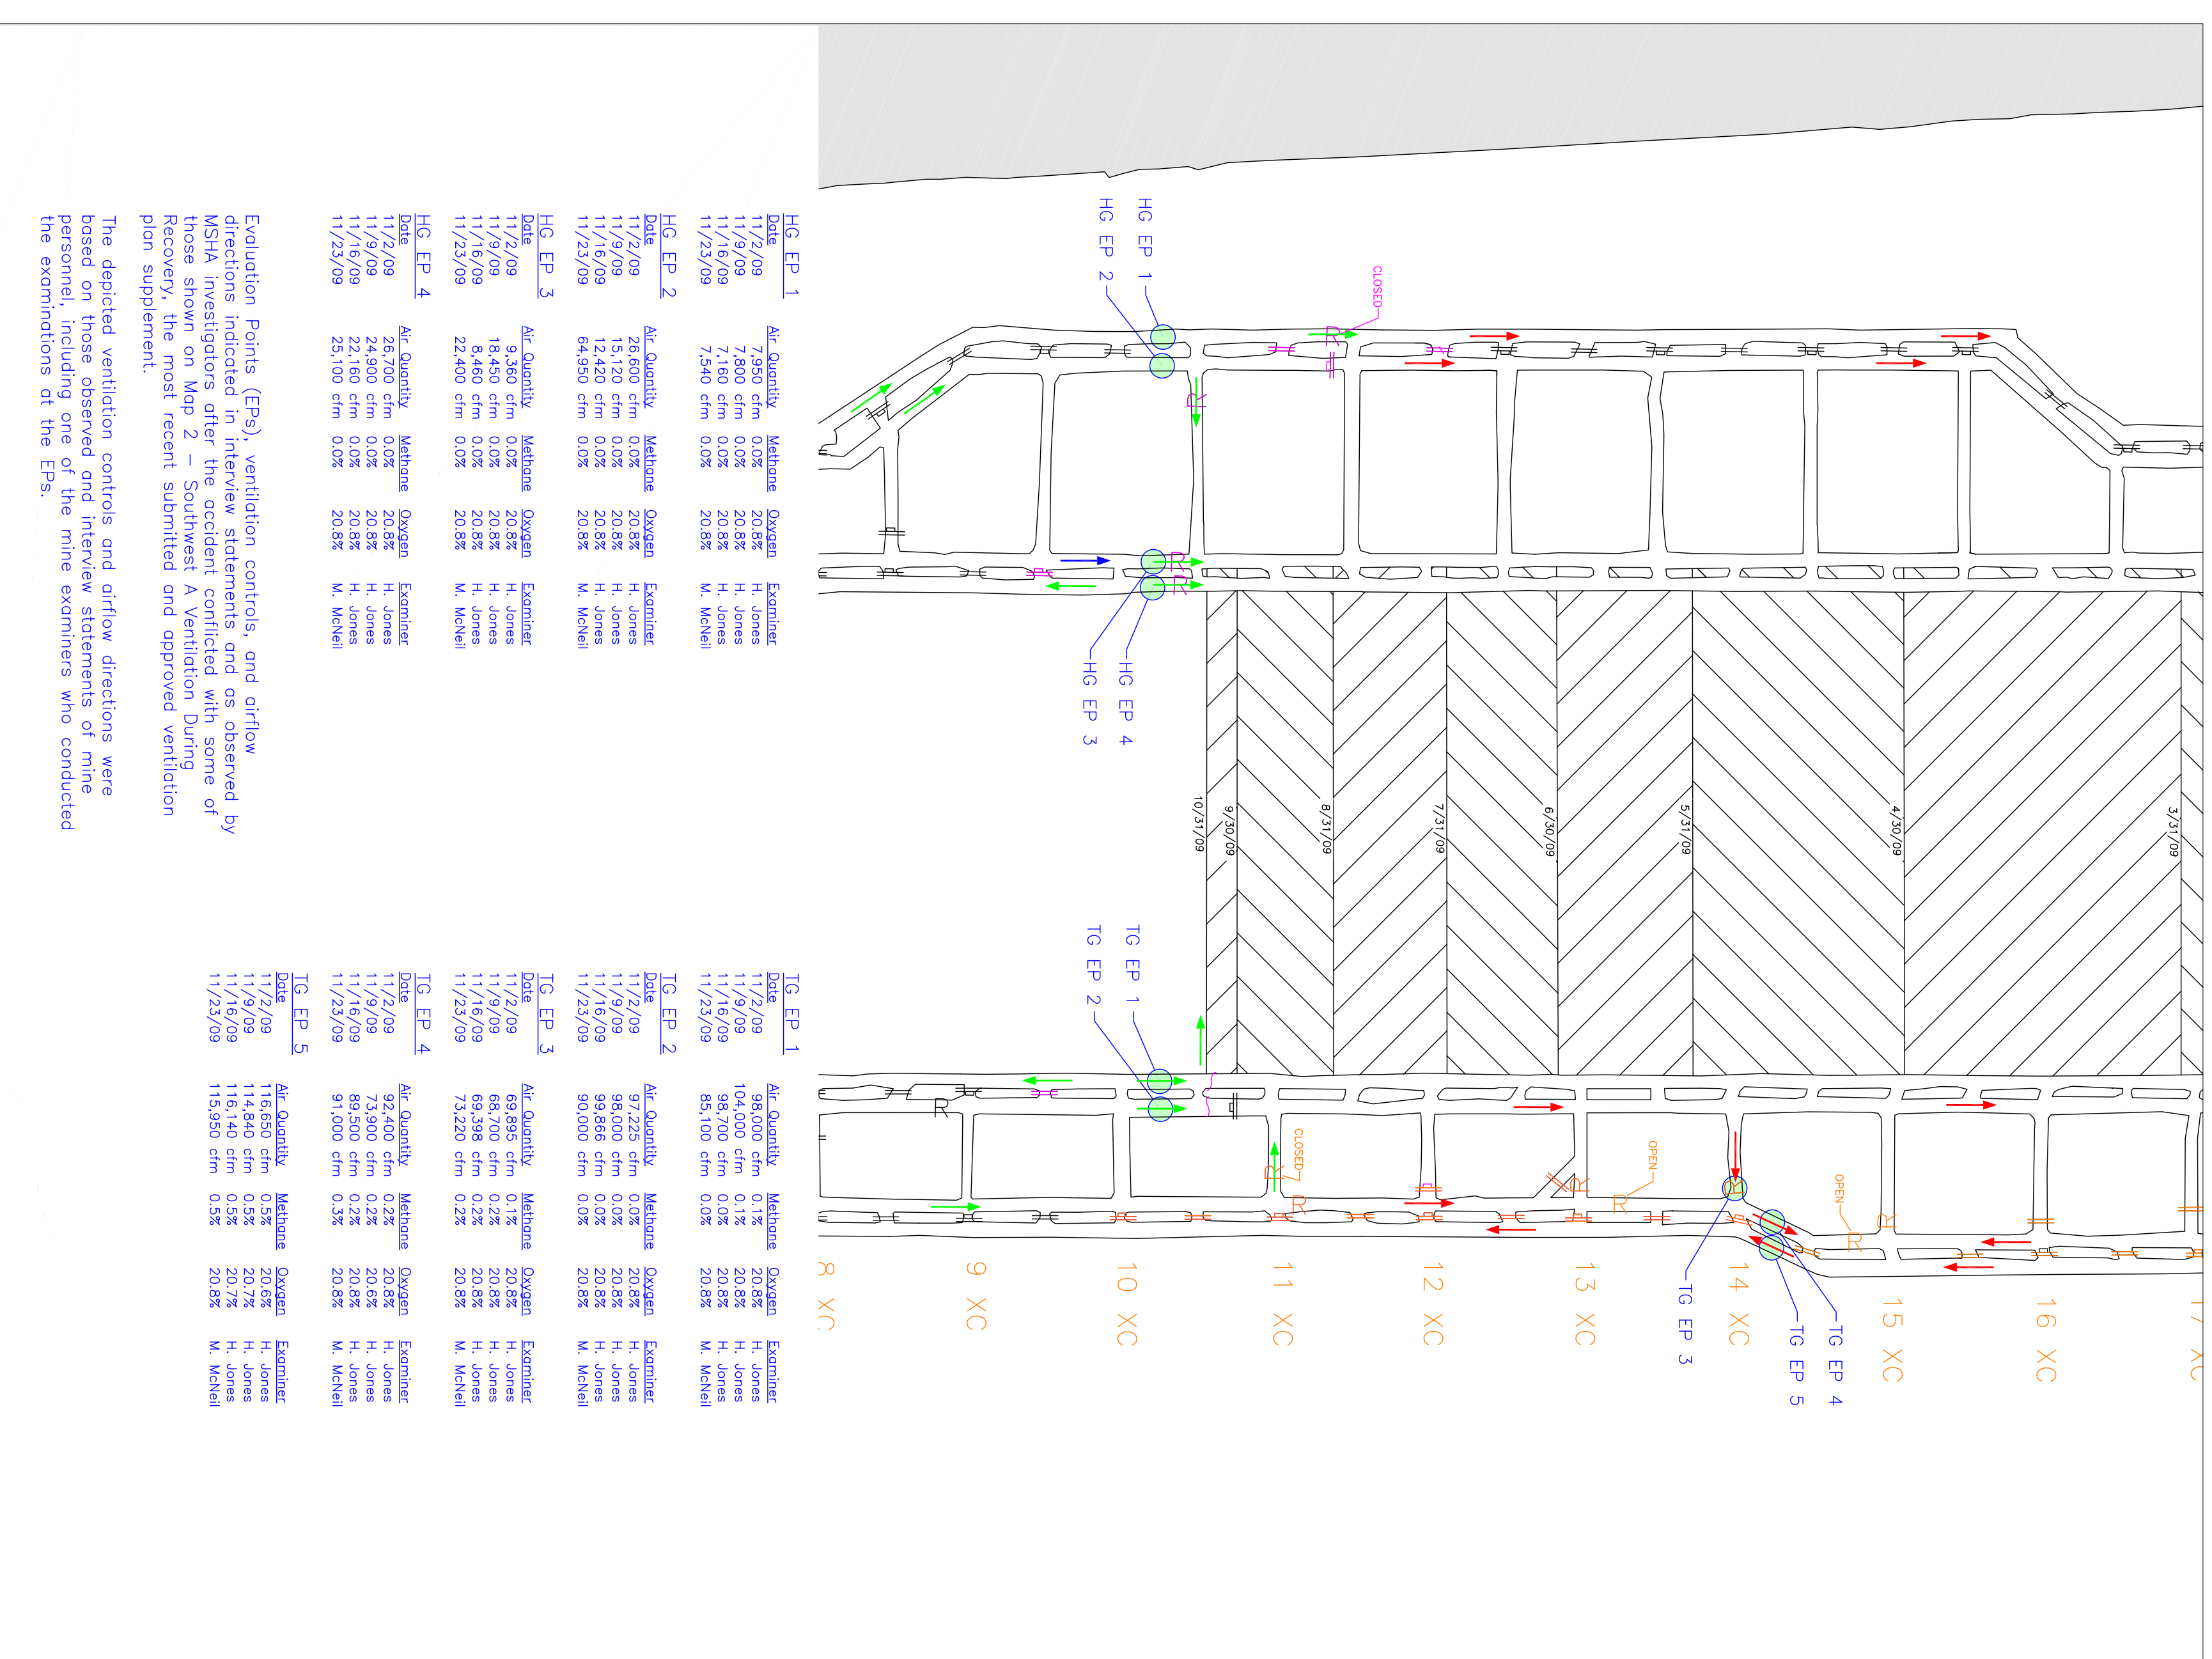
Detail 2B — Results of recorded daily examinations performed at the Southwest A Longwall Headgate and Tailgate EPs located near the longwall face while the longwall face was ventilated from Tailgate to Headgate.

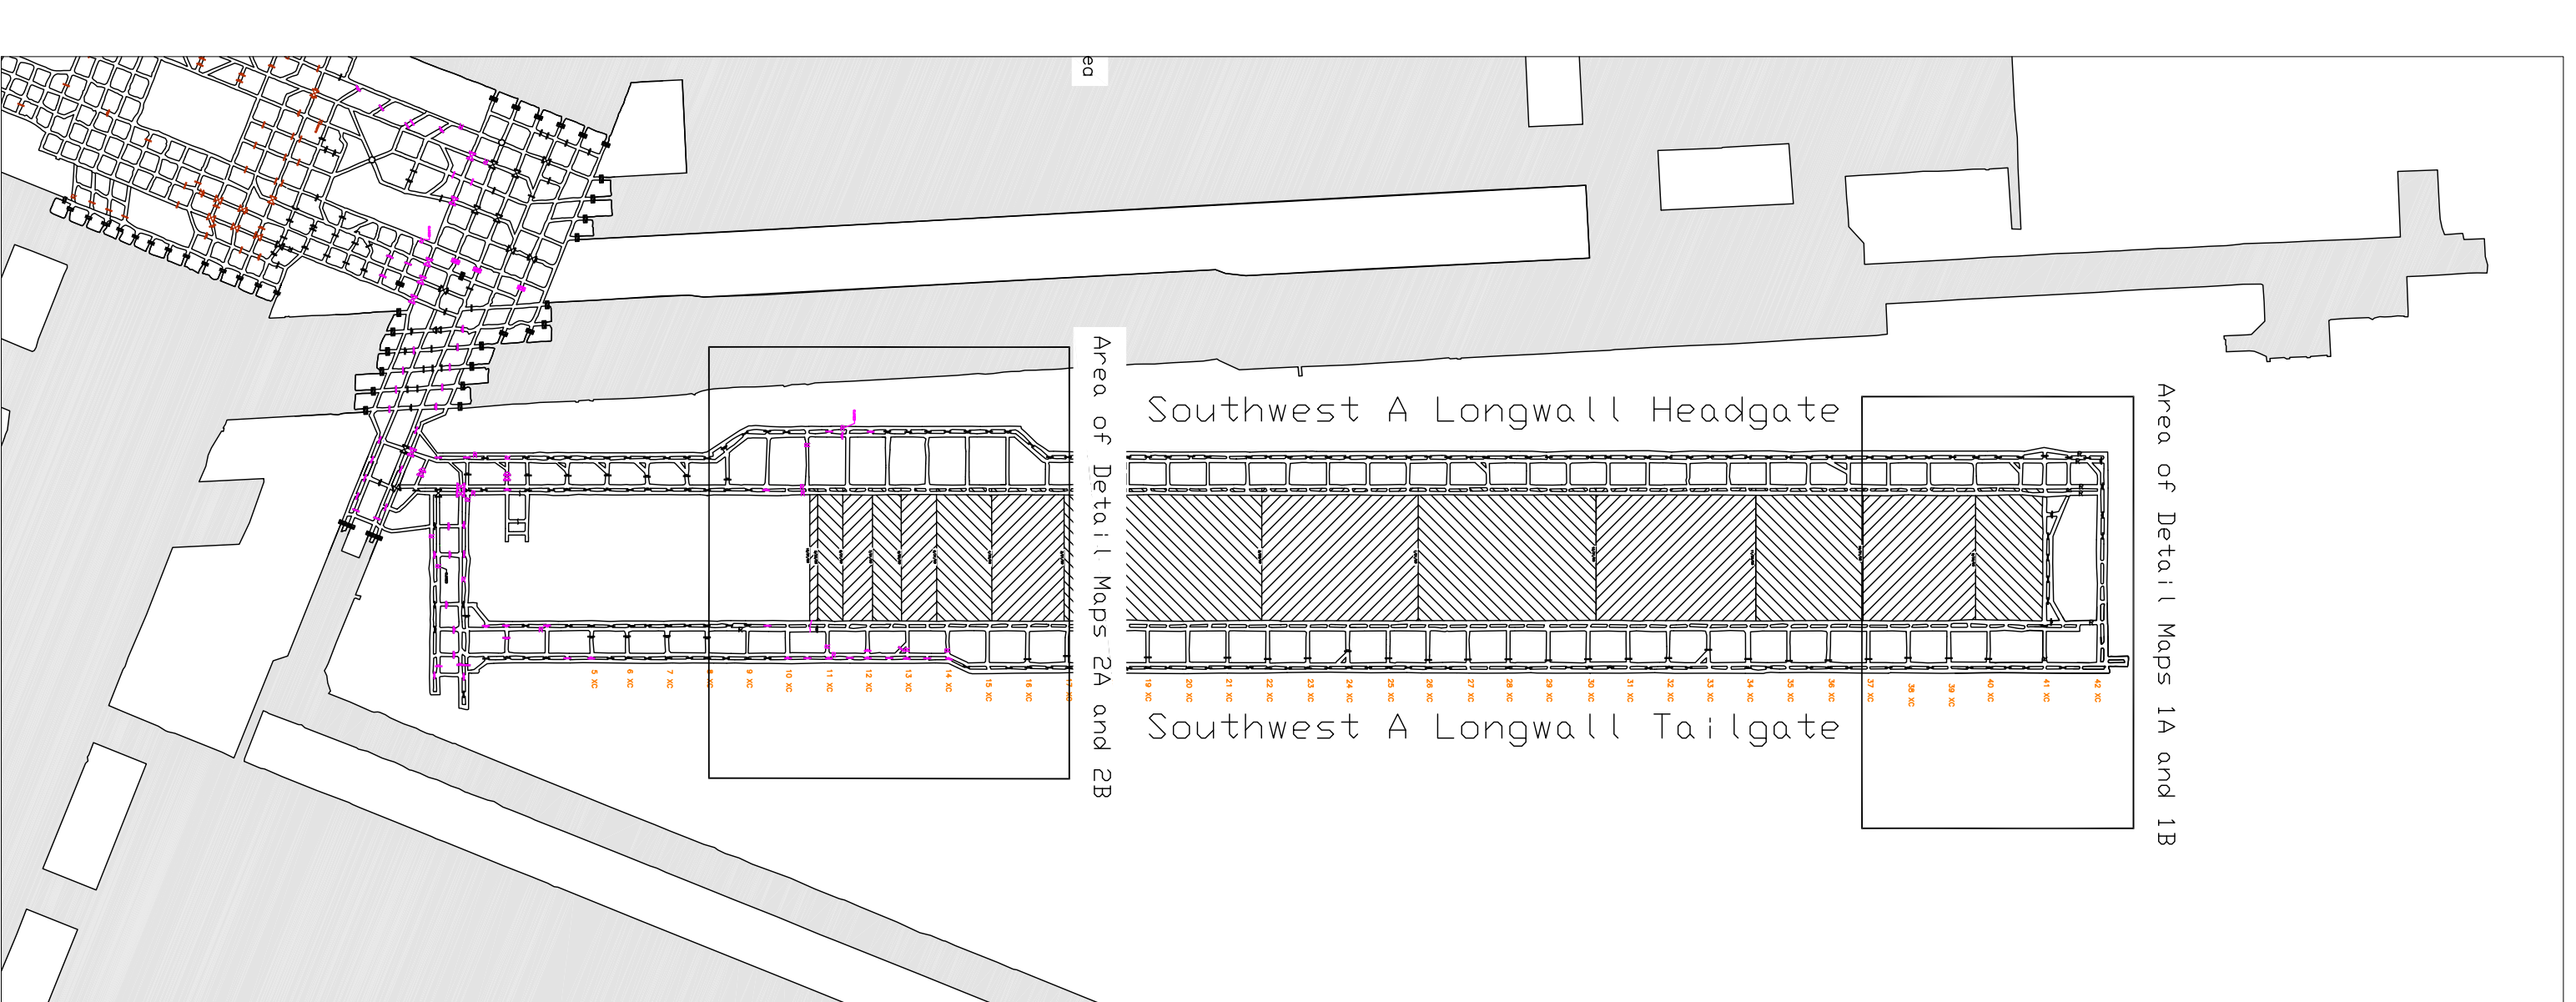
Notes: Stoppings at Crosscuts 38, 39, and 40 in the Southwest A Longwall mine personnel.

Interview statements indicated curtains had been placed over segment ventilation controls located between Entry No. 2 and Entry No. 3 of the Southwest A Longwall Tailgate bleeder prior to the date of the investigation. It was observed that some stoppings were intact, but that most of the stoppings had curtains over them. Although numerous curtains were observed, it was not possible to determine which, if any, of those observed had been installed during the rescue and recovery operations. Further, miners who had locations where they had been installed. Because the exact locations of these curtains was not able to be determined, they were not included in this appendix as being in place before the time of the accident.
