Fatality #4 – March 6, 2009

Machinery - Surface - Louisiana

Dolet Hills Lignite Company LLC - Dolet Hills Lignite Company

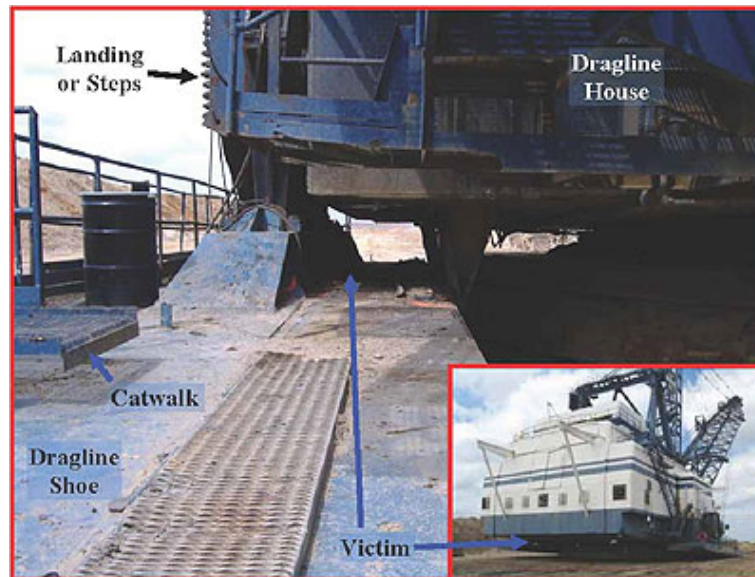
COAL MINE FATALITY - On Friday, March 6, 2009, a dragline oiler with 5 years of mining experience, was fatally injured at a surface lignite mine. While the dragline was being deadheaded or walked to a new cut in the pit, the oiler needed to add extra grease to the cam slide area of the walking mechanism. He walked from one shoe to the other through the dragline house, and was last seen standing on the end of the catwalk on the shoe. The victim was found in a pinch point between the shoe and the dragline house, approximately 10 feet from where he was last seen.

- Persons should not be on the walking shoes of draglines while the machine is walking.
- Persons should only board or dismount the dragline house after verbally communicating with the dragline operator and the operator has brought the dragline to a full stop and set the brakes.
- All miners who work on the dragline should have a positive means of verbal communication, such as a radio, with the dragline operator.
- Extra grease during walking should be applied to the cam assembly by remote and/or automatic means without persons needing to perform this work from the dragline shoe.
