**Fatality #16 - November 23, 2009**  
**Other - Underground - Alabama**  
**Jim Walter Resources Inc - No 7 Mine**

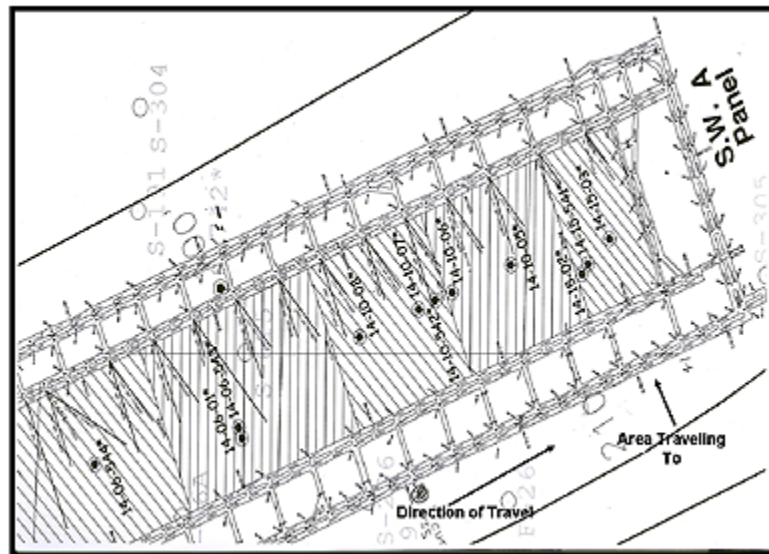
On Monday, November 23, 2009, a mine foreman, accompanied by another miner, was conducting the weekly examination in the tailgate entries of the Southwest A Panel (No. 2 Longwall) bleeder system. When the miners failed to report out of the bleeders, a search began for them. They were found on the tailgate side of the bleeder, one responsive and the other non-responsive. Rescue operations were implemented, but hampered due to environmental conditions. When brought to the surface, the responsive miner was hospitalized and later released. The non-responsive miner, age 53, was brought to the surface and pronounced dead. The investigation is focusing on issues related to the environmental conditions (heat/humidity/atmosphere) found in the bleeder system.

- Always remain cognizant of the surrounding conditions in the mine and dress accordingly.
- Do not over exert, especially in areas of high heat and humidity.
- Provide cooling vests when heat stress is a concern.
- Use and maintain the proper air monitoring equipment.
- Ensure that all required examinations are properly conducted.
