UNITED STATES  
DEPARTMENT OF LABOR  
MINE SAFETY AND HEALTH ADMINISTRATION

REPORT OF INVESTIGATION

Fall Accident  
February 26, 2009

Minuteman Fines Recovery Plant  
Covol Fuels No 2 LLC  
Greenville, Muhlenberg County, KY  
ID No. 15-19205

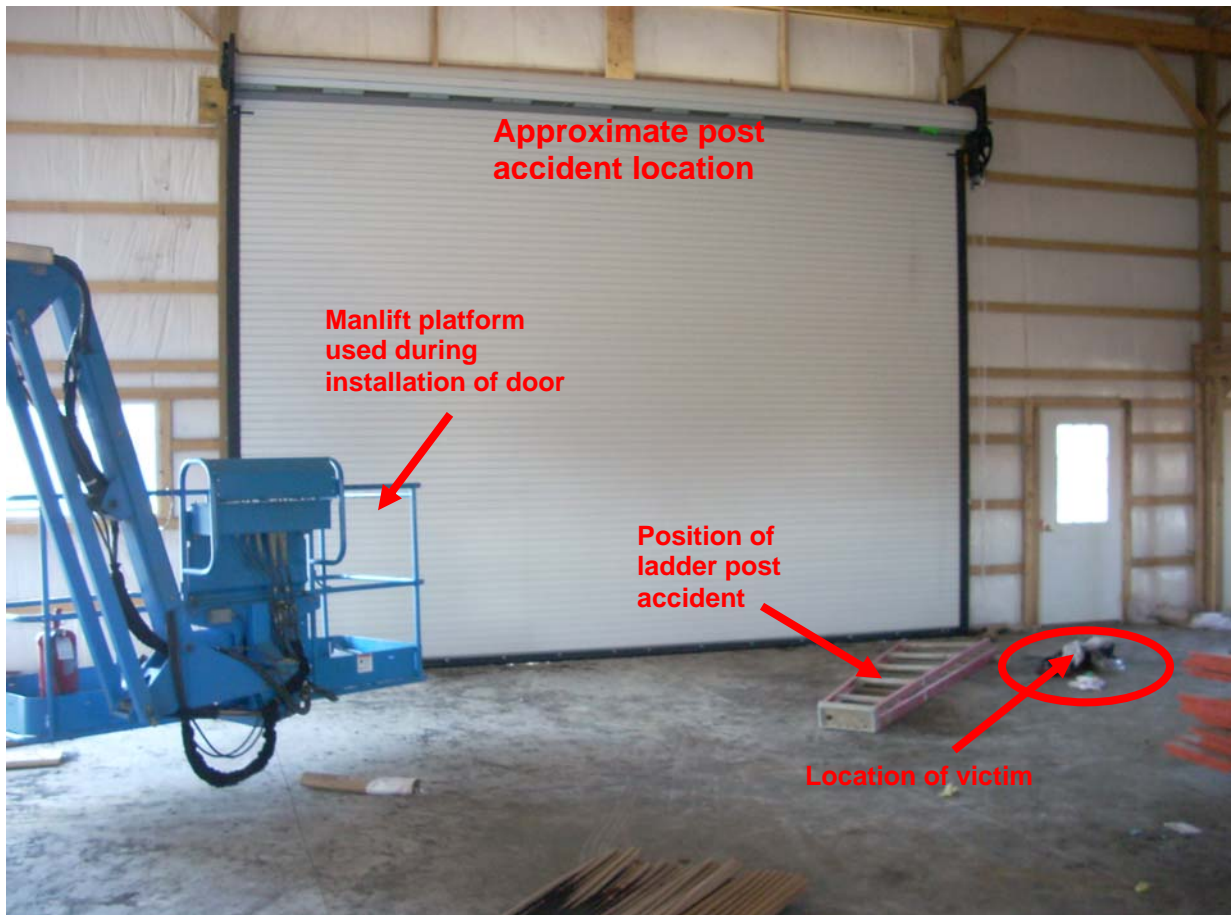
Photo of the Accident Site

On February 26, 2009, at approximately 2:08 p.m., David W. McCarty, a contract garage door installer received fatal injuries while he assisted in the installation of a rolling steel overhead door. McCarty was positioned on a 10 foot step ladder as he and a co-worker tested the tension on the door. The door began to descend from the fully opened position and struck the ladder. McCarty fell, striking his head on the concrete floor below.

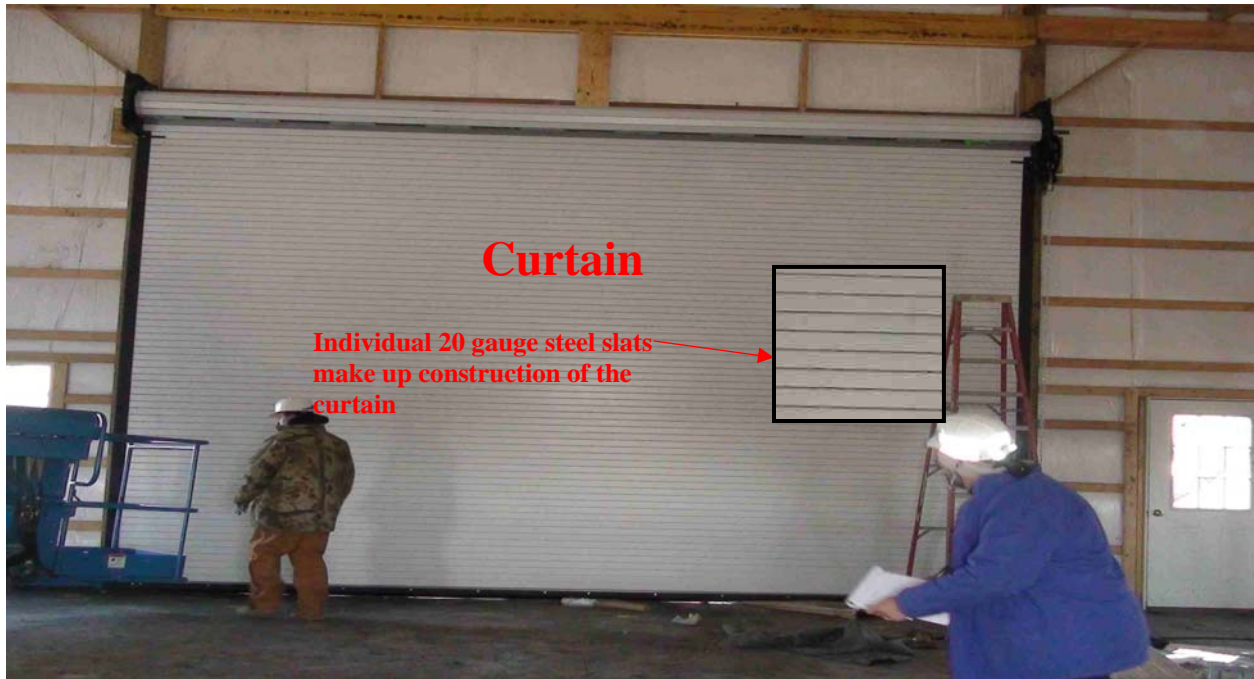
The overhead door involved in the accident was a C.H.I. Model 6202 Series 6000 Insulated Rolling Steel Door, manufactured by C.H.I. Overhead Doors Inc. The manufacturer's unique identifying number for this door was 72034. The door measured 20' x 14' and weighed approximately 2,400 lbs. The door's dominant feature was an insulated curtain made up of interlocking 20 gauge steel slats that fit into steel guides mounted on either side of the door opening. The curtain weighing 1,803 lbs hung on a steel tube called the barrel in which the door's torsion spring was housed. There was a tension adjuster on one end of the 8" diameter barrel and a hoist drive gear on the other. The barrel was held in place on head plates bolted into the door jambs and was to be covered with a sheet metal hood that fit inside the head plates. These features can be seen in Figures 1 and 2. The door was new from the manufacturer and was in the process of being installed.

Figure 1. Door view – Full curtain straight on

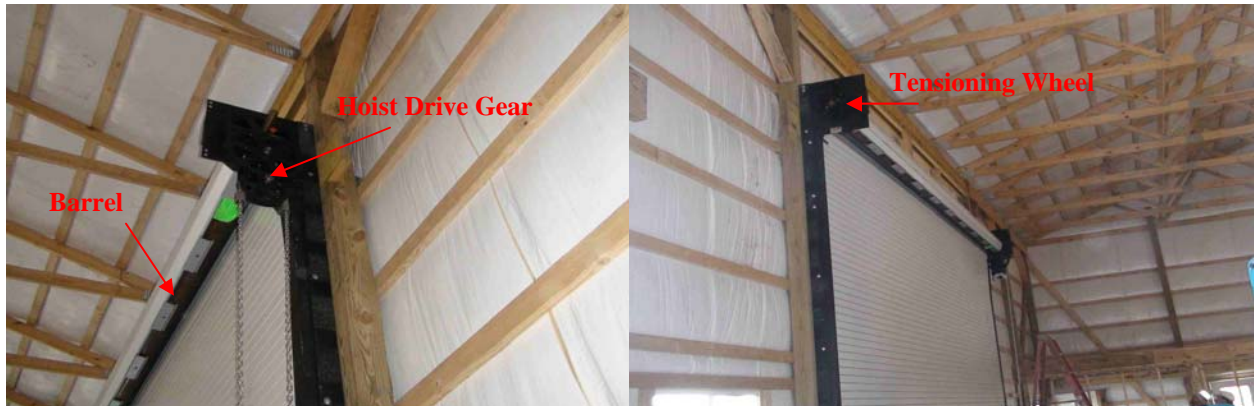
Figure 2. Door views – drive gear side (l), tensioning wheel side (r).

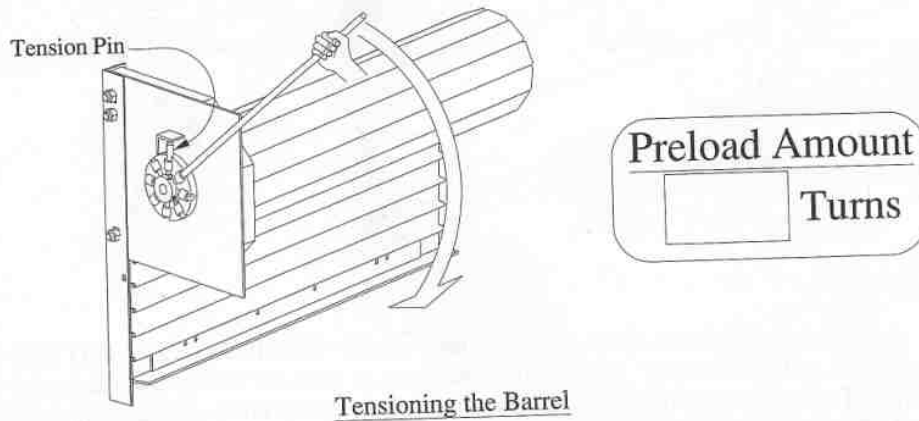
With the installation nearly complete, Means and McCarty decided the spring was loaded with too much tension and proceeded to take some tension off the spring by reversing the tension wheel. Means positioned himself to work on the tension wheel using a man lift basket. Means inserted an adjusting bar into the lug sockets on the tensioning wheel and began to de-tension the spring. Refer to Figure 3 to view an illustration of the tensioning procedure. Means relied on his past installation experience to make the adjustment by feel instead of counting the number of turns on the tension wheel.

Figure 3. Illustration for tensioning procedure from page 12 of the C.H.I. Installation Instructions. Note box to record turns for recommended preload tension.

Means and McCarty deviated from the C.H.I. installation instructions at several points and did not always use other means to satisfy critical safety factors detailed in the instructions. For example, page 12 of the instructions include warnings in bold faced print that the spring is very dangerous when under tension and to never exceed the recommended number of turns by more than a half of a turn. The installation procedures instruct the installers to record the number of pretension turns inscribed on the barrel shaft in a designated space on page 12 of the instructions. Knowing the number of turns recommended from the manufacturer permits installers to preload the spring with the proper amount of tension without having to feel and guess the correct amount of preload tension after the curtain is installed. Recording the number of turns on page 12 can prevent this information from being lost when the curtain covers the inscription later in the assembly process. This step was twice emphasized with reminders in bold faced print on pages 6 and 10, but neither installer recorded the

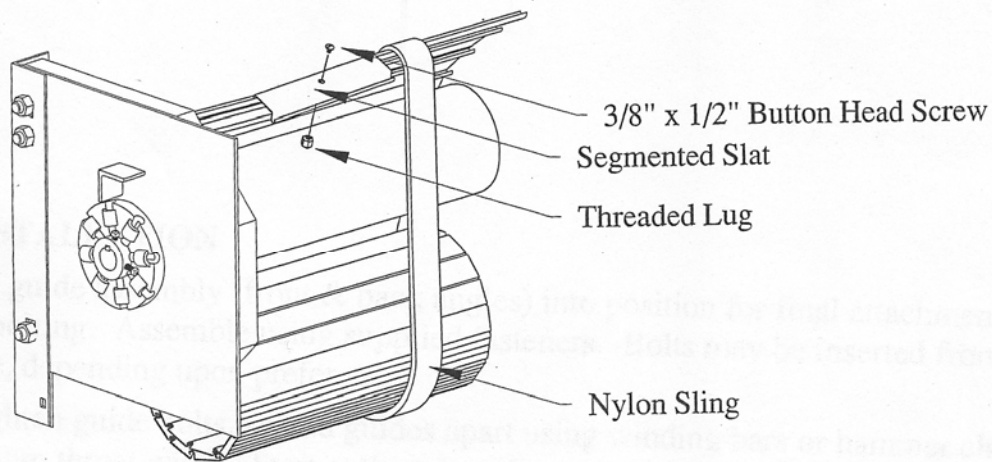
Installers are directed to fasten slings over the barrel to support the curtain during installation according to the C.H.I. Installation Instructions. Refer to Figure 4 for an illustration of the suggested sling configuration. The specifications for the sling assembly, found on page 10 of the instructions, direct installers to use a minimum of two straight eye nylon slings rated at no less than 5,000 lbs each and fastened with screw pin shackles rated at no less than 10,000 lbs. The slings are not to be removed until the proper preload tension is set and the top guide rail sections have been checked for secure installation. Means and McCarty used no slings during the installation process, but did support the curtain with a fork lift during part of the installation.

Figure 4. Curtain sling illustration from CHI Installation Instructions.

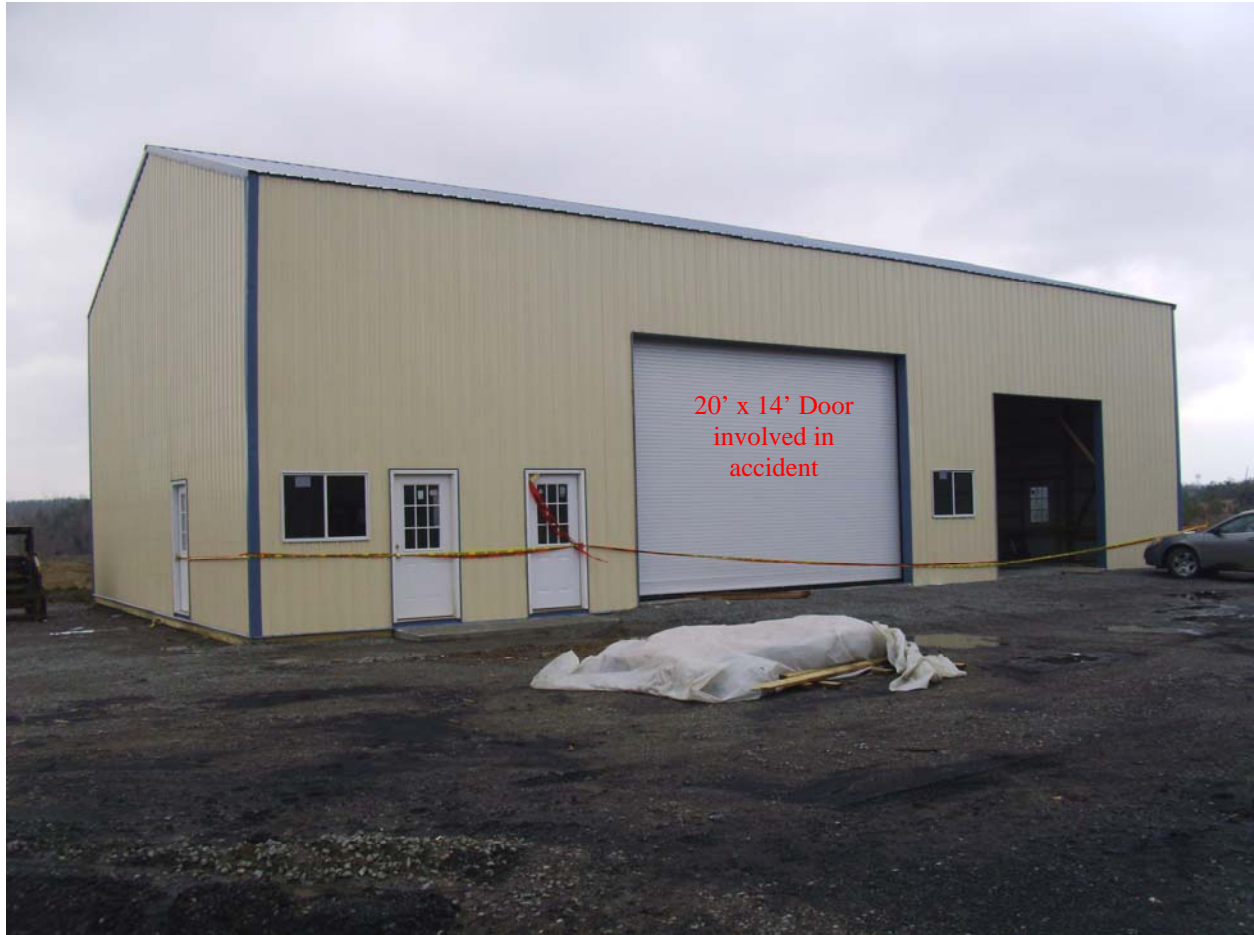
## Appendix C

The accident occurred while installing a 20' x 14' overhead door. The 40' x 70' building was near completion. The exterior of the building and concrete floor were finished. The work remaining included some electrical wiring, interior finish work for office walls and the installation of two overhead rolling steel doors. SEE APPENDIX C.

40' x 70' Warehouse/Shop under construction
