**UNITED STATES  
DEPARTMENT OF LABOR  
MINE SAFETY AND HEALTH ADMINISTRATION  
COAL MINE SAFETY AND HEALTH**

**REPORT OF INVESTIGATION  
Surface Coal Mine  
Fatal Machinery Accident  
March 6, 2009**

**Dolet Hills Lignite Company Mine  
Dolet Hills Lignite Company LLC  
Mansfield, De Soto County, Louisiana  
ID No. 16-01031**

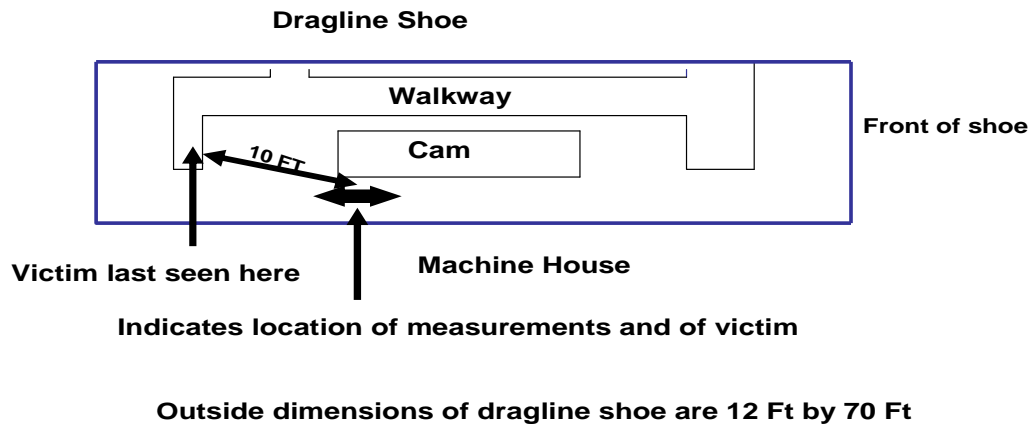
Refer to the aerial view sketch below for location of measurements and victim:

Freeman was found approximately 10 feet from the walkway on the left dragline shoe where he was last seen standing, apparently waiting to board the dragline house. He was found lying in a prone position on top of the shoe, between the inside edge of the shoe and the cam housing. The victim was located parallel to the inside edge of the shoe, facing forward and his feet nearer to the walkway where he was last seen. In this location, he was positioned between the cam housing on his left and the shoe guide located on the bottom of the house to his right. The cam housing and shoe guide prevented Freeman from rolling left or right to avoid being crushed by the dragline house. His hard hat was found on the top of the shoe, just to the side of his head, and was undamaged. He was wearing the electrical gloves that were normally used to

Measurements were taken between the top of the left walking shoe and the bottom of the dragline house at the location where Freeman was found to determine the clearance distance between the shoe and house during the walking procedure. The left shoe is located on the opposite side of the dragline from the operator's cab. Refer to Appendix B for the shoe location. With the walking shoe fully retracted in the minimum clearance position, the minimum distance from the shoe to the machine house was 7.25 inches. The clearance increased to 8.37 inches at the center of the area and 10.5 inches along the inside edge of the dragline shoe closest to the tub. With the walking shoe just touching the ground, measurements at these locations ranged between 34.25 and 35.75 inches. In the high cam position, where the maximum clearance occurred, the measurements ranged between 56 and 56.5 inches.

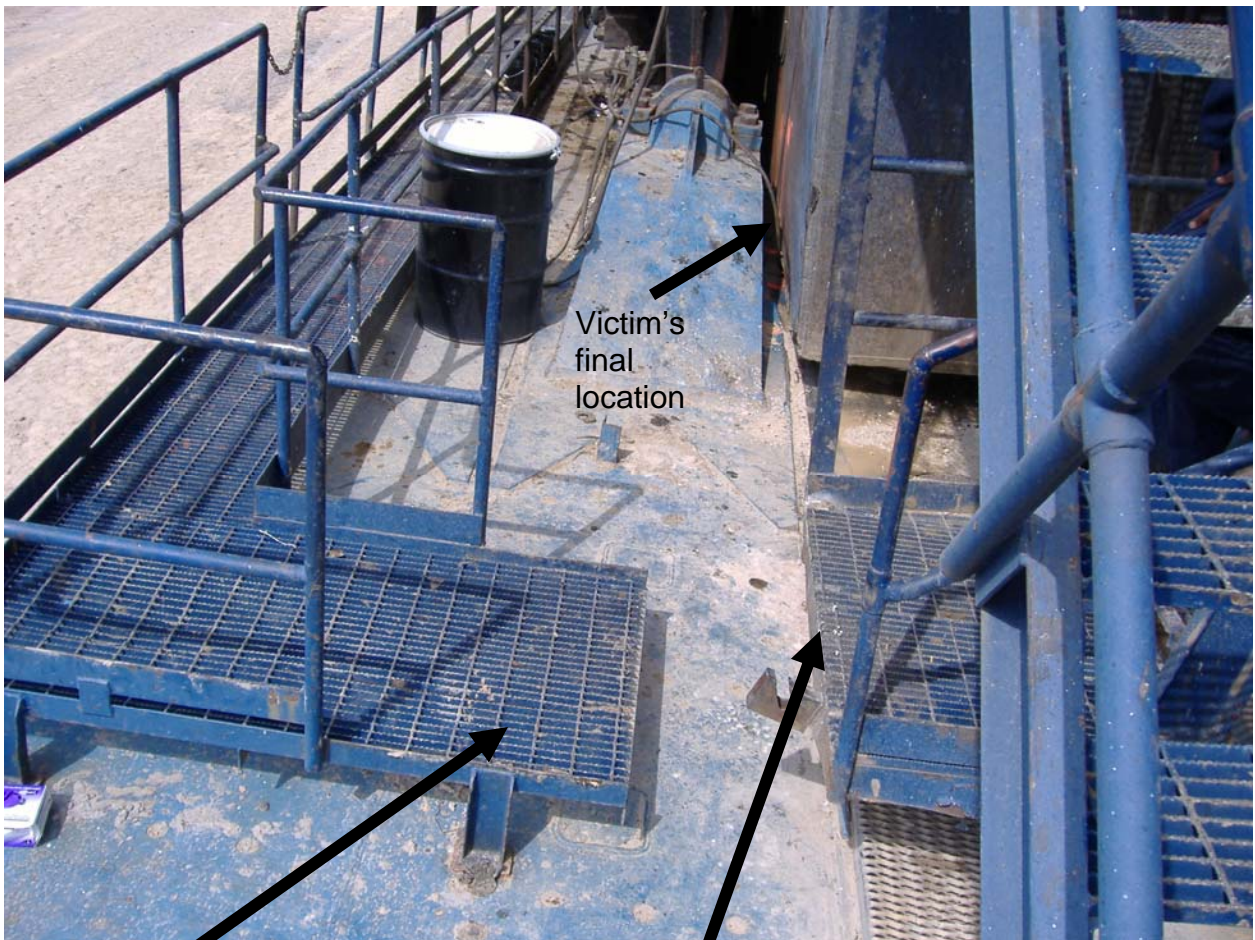
PICTURE OF WALKWAY WHERE VICTIM WAS LAST SEEN AND THE LANDING/STEPS ON THE DRAGLINE HOUSE

Freeman was last seen standing on the walkway on the left shoe, apparently waiting to board the dragline house after having added grease to the cam/slide mechanism on the shoe. To board the house, Freeman had to wait during the walking process for the walkway to line up with the landing/steps on the house. This occurred once during each step as the shoe rotated on the cam assembly. When aligned, the walkway on the shoe and the landing on the house presented an easy stepping situation from the shoe to the house. See Appendix D for a picture of the step required. Freeman was found approximately 10 feet away from the walkway where he was last seen waiting to board

Investigators observed a hand/finger mark on the left-side, middle handrail on the house landing/steps. The mark could have been made by Freeman as he placed his hand on the rail and it slid off in an attempt to board the house. A short vertical piece of angle iron was located on the dragline shoe a short distance from the end of the walkway where Freeman was last seen. See Appendix E for a view of this angle iron. The angle iron had a smudge on it that could have been made by a shoe impact. It is possible that Freeman attempted to board the dragline house before the walkway and landing lined up, lost his balance and grip and fell, striking the angle iron, and stumbled, landing between the shoe and the house where he was found.

Walkway where Victim was last seen

Landing/steps on dragline house

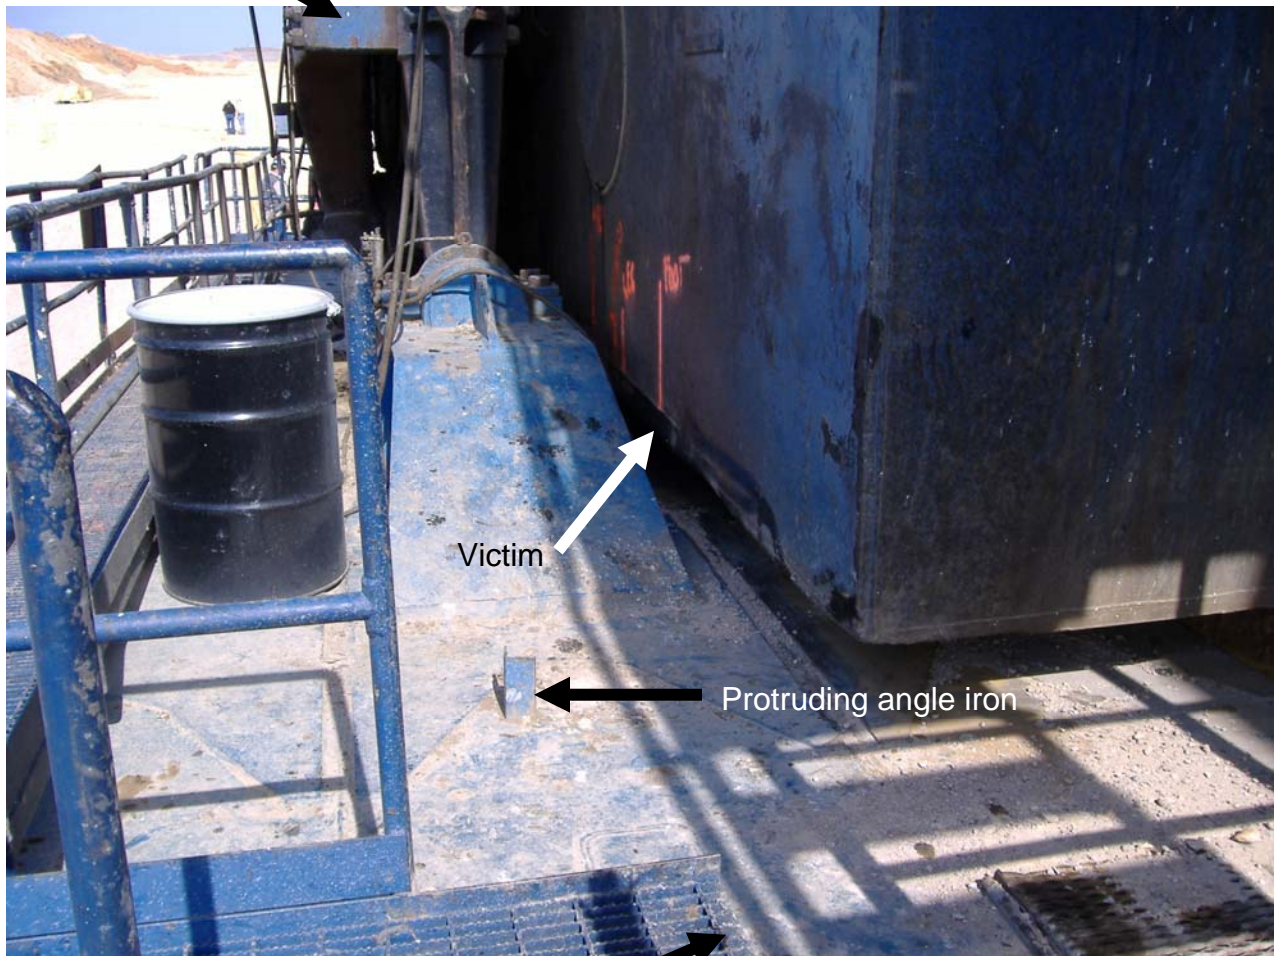
PICTURE OF WALKWAY WHERE VICTIM WAS LAST SEEN,  
PROTRUDING ANGLE IRON, LOCATION OF  
CAM/WALKING MECHANISM

A second scenario involves the three bolts on the C-frame assembly that were reported to have been found loose the shift prior to the accident. These bolts were located near the bottom of the C-frame and could be viewed both from the front and back side of the C-frame. See discussion above regarding these bolts and their location. Freeman could have entered the area where he was injured to look at the back-end of these bolts. However, this scenario is not considered likely as the movement of the shoe and house, with clearances between 7 and 56 inches, would preclude ready access to this area for inspection purposes. In addition, an experienced oiler would have likely realized the hazard presented by the moving dragline shoe in this area and would not have entered it during the walking process.

Cam/Walking mechanism

Walkway where Victim was last seen
