REPORT OF INVESTIGATION

**Fatal Powered Haulage Accident
April 2, 2009**

**Reed Minerals, Inc.
Town Creek Mine
Sipsey, Walker County, Alabama
I.D. No. 01-03376**

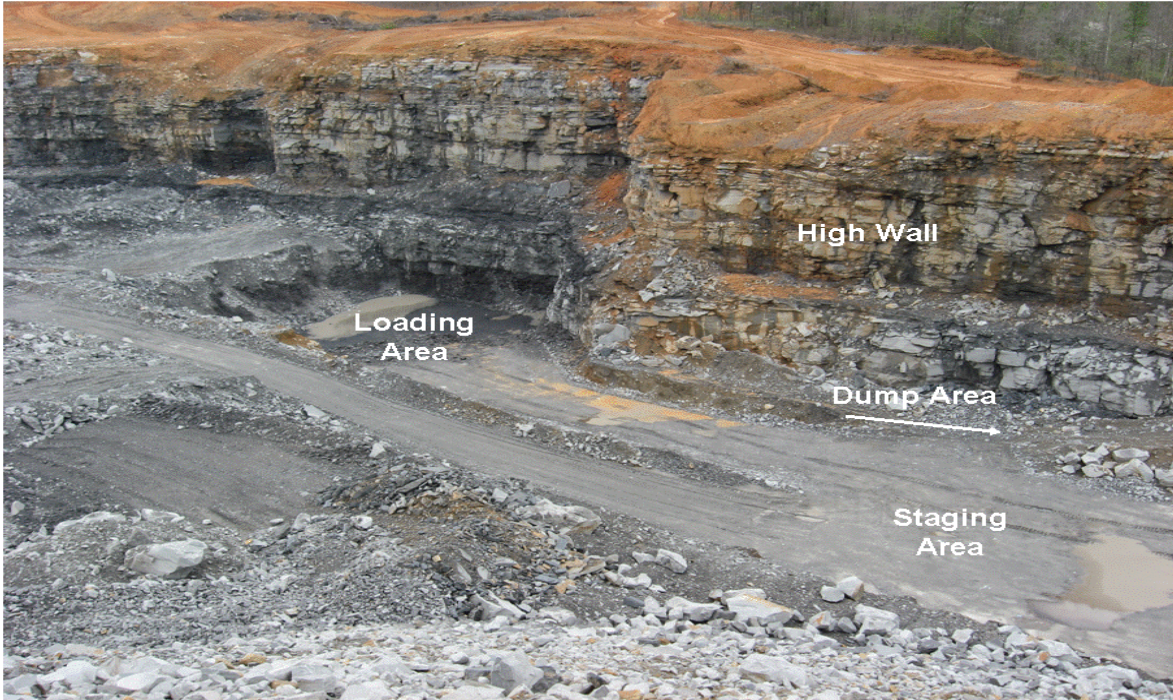
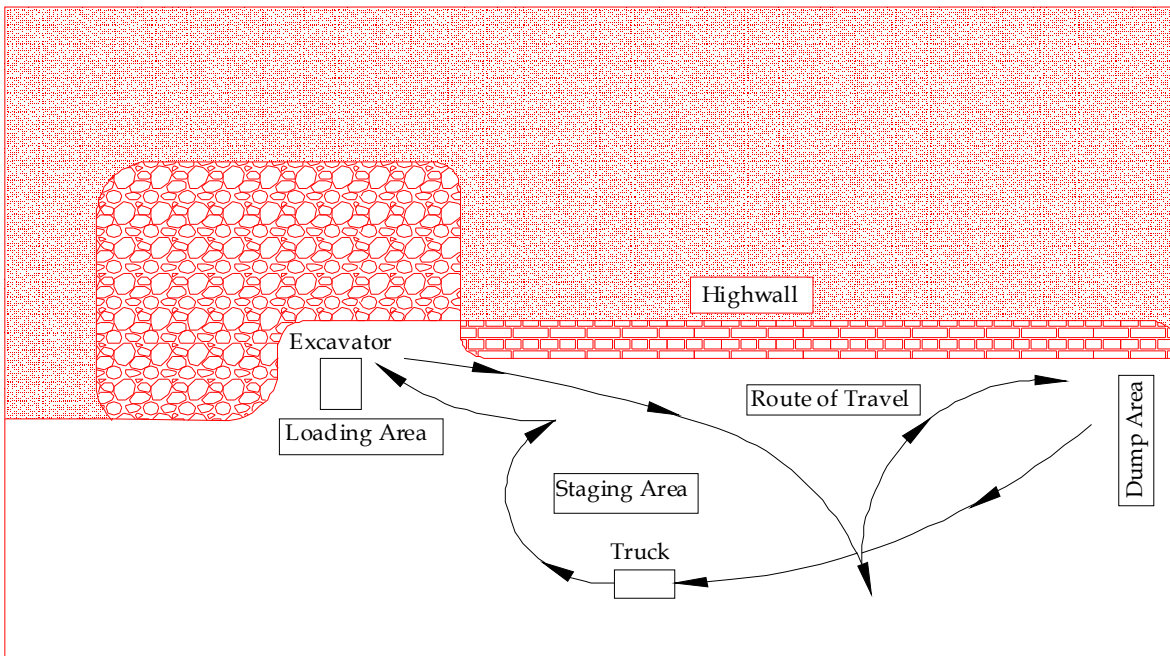
Accident Scene

Once the leak was determined to be from Mayall's truck, he stopped between loads and completed a walk around inspection of his truck, looking for the source, which was normal procedure for equipment operators. This walk around inspection did not reveal the location of the leakage. It appears he was advised by another truck driver to look for the leak by raising the dump bed, placing the dump bed control lever in the FLOAT position, then quickly going out on the catwalk to look for the leak. After dumping his next load, the victim returned to the staging area with the bed already in a raised position, exited the cab of the truck and walked to the back of the catwalk located along the operator's cab. He was looking for a leak in the frame area of the truck when the dump body lowered, crushing him between the handrail and the dump body frame.

Root Cause: The victim left the operator's cab, with the dump body in a raised position, without the dump body being blocked against motion.

Note: Arrows indicate route of travel by victim.

Corrective Action: The operator developed and implemented a program to train truck drivers to never exit the cab of their vehicle with the engine running, and never exit the operator's cab with the dump body raised, until they are certain that the dump body has been properly blocked in place to prevent motion.

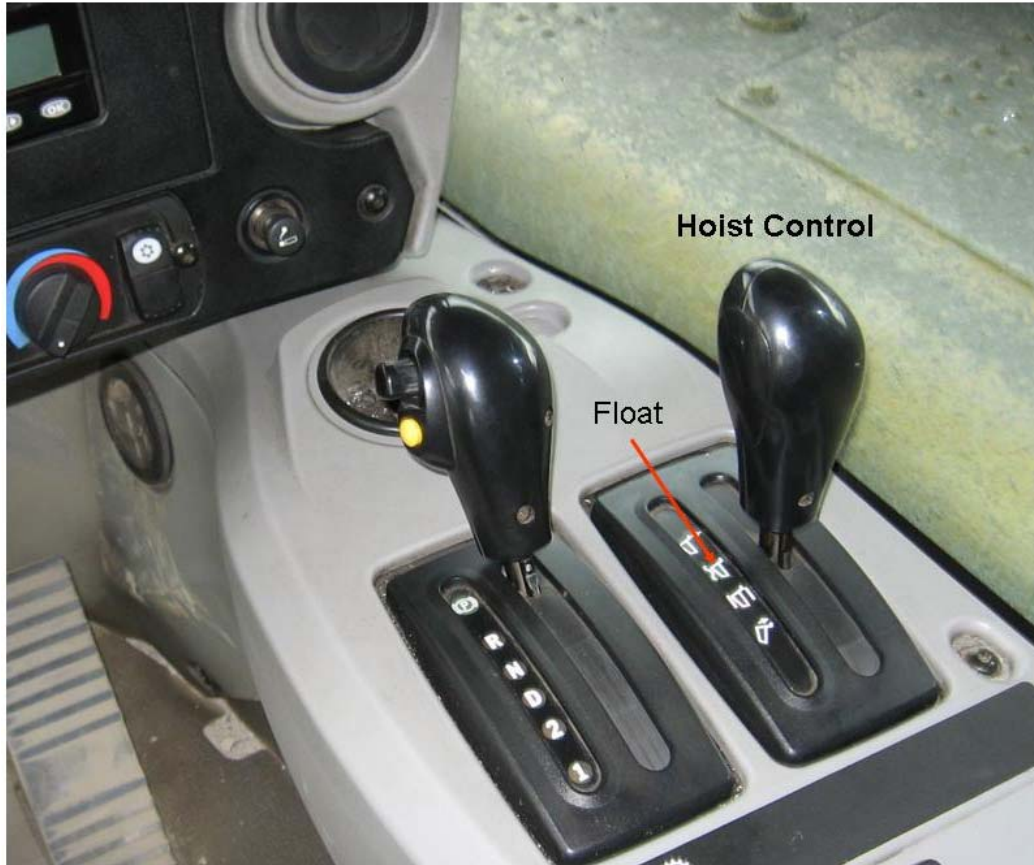
Hoist Control Lever

After the accident occurred, the engine was found to be idling and the hoist control lever in the FLOAT position (Appendix C).

The evidence obtained through interviews and testing indicates that the victim left the operator's cab with the dump body raised, but not blocked against motion. The hoist control lever was found in the FLOAT position and no problems discovered with the lever mechanism or the hydraulic system. It appears the victim placed the control in this position before he exited the operator's cab in an effort to locate what he thought was an oil leak somewhere within the confines of the dump body and the truck frame.
