REPORT OF INVESTIGATION

Fatal Machinery Accident
June 9, 2009

D & C Mining Corp
D & C Mining Corp Mine
Cranks, Harlan County, Kentucky
ID No. 15-18182

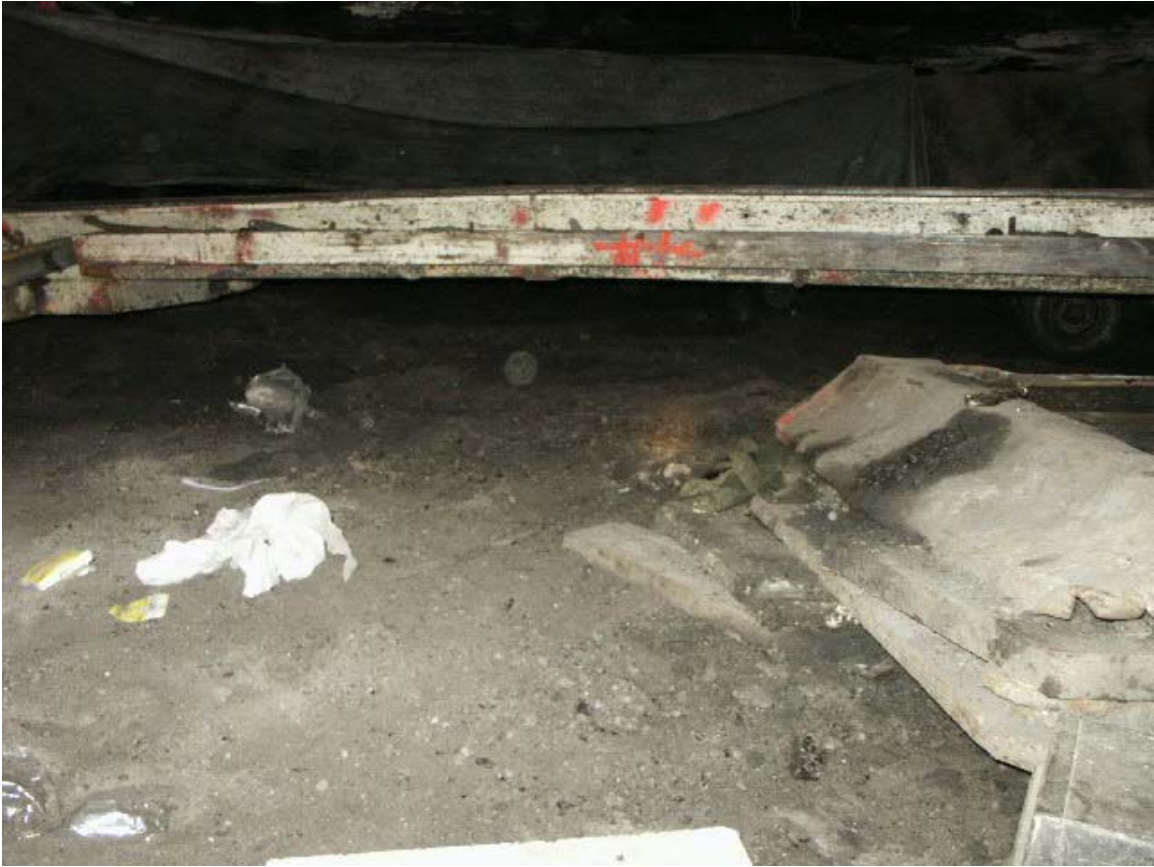
View of Accident Site

At approximately 7:15 p.m. on Tuesday, June 9, 2009, a fatal machinery accident occurred at the D & C Mining Corp, D & C Mining Corp Mine. The accident occurred when the chain attaching a rubber tired supply car to the S&S Model 482 scoop failed. The loaded supply car rolled downhill, through a ventilation curtain, and struck the victim. As a result, he was pinned between the supply car and a mobile bridge conveyor.

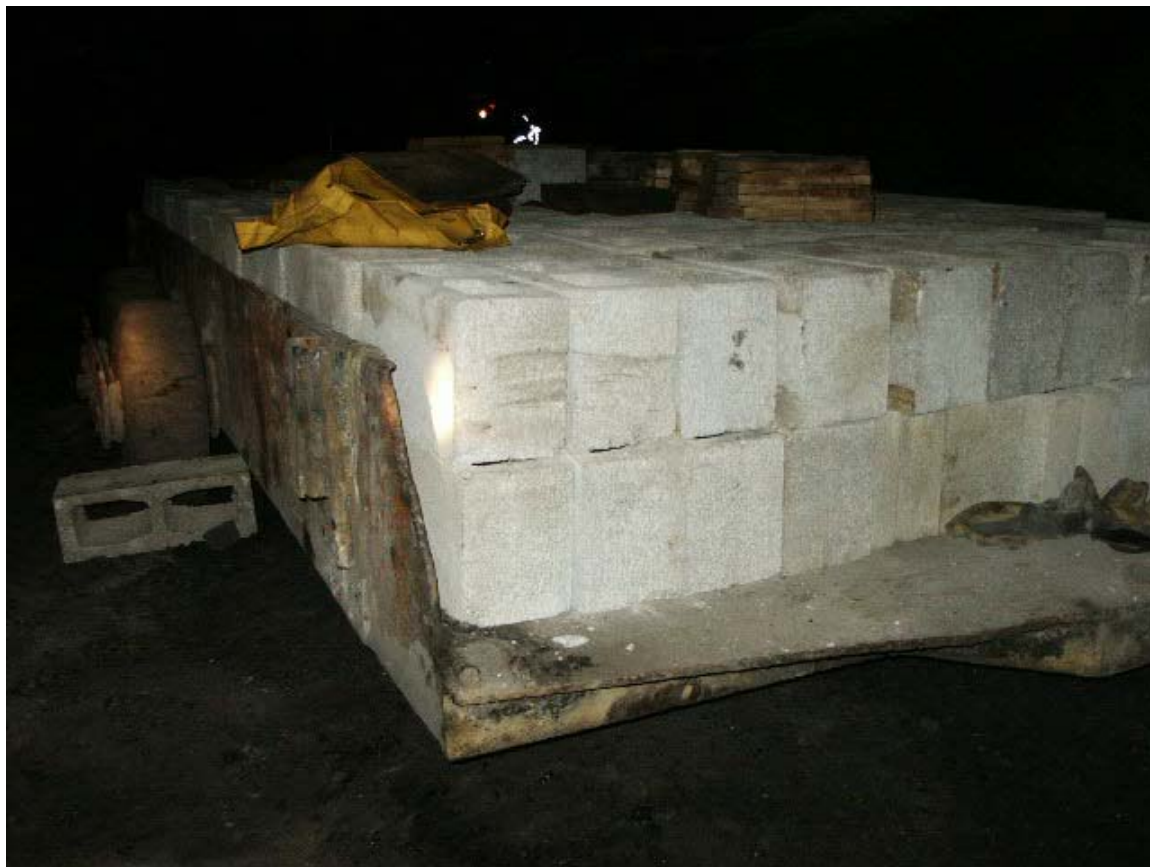
EXHIBIT 1
PHOTO OF SUPPLY CAR WITH CONCRETE BLOCK

The supply car involved in the accident was manufactured by the Frank Kersey Corporation of Bluefield, Virginia. The legible portion of the model number on the supply car data plate is 6514, with a serial number of 68194. This supply car was taken to the company's truck scales and weighed. An empty weight of 3,280 pounds was determined. The investigation revealed that when the accident occurred, the supply car was loaded with 228 concrete blocks, as well as a few wooden wedges and wooden cap blocks.

The towing resistance of the trailer is a combination of the weight of the loaded trailer, the ground condition, and the slope. It was determined this batch of concrete blocks had an average weight of 29 pounds each. Considering the weight of the wedges and cap blocks as insignificant, the total weight of the supply car and block was 9,892 pounds or 4.95 tons. The ground was relatively smooth, dry, without ruts in the area of the accident, and the mine floor was sloping at a surveyed grade of 7.36%. With the trailer being pulled upslope the towing force was calculated to be between 1,045 pounds and 1,223 pounds.

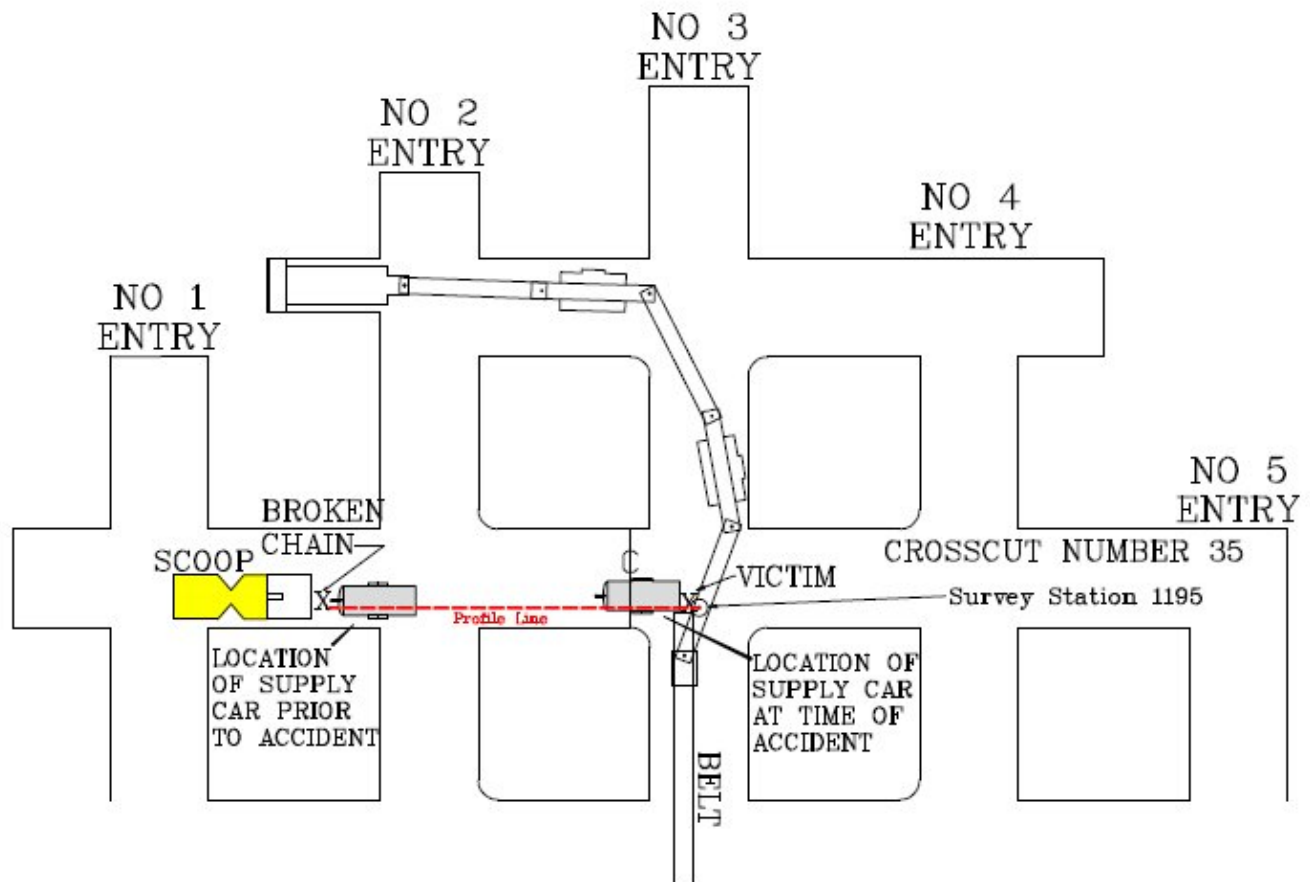
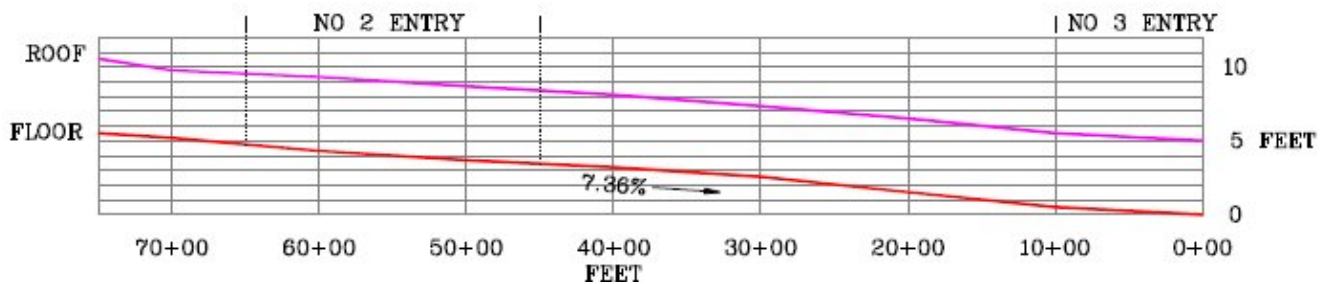
EXHIBIT 2
DRAWING OF ACCIDENT SITE

Bruce hooked the steel tongue of the rubber-tired supply car to a hole in the center of the bucket of the S & S 482 scoop by lining up the hole in the tongue with the hole in the bucket and looping a 1/4 inch chain through both. Bruce pulled the supply car loaded with block up the roadway and turned into the crosscut between the Number 1 and 2 Entries, lining up the supply car with the crosscut where the stopping was to be constructed. Bruce stated that the car "jerked real hard," and broke away from the scoop. The loaded supply car rolled down grade, through the crosscut between Number 2 and 3 Entries, towards the Number 3 Entry. Meade was shoveling the belt conveyor tailpiece in the Number 3 Entry when the supply car continued through a ventilation curtain, striking and pinning him against the outby Jeffrey 94L bridge conveyor.

Representatives of MSHA, OMSL, and the operator traveled underground to the accident site to examine the scene and begin an investigation of existing physical conditions. Digital photographs and relevant measurements were taken. A series of measurements were taken along the travel path of the car in order to produce a sketch of the scene.

On Wednesday, June 10, 2009, MSHA investigators conducted a survey of the area to determine the grade along the path of travel of the supply car. An MSHA electrical specialist examined the S & S Model 488 scoop for defects that could have contributed to the accident. A representative of MSHA's Educational Field Services reviewed the training records and a representative of MSHA's Pittsburgh Technical Support office provided assistance with evaluation of the equipment involved in the accident.
