REPORT OF INVESTIGATION

Underground Coal Mine
Fatal Fall of Roof Accident
June 23, 2009

Bailey Mine
Consol Pennsylvania Coal Company
Wind Ridge, Greene County, Pennsylvania
I.D. No. 36-07230

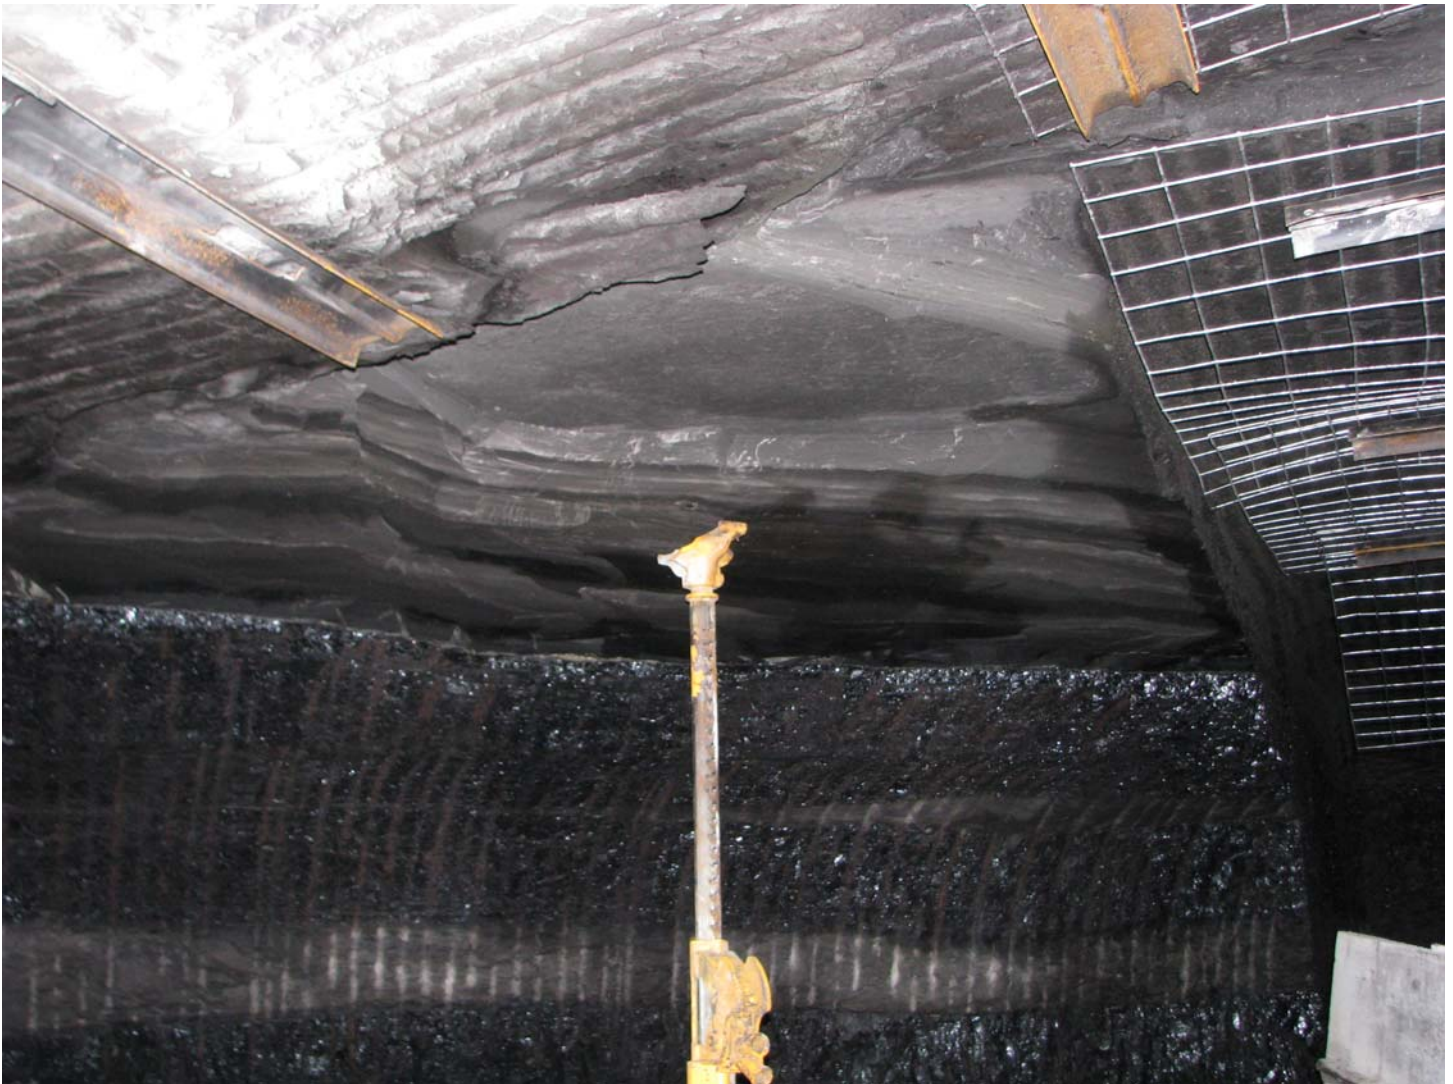
The roof jack was installed by the crew members after the accident to support the top while performing First Aid/CPR on the victim.

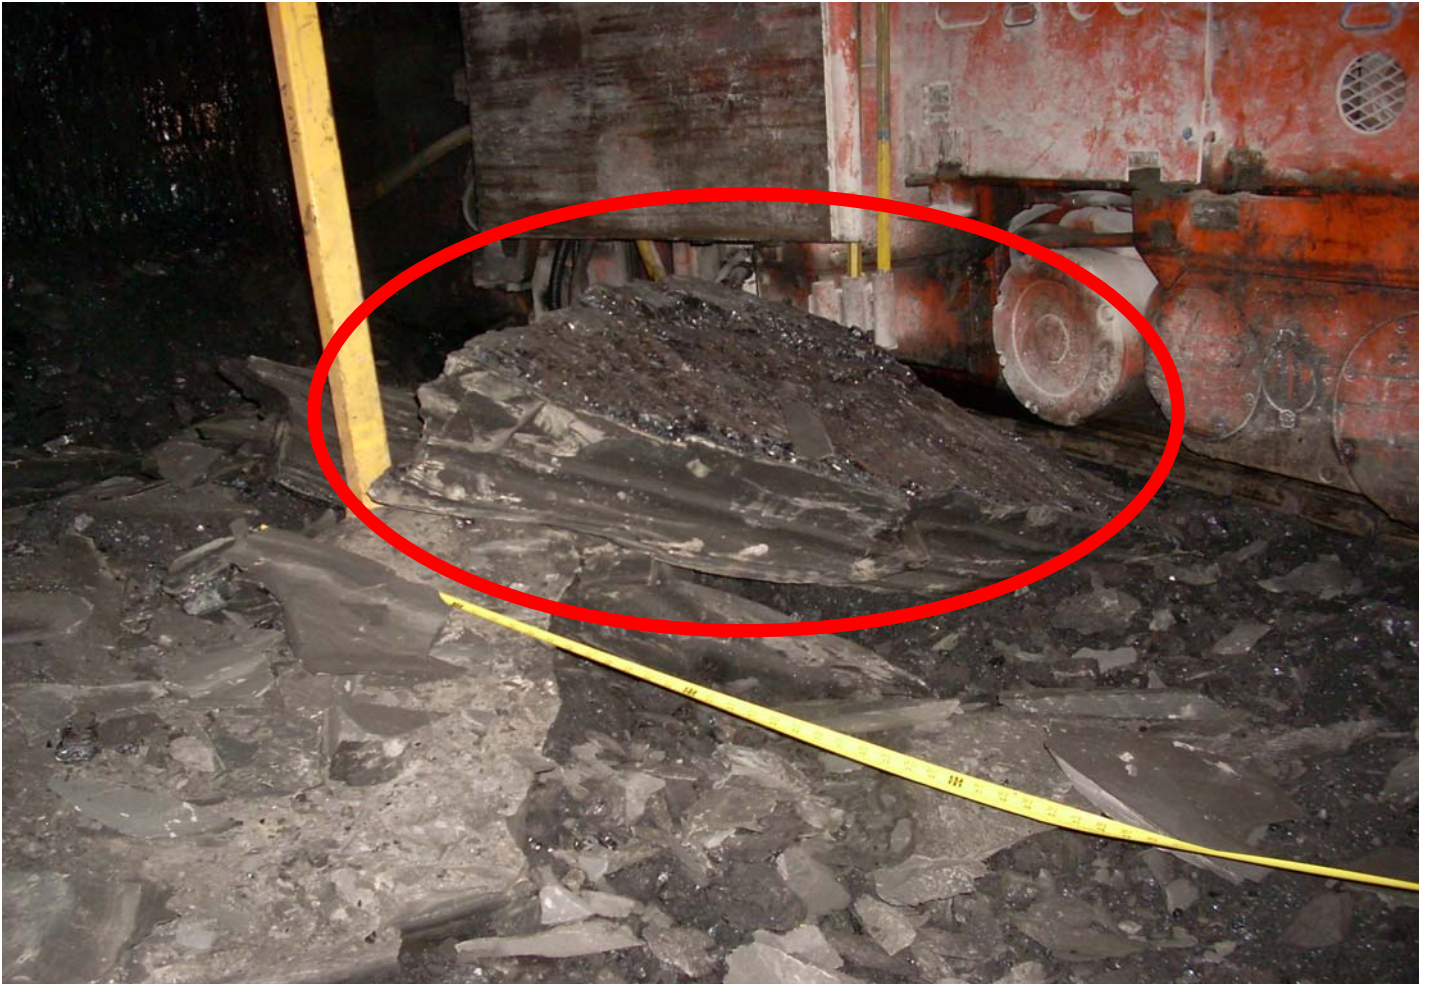
The head of the continuous mining machine was lowered to prevent the previously installed roof supports from being cut out while mining the left corner. This created a brow. The brow was triangular in shape and measured approximately 4 feet by 3.1 feet by 3.5 feet. The thickness of the rock and coal ranged from 9 inches to 11.5 inches thick.

Robert Maust, left side bolter, was fatally injured when a portion of the mine roof fell while he was installing a roof jack on the left inby corner of 60 crosscut in the No. 2 entry. The brow that was left when the corner was mined dislodged from the mine roof and struck the victim. According to the continuous mining machine operator, there was no evidence of bad roof when the area was mined. A hammer, which is commonly used as a roof sounding device, was found lying on the mine floor in the vicinity of the accident site. Roof jacks were commonly set on corners to provide temporary support until the permanent supports are installed. The mine operator did not have procedures in place to permanently support corners prior to operating inby the area.

Rock that struck victim was triangular in shape and measured approximately 4.5 feet by 3.1 feet by 3.5 feet, and ranged from 9 inches to 11.5 inches thick.

Corrective Action: The roof control plan has been revised to require the installation of permanent supports prior to working inby corners.

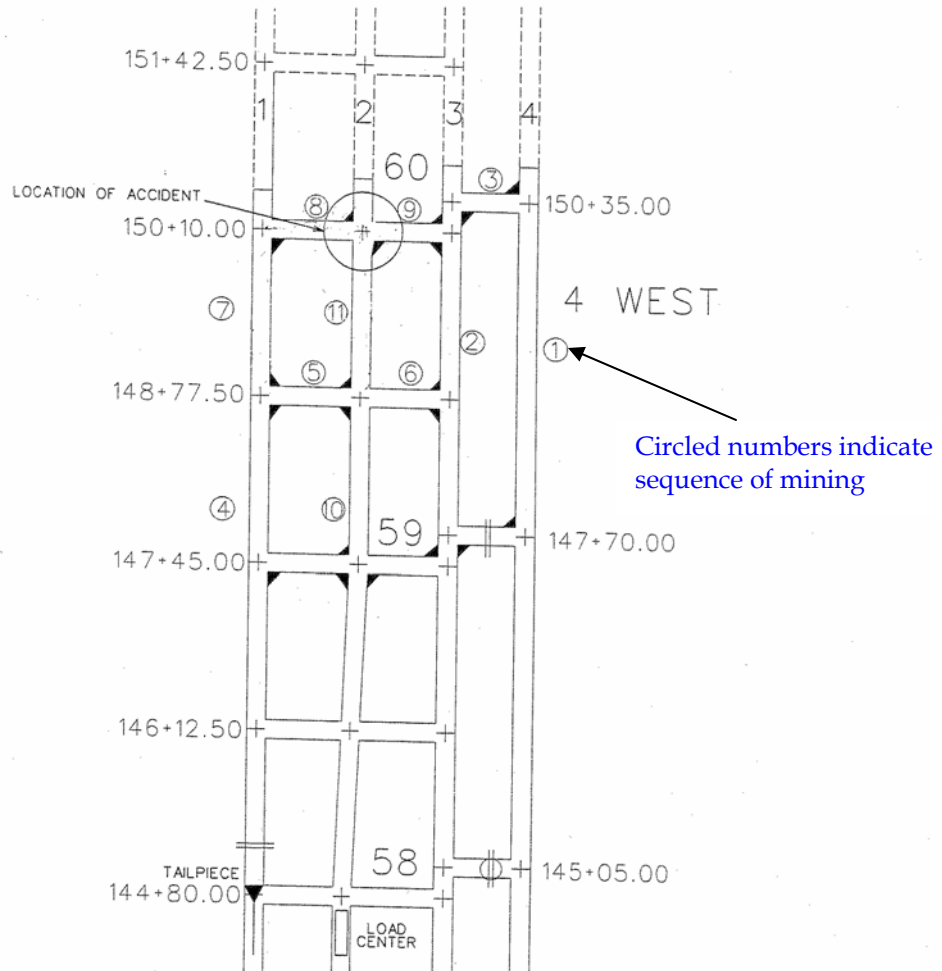
APPENDIX D
DRAWINGS CONT'D.

The mining height in the crosscut averaged 100 inches and entries and crosscuts averaged 16 feet in width. The left inby corner in the No. 2 entry at the No. 60 crosscut was triangular in shape. The corner measured approximately 11 feet by 11.8 feet by 16 feet. (See Drawings in Appendix D). Harteis and Farrell commented that the roof conditions in the No. 2 entry and the intersection at 60 crosscut were good. The crew had not detected any bad roof up to the time of the accident. A hammer, which is commonly used as a roof sounding device, was found lying on the mine floor, in the vicinity of the accident site.

The No. 2 entry was mined to intersect the Nos. 59 and 60 crosscuts. Once a crosscut is intersected and the area is bolted up to the previously installed roof supports, the corners are cut. The roof above the outby corners are bolted from the continuous mining machine as the corners are mined. The left inby corner is cut, head on, from the No. 2 entry and is not bolted from the continuous mining machine. In order to prevent the previously installed roof supports from being cut out while mining the corner, the head of the continuous mining machine is lowered away from the mine roof. This leaves a brow of rock and/or roof coal. (See Drawings in Appendix D)

Prior to mining into the No. 60 crosscut, the intersection was center-bolted with 8 foot combination bolts and 16 foot cable bolts. The cable bolts are a non-tension resin bolt system. The cable bolts were installed in every other channel across the intersection area. (See Drawings in Appendix D)
