REPORT OF INVESTIGATION

Surface Coal Mine

Fatal Powered Haulage Accident  
July 28, 2009

Hawkeye Contracting, LLC  
Robinson Creek, Pike County, Kentucky  
I.D. No. F843

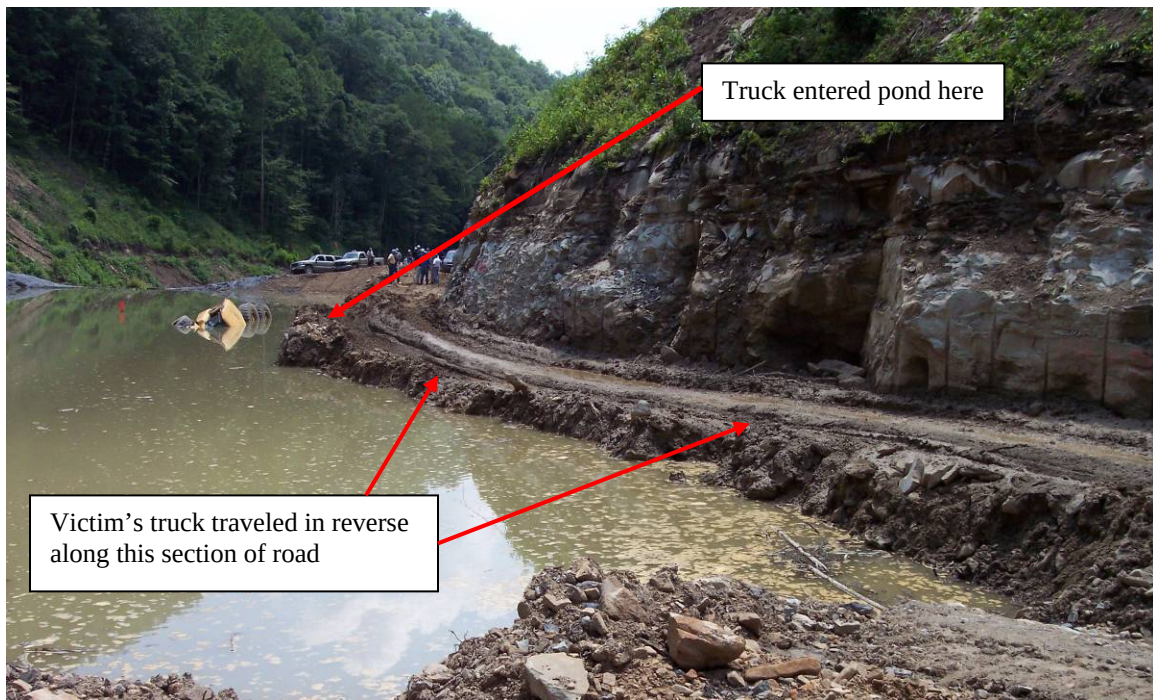
| PHOTO OF ACCIDENT SITE ..... | 2 |

At 9:45 a.m., on Tuesday, July 28, 2009, a 27 year-old Equipment Operator employed by Hawkeye Contracting, LLC, with six years mining experience was fatally injured when the loaded articulated dump truck he was operating overturned into a newly constructed sediment pond. The driver was traveling in reverse along a narrow road adjacent to the pond. The truck rolled onto its top, trapping the driver under water.

The accident occurred because the equipment operator failed to maintain full control of the articulated truck while it was in motion.

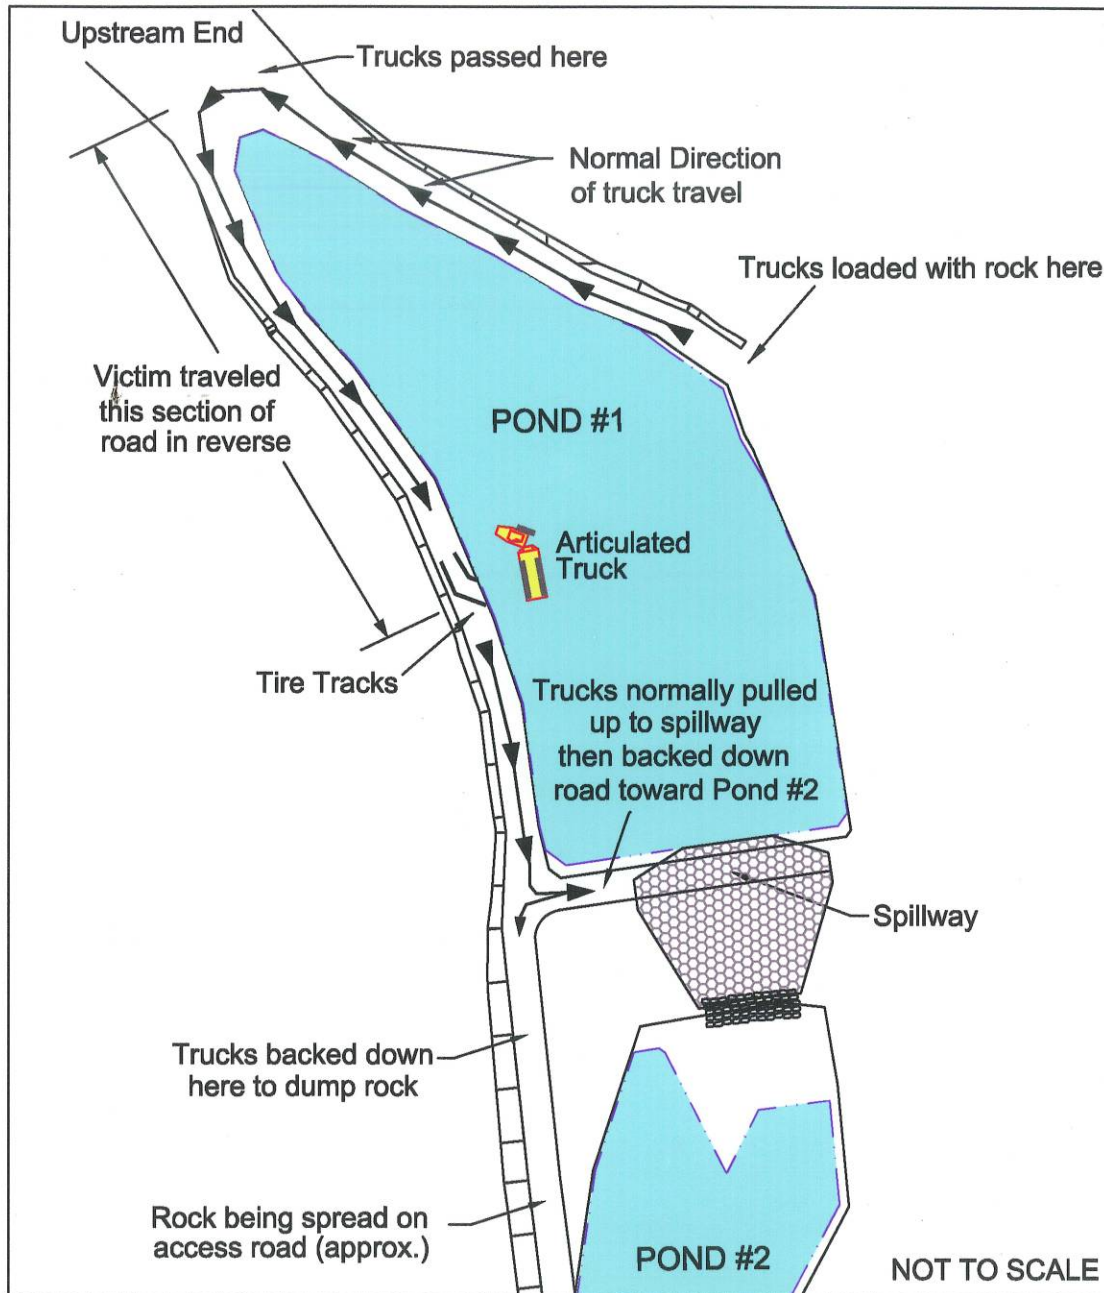
**Appendix B**  
**Map of the accident scene**

Rife observed the dump trucks being loaded and traveling forward from the rock loading area, around the upstream end of Pond #1 (upper pond), then along the highwall downstream to the spillway (See Appendix B). The trucks were turning on the spillway level and backing down the road toward Pond #2 where they were dumping their loads. Shawn Legg was spreading the rock delivered by the trucks, in order to grade the road surface at Pond #2. Rife traveled down the road to Pond #2. Gray and Hanson continued to haul rock, passing at the upstream end of Pond #1. While being loaded, Hanson noticed that Gray was no longer traveling forward toward the spillway and had begun backing down the road along the highwall, in reverse. After dumping his load, Gray passed Hanson (loaded) who gave him a hand signal to turn around. Gray acknowledged the signal. Hanson dumped his load and passed Gray again. While backing up to get loaded by Sanders, Hanson noticed Gray backing down the road a second time.

The accident occurred because the equipment operator failed to maintain full control of the Volvo A30D articulated dump truck, Company No. 4033, he was operating while it was in motion. The victim over-traveled the berm and overturned the truck into the pond. No equipment safety defects were found which contributed to the accident.
