REPORT OF INVESTIGATION

Underground Coal Mine
Fall of Face, Rib, Pillar or Highwall
August 20, 2009

Big Laurel Mining Corporation
Mine No. 2
Roda, Wise County, Virginia
ID No. 44-07087

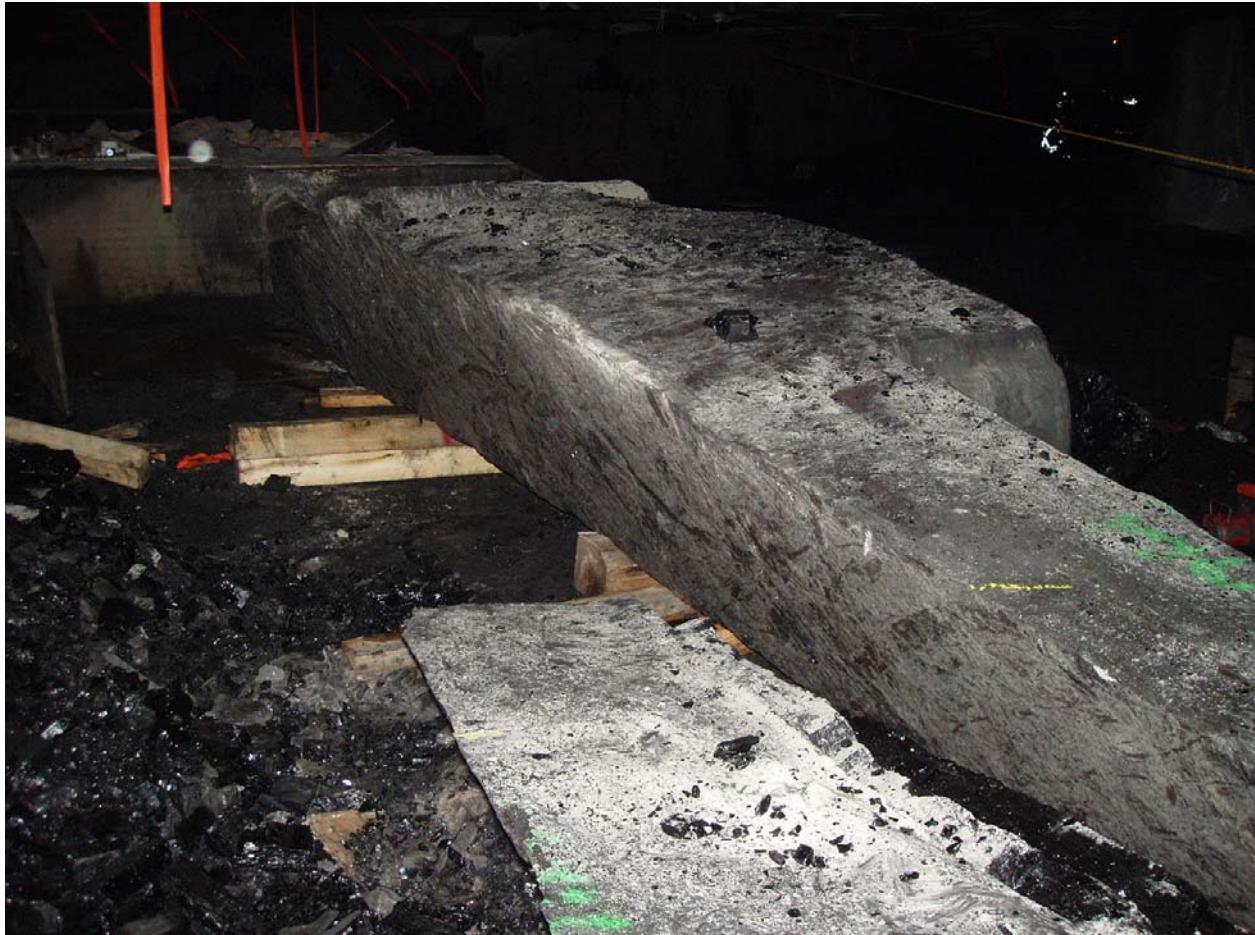
The fatal rib roll represents a long slab that toppled from the right rib along geological planes of weakness. Although the original complete slab may have contained coal, it appears to have broken up and turned to rubble during the failure, such that the remaining solid slab is composed of hard shale and siltstone (Figure 1). The intact slab is estimated to weigh 20 tons. Based on the distribution of rock dust, it does not appear that the failure occurred as a cantilever of shale after being undercut by sloughing coal. Instead, the slab separated along prominent N 65° E-striking coal cleat and a steeply dipping N 65° E-striking joint that isolated the edge of the pillar, and toppled outward

Figure 1. Long, thin slab of shale separated from smooth bedding parting characterized by plant fossil debris, rotating down and out into entry. Smooth, flat surface at left represents top of rock.

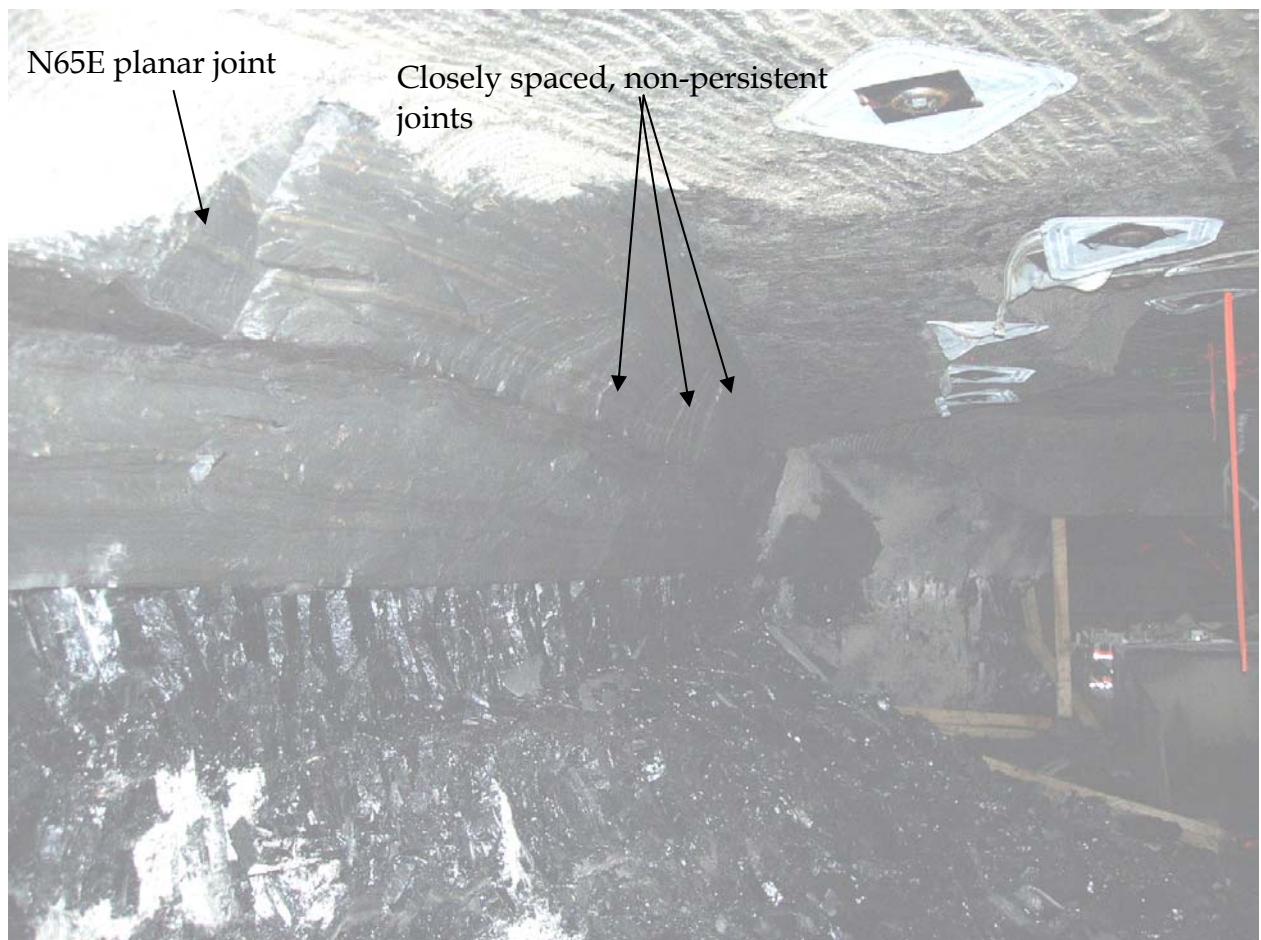
and rotated out into the entry (Figure 2). The slab separated from the immediate roof along a prominent bedding parting that hosted randomly oriented, plant fossil debris (Figure 3). The actual failure surface of the shale is not controlled by a single, planar joint, but is instead composed of a series of parallel, non-persistent joints that result in a slightly curved surface (Figure 3). The controlling joint was exposed in the last open crosscut, where it was turned right from the No. 4 Entry (Figure 4).

Figure 2. Planar joint strikes N 65° E and projects behind failed slab into outby right-hand crosscut, isolating the pillar corner that resulted from changing orientation from 2 West Main to 3 West Main. Rear bounding failure surface is composed of closely spaced, but non-persistent joints that parallel the smooth-surfaced joint.

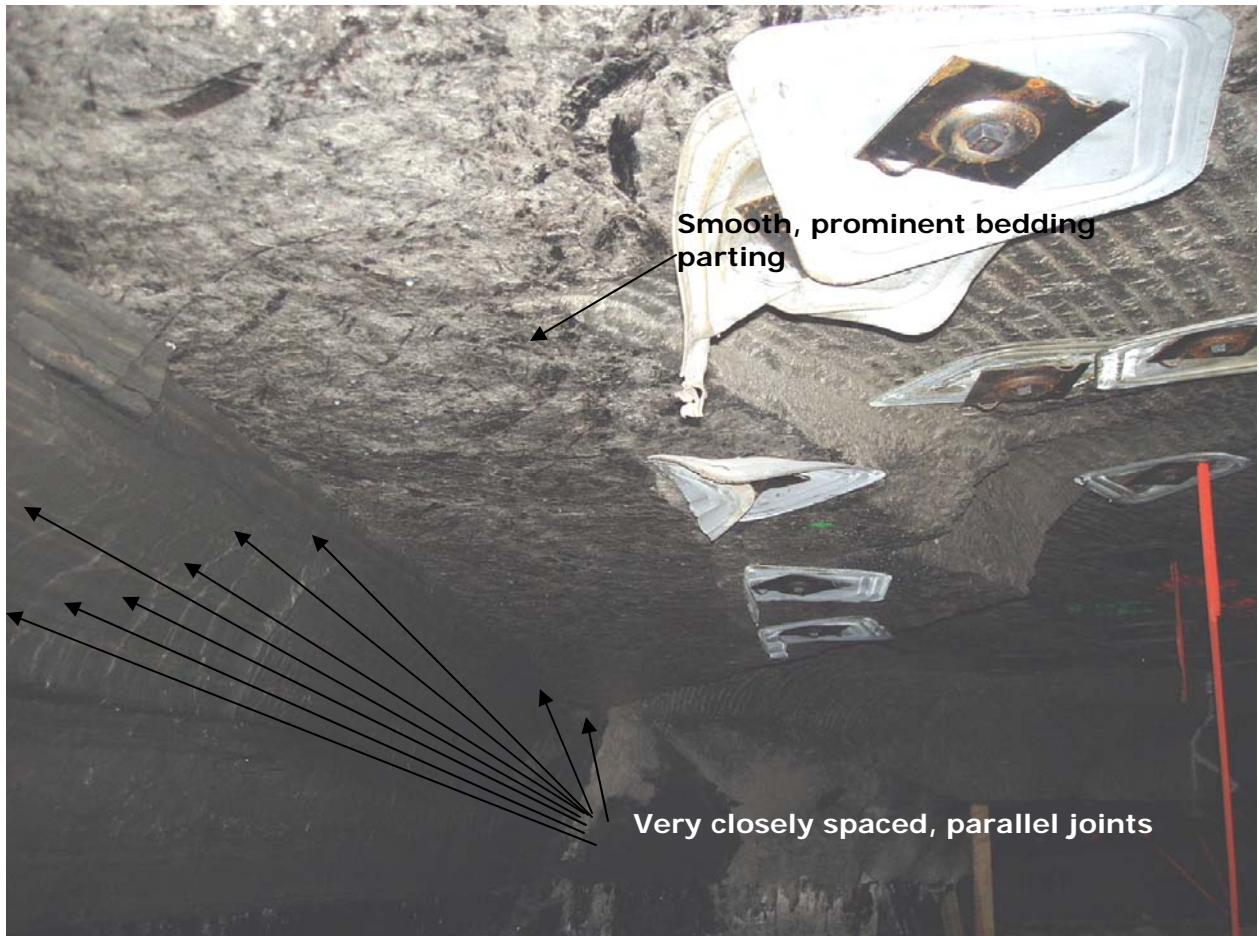
Figure 3. Smooth, prominent bedding parting exposes fossil plant debris, matching surface of failed slab. The failed slab delaminated from the roof along this plane of weakness. Slightly darker area represents freshly exposed surface, indicating extent of failed slab. Left of photo shows smooth surface defined by very closely spaced, parallel joints that acted as rear bounding failure surface.

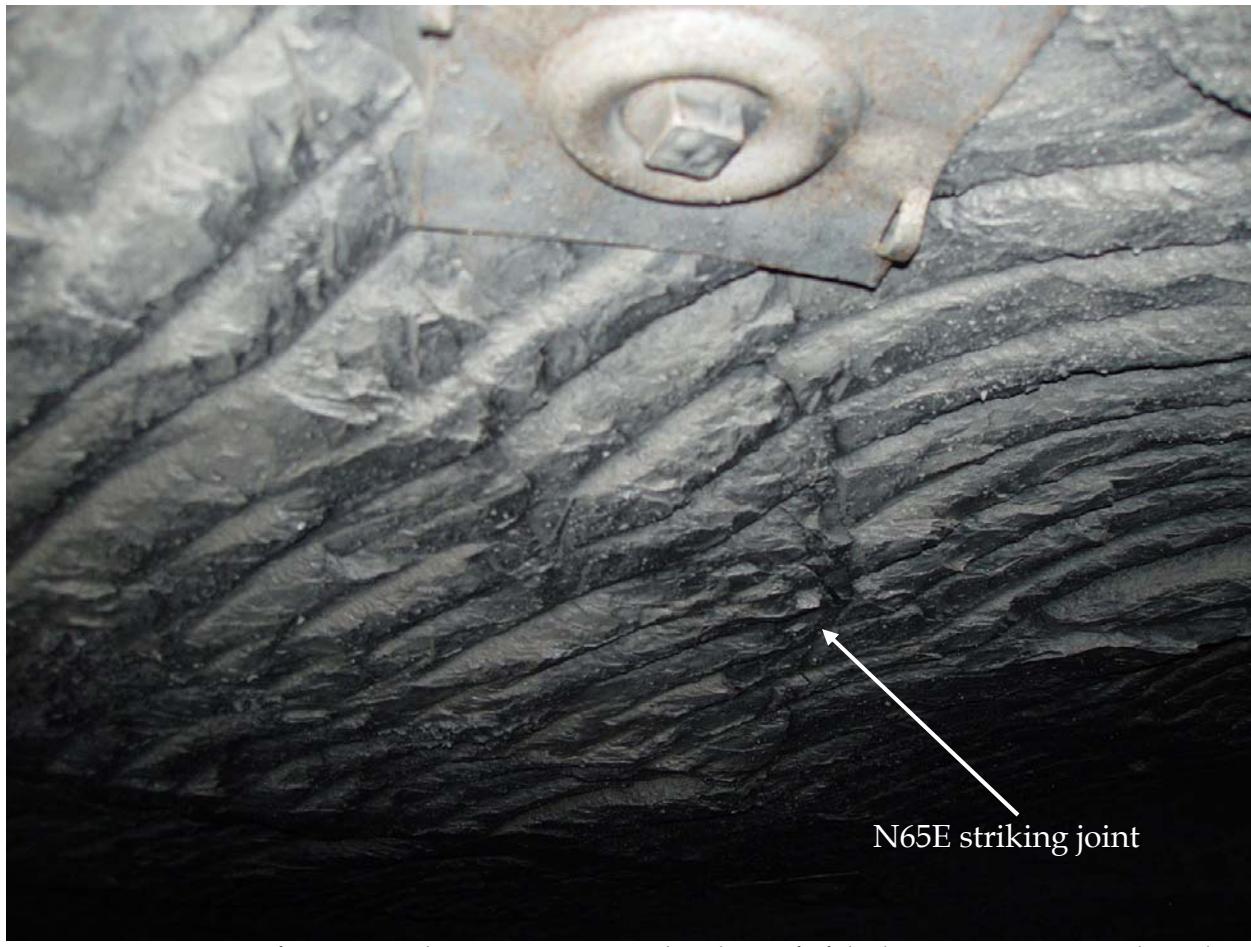
Figure 4. Expression of N 65° E striking joint as exposed in the roof of the last open crosscut to the right of No.4 Entry, outby the accident site.

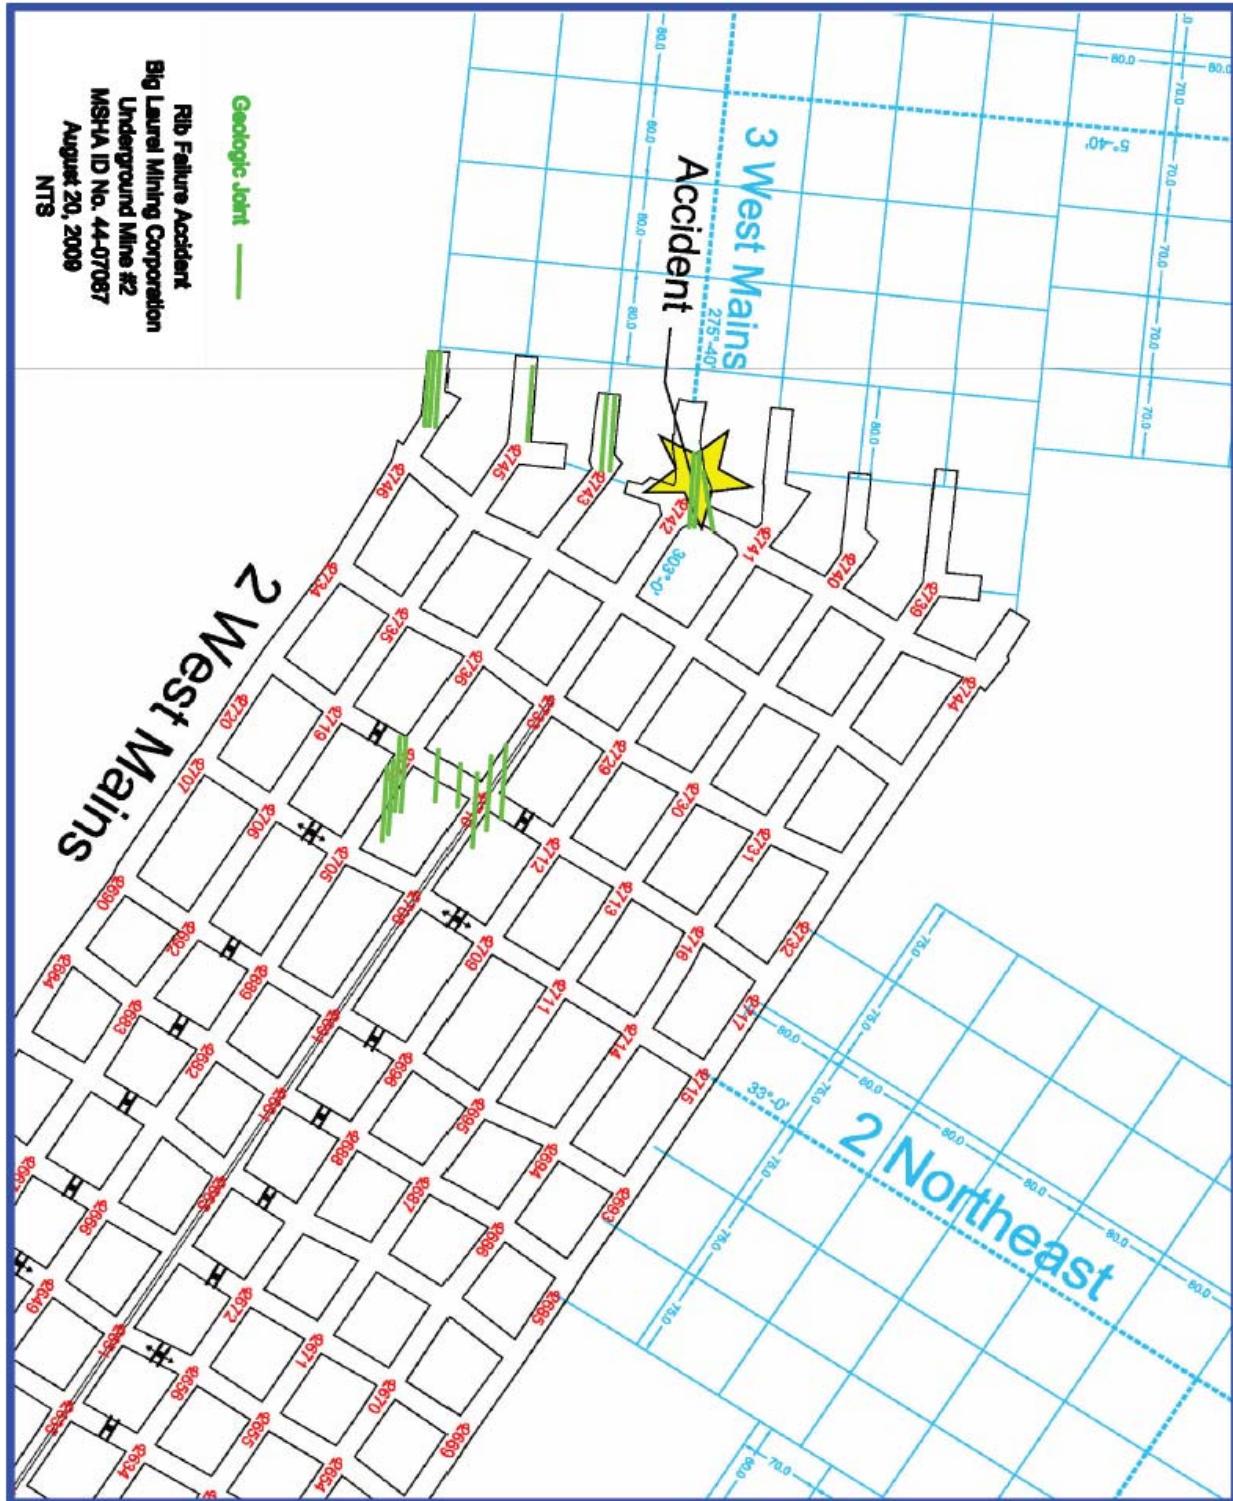
Section Map of Plotted Roof Joints

Very well developed joints that exhibited a strike of N 70-80° E were observed from the faces to four crosscuts outby on the 2 West Mains. The N 57° W azimuth of the 2 West Mains placed the joints in a diagonal “corner to corner” orientation that minimized their impact on instability. When the 3 West Mains began to be turned in the new orientation of approximately Due West (N 84 degrees, 20 minutes W) the joints became approximately parallel to the new rib line. In the No.4 Entry, where the fatality occurred, a N 65° E joint trended through the right-hand crosscut inby into the No. 4 Entry, isolating the south pillar corner and defining the tall slab. The same geometry was observed in the No.1, No.2, and No.3 Entries, where the turn to the new orientation had also been made. (See Section Map of Plotted Roof Joints-Appendix B)

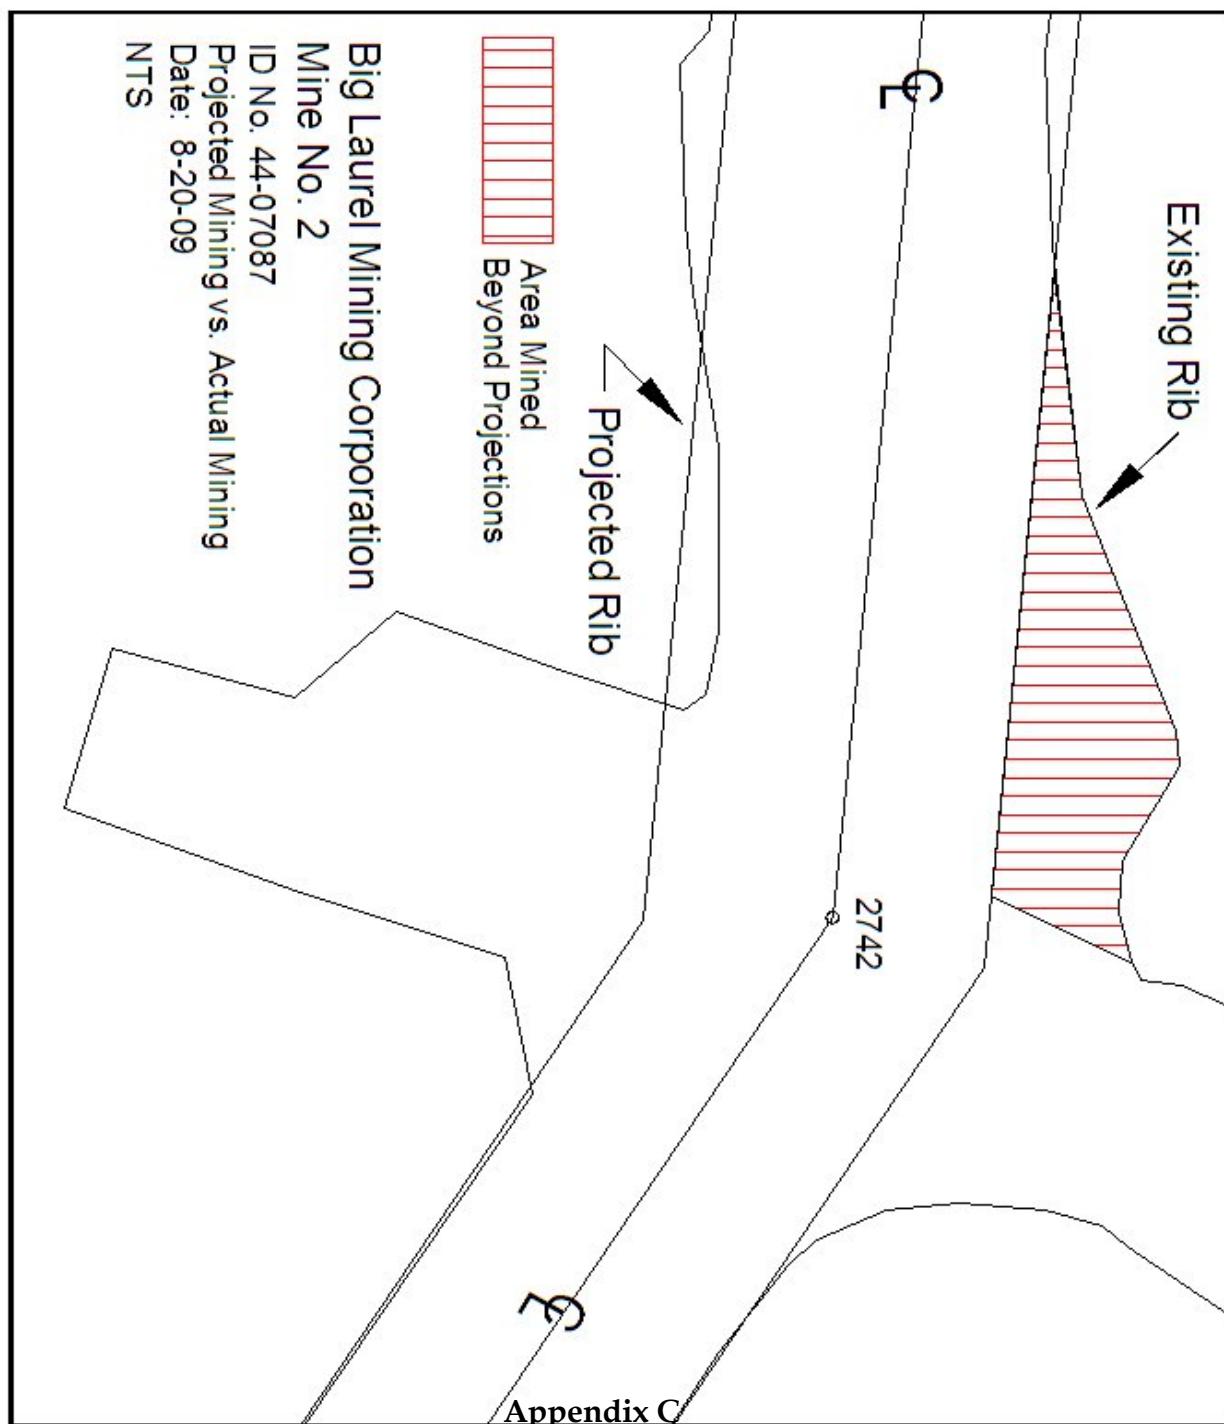
Projected Mining vs. Actual Mining Drawing

The cut which created the wide entry was taken on the 3rd shift on August 18, 2009 and the wide condition was noted as a hazardous condition on the day shift onshift and preshift reports for August 19, 2009. All subsequent cuts taken in the No. 4 heading inby Survey Station 2742 were taken by the 3rd shift crew. The actual mining of the turn from 2 West Mains to 3 West Mains in the No. 4 Entry exposed entry widths of 28.5 to 31.8 feet. If this projected turn had been mined properly, an approximate additional 6.5 to 9.8 feet of coal would have remained in place in the turn area. This additional coal could have mitigated the consequences of the rib roll. Survey spads had been set in the No. 4 Entry on August 18, 2009. These survey spads were not utilized properly to accomplish the change in mining direction from 2 West Mains to 3 West Mains. (See Projected Mining vs Actual Mining Drawing -Appendix B)
