#### **REPORT OF INVESTIGATION**

Fatal Automobile Accident (Powered Haulage) September 5, 2009

Rock Mountain Mining-Div/Twin Pines Coal Co., Inc. Shannon Mine Johns, Jefferson County, Alabama I.D. No. 01-03303

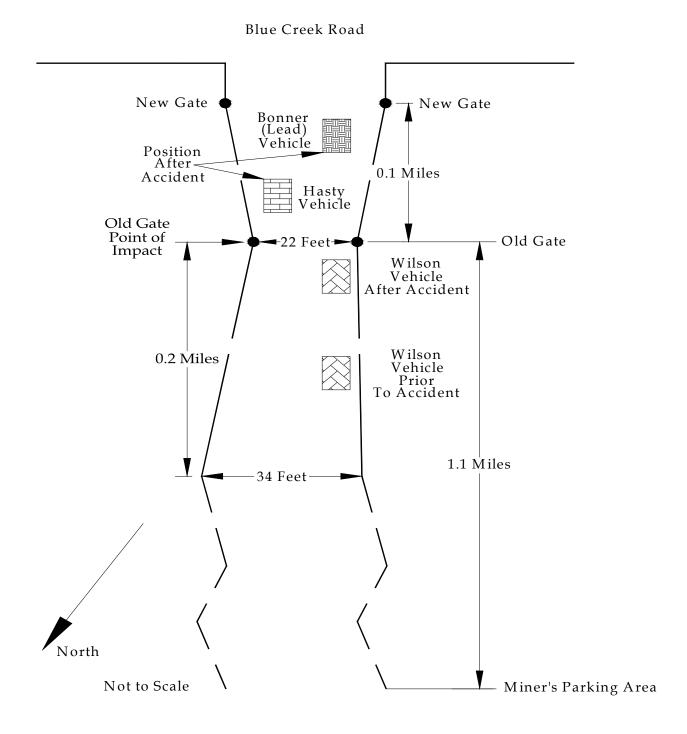
### **APPENDIX B**

The parking area is approximately 1.2 miles from the Blue Creek Road, a public highway, and is connected to this public highway by a dirt road. There are two gates along the dirt road: the "old gate," which remains open, and the "new gate," which is at the access point to the public highway. The old gate is approximately 1.1 miles from the mine parking area, and the new gate is approximately 1.2 miles from the parking area (Appendix B).

The dirt road where the accident occurred is approximately 1.2 miles in length and 30 to 34-feet wide along its length, until it narrows to approximately 22-feet at the old gate (Appendix B). The road was well graded, free of standing water, and visibility was not affected by road dust.
