REPORT OF INVESTIGATION

Fatal Slip/Fall of Person Accident  
September 23, 2009

Cowin & Company, Inc. (B84)  
Birmingham, AL  
at  
MC #1 Mine  
M-Class Mining  
Macedonia, Franklin County, Illinois  
I.D. No. 11-03189

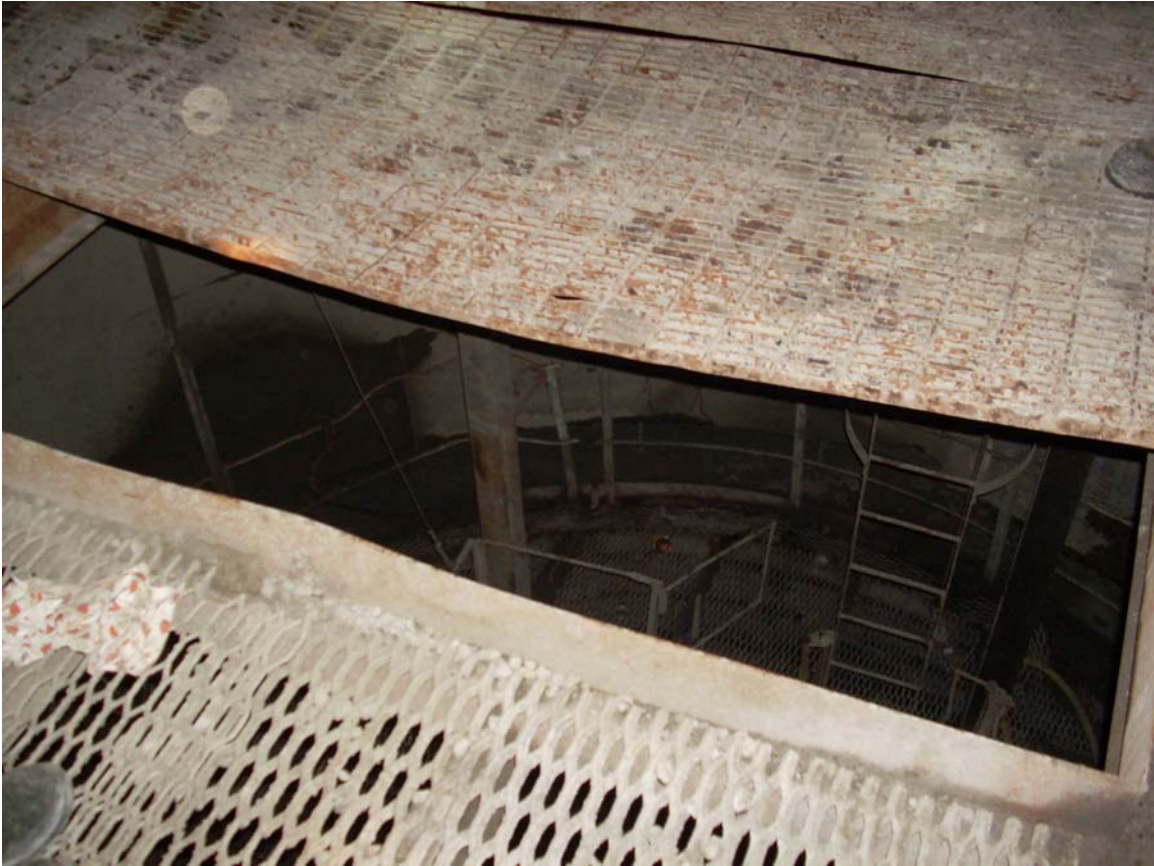
Photograph showing the top deck bucket well opening with one section of grating removed.

On the day of the accident, the handrails around the bucket well on the top deck had been removed. Three sections of steel grating, each measuring 3 feet by 10 feet, had been installed to cover the bucket well. According to statements by witnesses, one of the sections of grating had been slid over on top of the adjacent section, creating the opening through which the victim fell. In order to remove the victim from the shaft bottom, all three sections of grating had to be removed, to allow the muck bucket clearance through the work platform. After the victim was hoisted to the surface, the grating was placed back over the bucket well.

There were several potential tripping hazards located on the work deck, including a ladder, a nylon sling, a concrete vibrator hose, and a wood board. Additionally, a set of suspension lugs used to secure the work platform suspension lines to the platform, were located along the walkway around the bucket well. Since there is no evidence that the material on the deck contributed to the victim's fall, it is believed he was clear of the tripping hazards at the time of the accident; however, it is possible that the victim may have tripped on the toe board surrounding the bucket well opening.

**Root Cause:** The policies and controls in place at this construction project did not ensure that persons could safely work in the shaft where there was a danger of falling. An opening through which a person could fall was present in the work deck and management failed to ensure that fall protection was utilized.

**Corrective Action:** The contractor submitted an addendum to their approved shaft sinking plan to the District Manager. The addendum details the 100% tie off policy for persons working in the shaft. All employees have been instructed in the requirements of the tie off policy, and have received training in proper use of fall protection equipment.
