**REPORT OF INVESTIGATION
(Surface area of a shaft development project for existing underground mines)**

**FATAL ACCIDENT (Hoisting)
November 23, 2009**

**Upper Second Creek Portals
Perry County Coal Corporation
Hazard, Perry County, Kentucky
I.D. No. 15-19364
Frontier-Kemper Constructors Inc.,
Contractor I.D. No. A01**

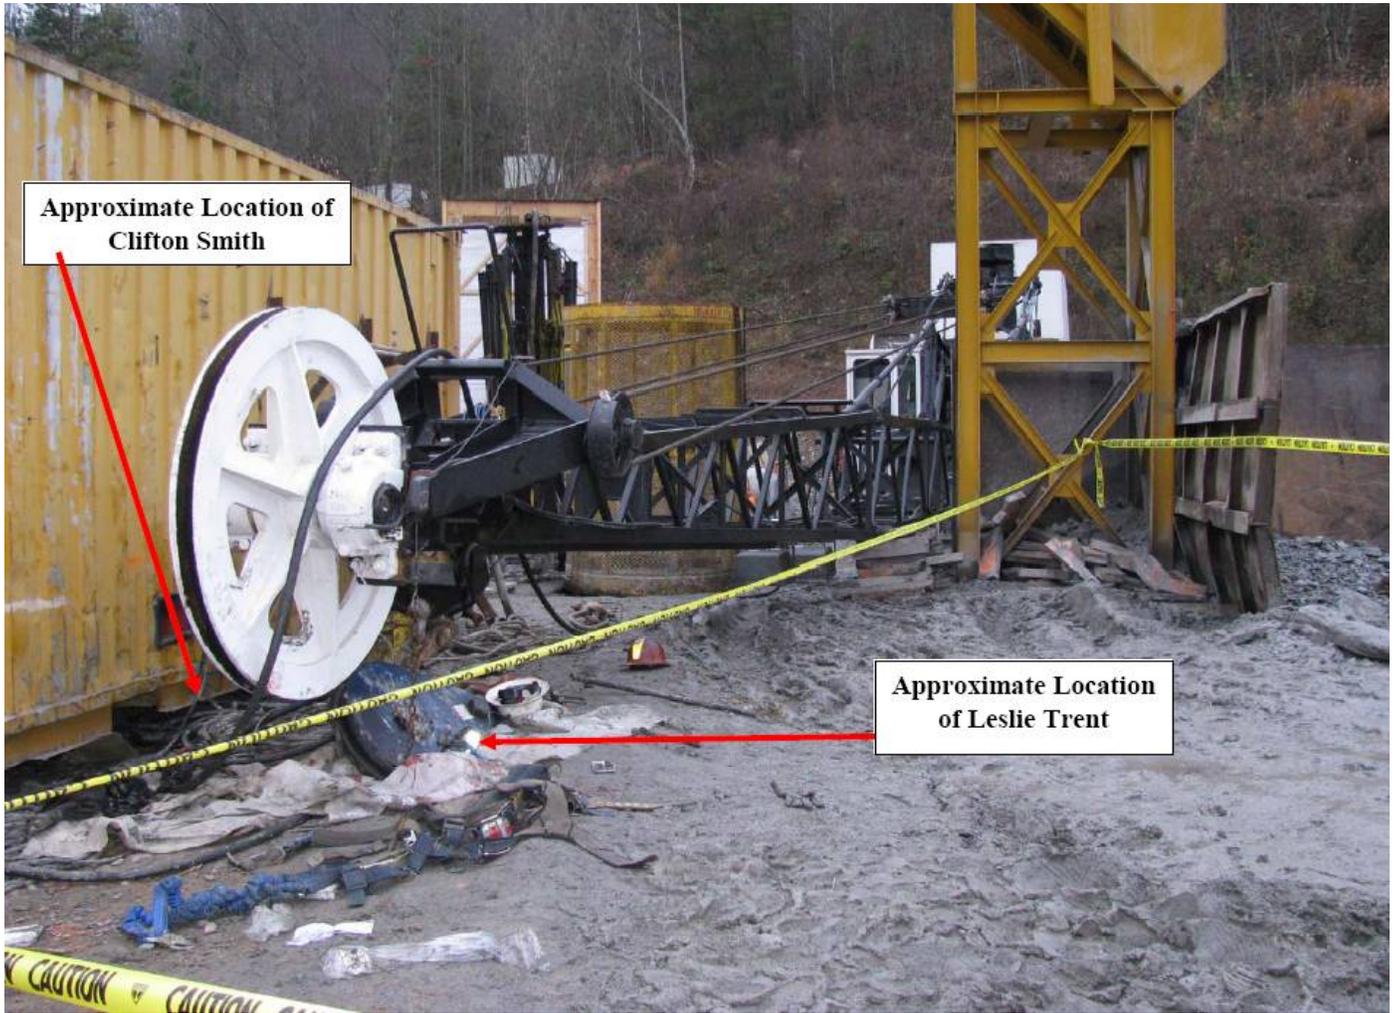
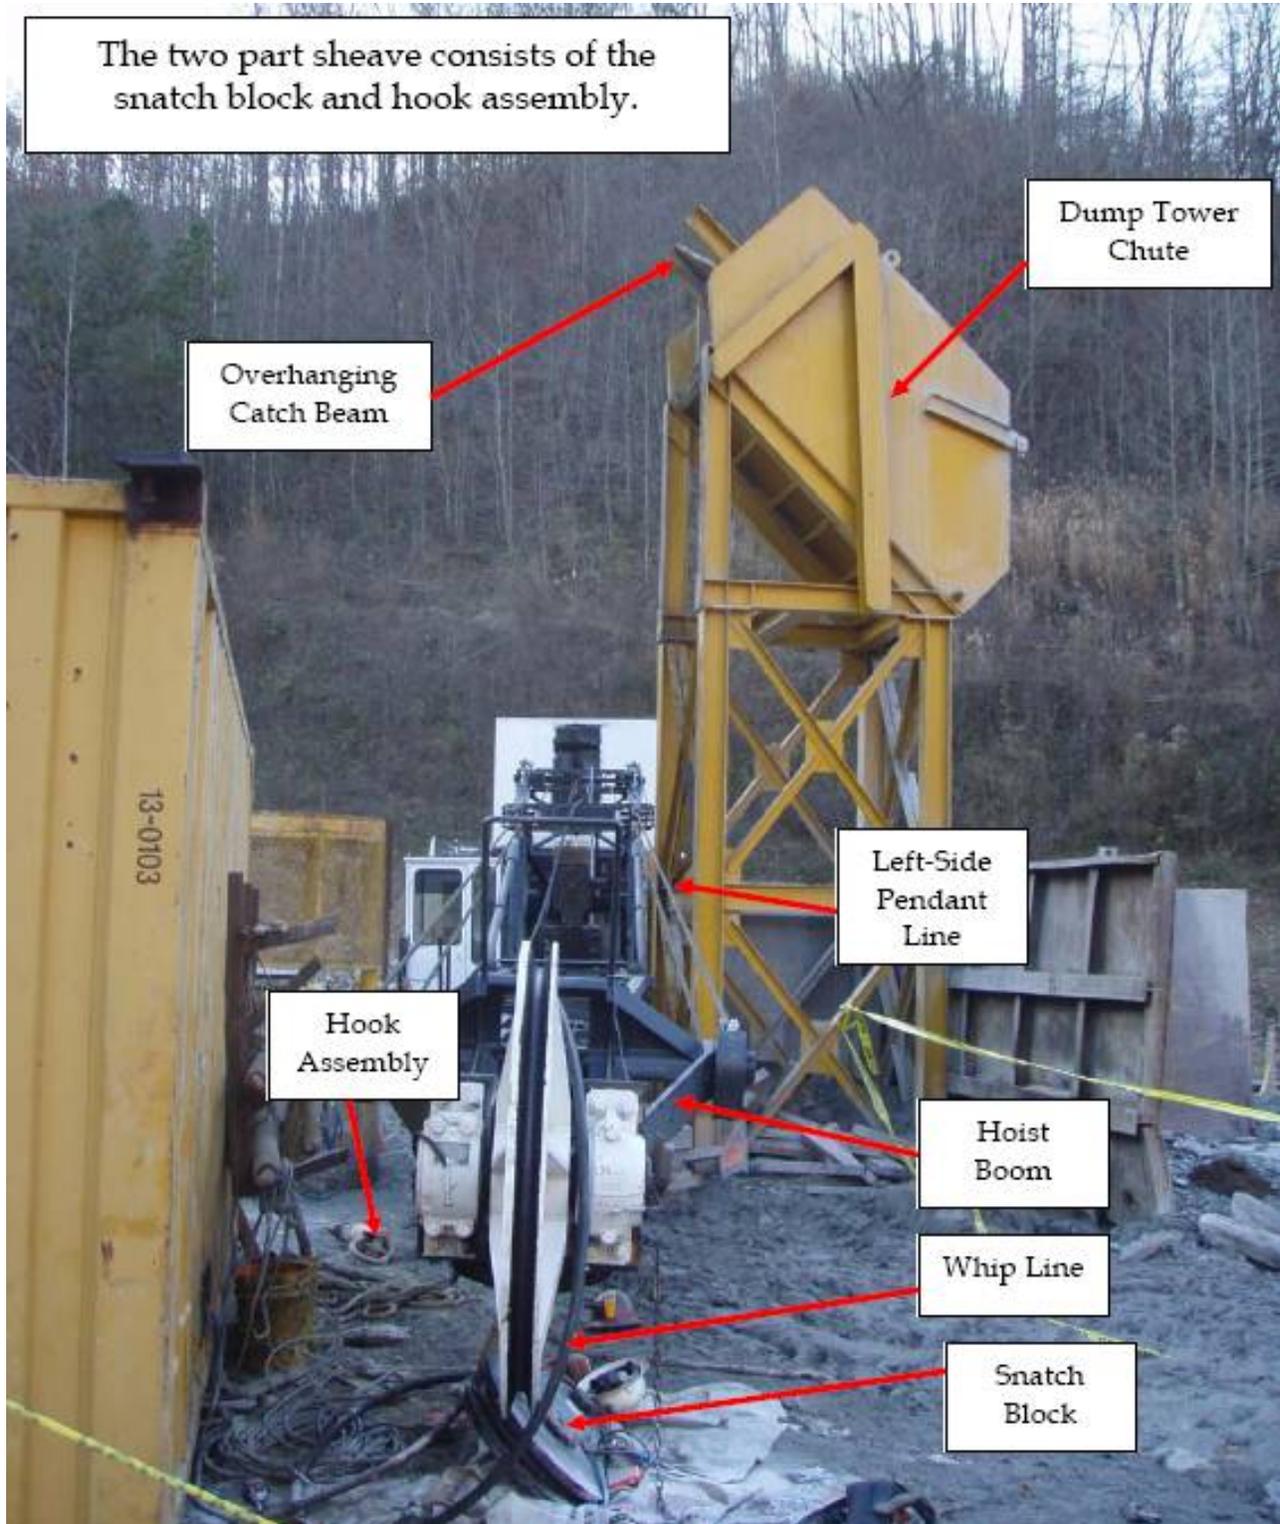
PHOTOGRAPH OF ACCIDENT SCENE

The investigation found that on the evening of the accident, Leslie Trent (victim) was working directly underneath the boom of a pivoting hoist. He was attempting to remove a 30 ton sheave from the whip line when the boom fell, striking the victim and another miner, resulting in both serious and fatal injuries. Interviews with miners and an agent of the operator, as well as the investigation into the circumstances of the accident, revealed that it was common practice for miners to work underneath the unsecured hoist boom. Further, it was determined that materials were not available in the immediate vicinity to block the hoist boom. The contractor, Frontier Kemper Constructors, Inc., and the mine operator, Perry County Coal, failed to insure that the hoist boom was securely blocked in position prior to allowing any work to be conducted by miners underneath the boom.

ACCIDENT SCENE: The scene of the accident was on the surface near the development area for the E3-1 ventilation shaft, directly adjacent to the Top Shack in close proximity to the drill steel rack mounted to the outside wall of the Top Shack, and directly underneath the pivot hoist boom. The ground at the accident scene, at the time of the accident, was damp to wet and muddy.
