REPORT OF INVESTIGATION

Surface Coal Mine

Fatal Powered Haulage Accident
December 12, 2009

Premier Elkhorn Coal Company
PE Southern Pike County
Myra, Pike County, Kentucky
I.D. No. 15-17360

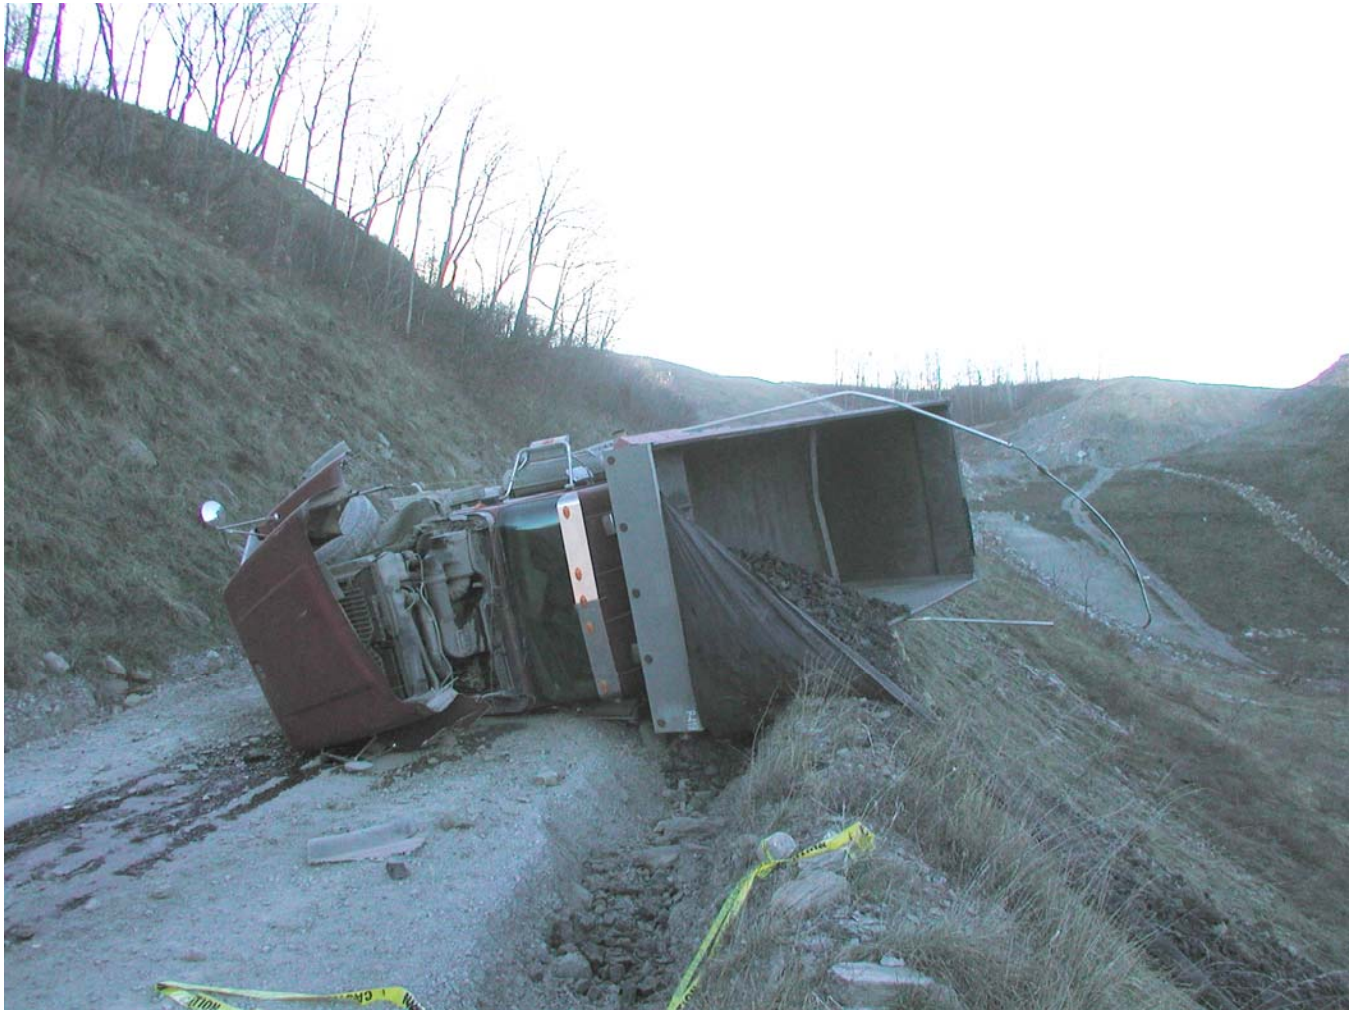
Photograph of Accident Scene

At approximately 6:30 a.m., on Saturday, December 12, 2009, Stevie Johnson, a 52-year old Truck Driver and Chief Mechanic for Trivette Trucking, received fatal injuries when he exited the truck he was driving, and was struck by the left rear tandems of the truck. Johnson had approximately 30 years of experience as a truck driver/truck mechanic, all of which was with this contractor. He had approximately seven years experience at this mine. Johnson was hauling coal from the PE Southern Pike County Mine when the accident occurred.

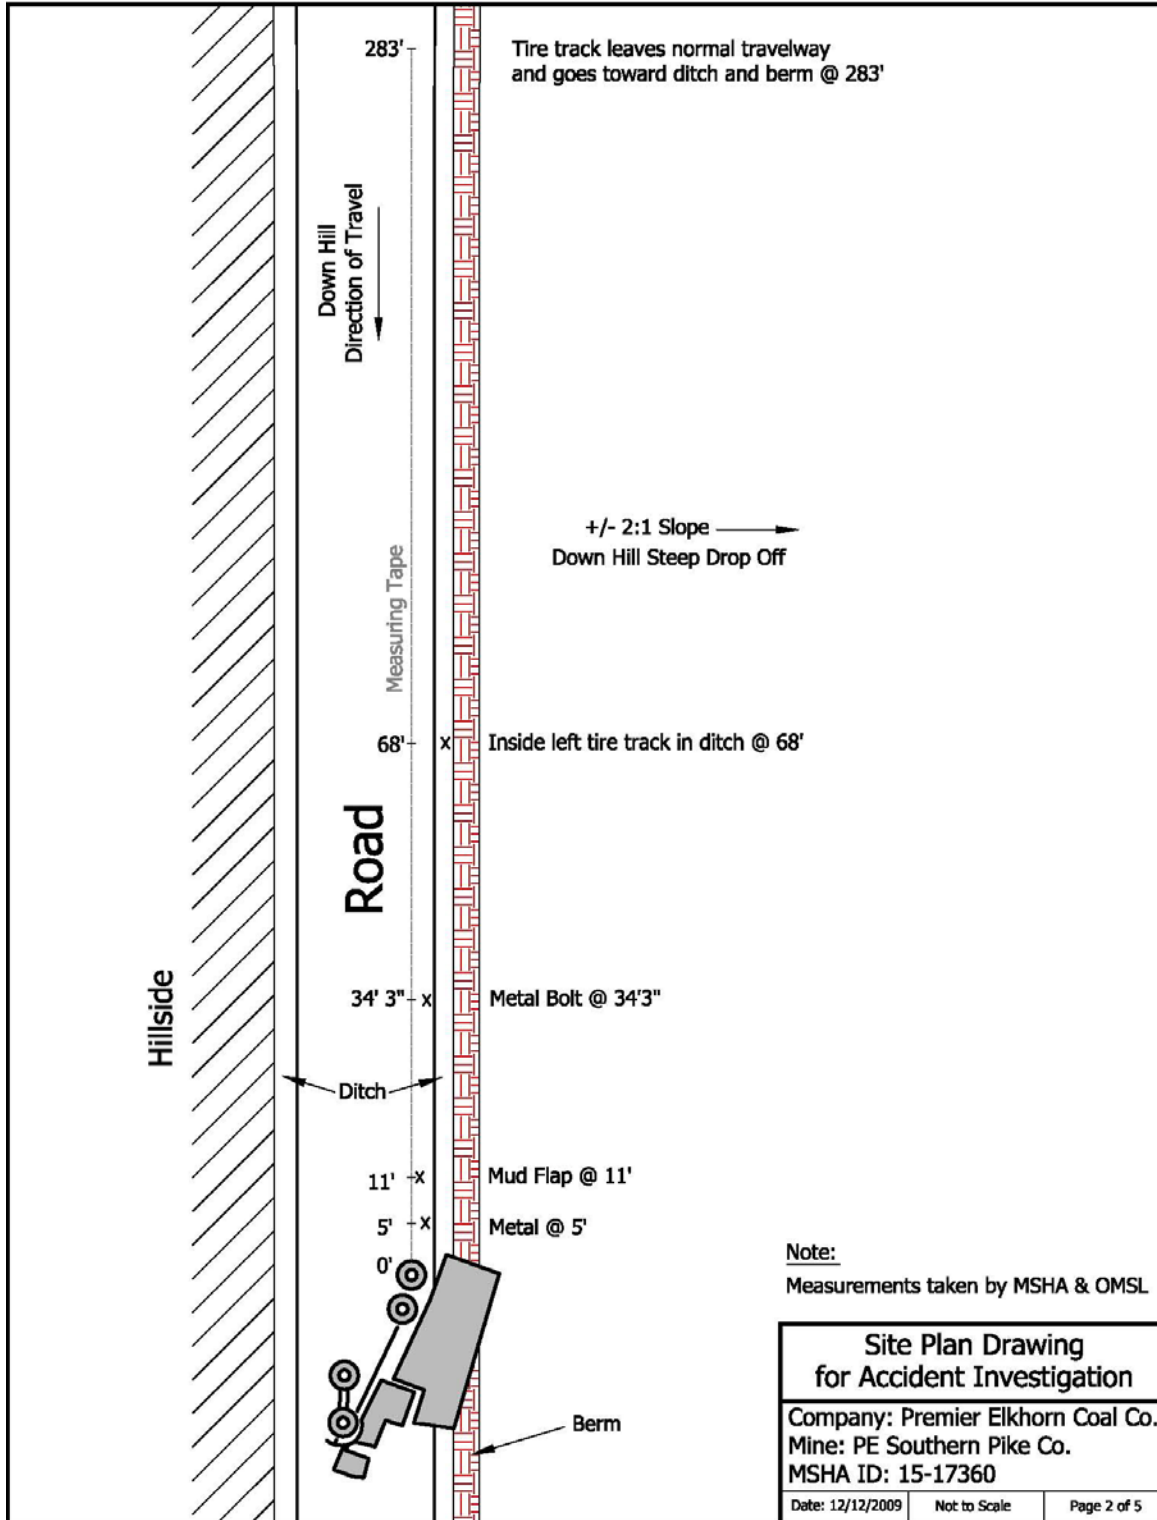
Appendix C Sketch of Accident Scene

After being loaded, the truck descended a grade approximately 1,300 feet long, with an average overall grade of approximately 14 percent to the point where the accident occurred. The haul road leveled off about 200 feet beyond where the truck came to rest. The berm height along the outer bank of this road was 36 inches from road bed level. A ditch at the base of the berm was an additional 18 inches in depth at the accident location.

Tire tracks from the truck travel lead toward the ditch and berm 283 feet from the point where the truck came to rest. These tracks continued in the roadway for an additional 215 feet before the inside left rear tire entered the ditch. Evidence indicates that Johnson left the truck cab at least 13 feet before the tire entered the ditch. The first location of disturbance in the berm was 53 feet from the final resting point of the truck. This is 230 feet from the point where the truck initially veers from the normal roadway. The first evidence of Johnson leaving the cab of the truck was 81 feet from the final resting point of the truck.
