REPORT OF INVESTIGATION

Fatal Fall of Roof Accident  
December 16, 2009

Sapphire Coal Company  
Sandlick II Mine  
Sandlick, Letcher County, Kentucky  
I.D. No. 15-18782

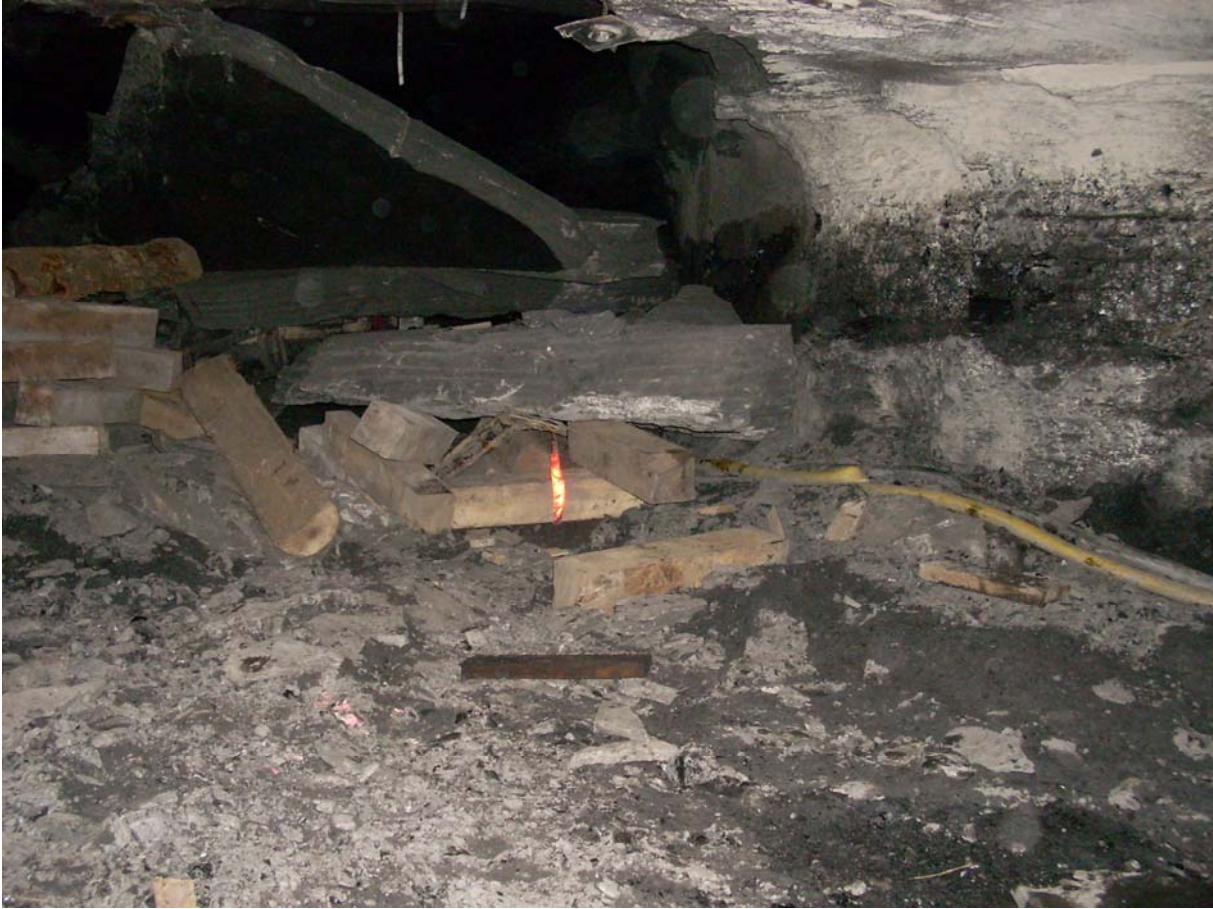
Photo of Accident Scene

At approximately 8:40 p.m., on Wednesday, December 16, 2009, Phillip Newton, a 34-year old continuous mining machine operator for Sapphire Coal Company, received fatal injuries when a piece of rock measuring 13 feet long by 6 feet wide by 12 to 16 inches thick fell from the roof and trapped Newton (victim) beneath it. The victim was cutting the No. 5 Right crosscut into the No. 6 entry (see Sketch of Accident Scene).

Newton's body was located under the fallen rock between the first and second row of roof bolts. Two roof bolts in the first row were broken and portions were in the rock which had fallen. A visual warning device was hanging on the roof bolt furthest outby, which was in the second row of installed roof bolts from the newly mined, unsupported area.

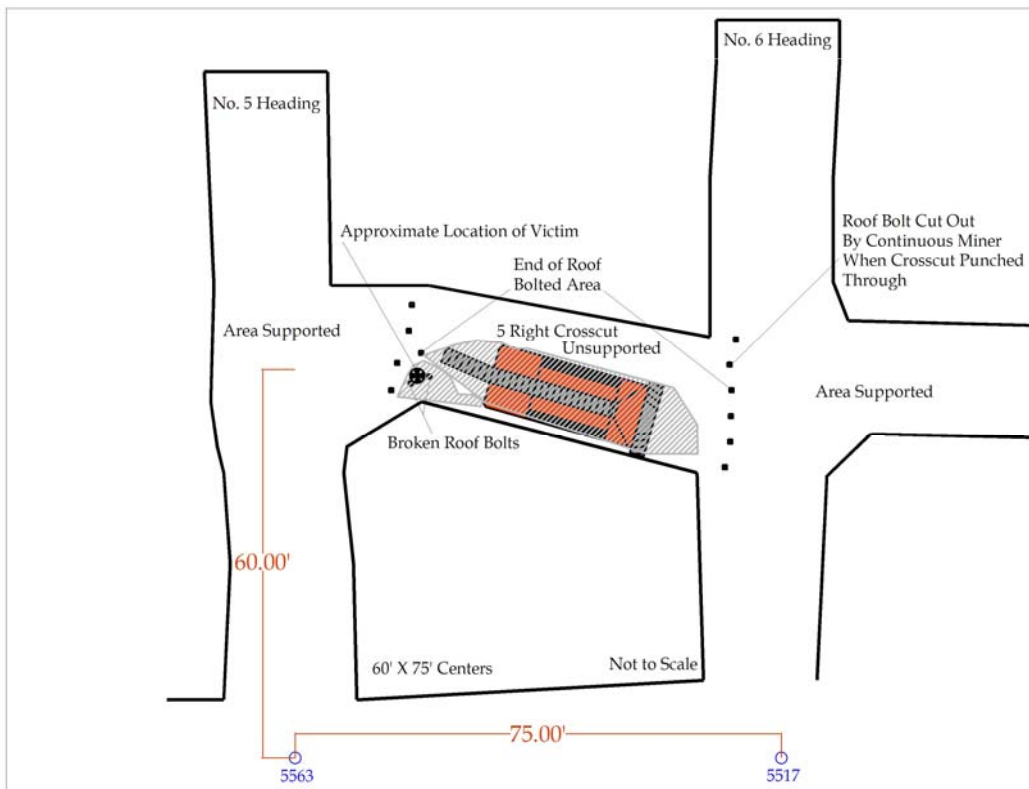
Sketch of Accident Scene

The cut depth from the last row of primary support in the No. 5 Right crosscut to the first row of roof bolts in the No. six entry was measured to be approximately 49 feet. The maximum cut depth allowed by the approved roof control plan was 40 feet.

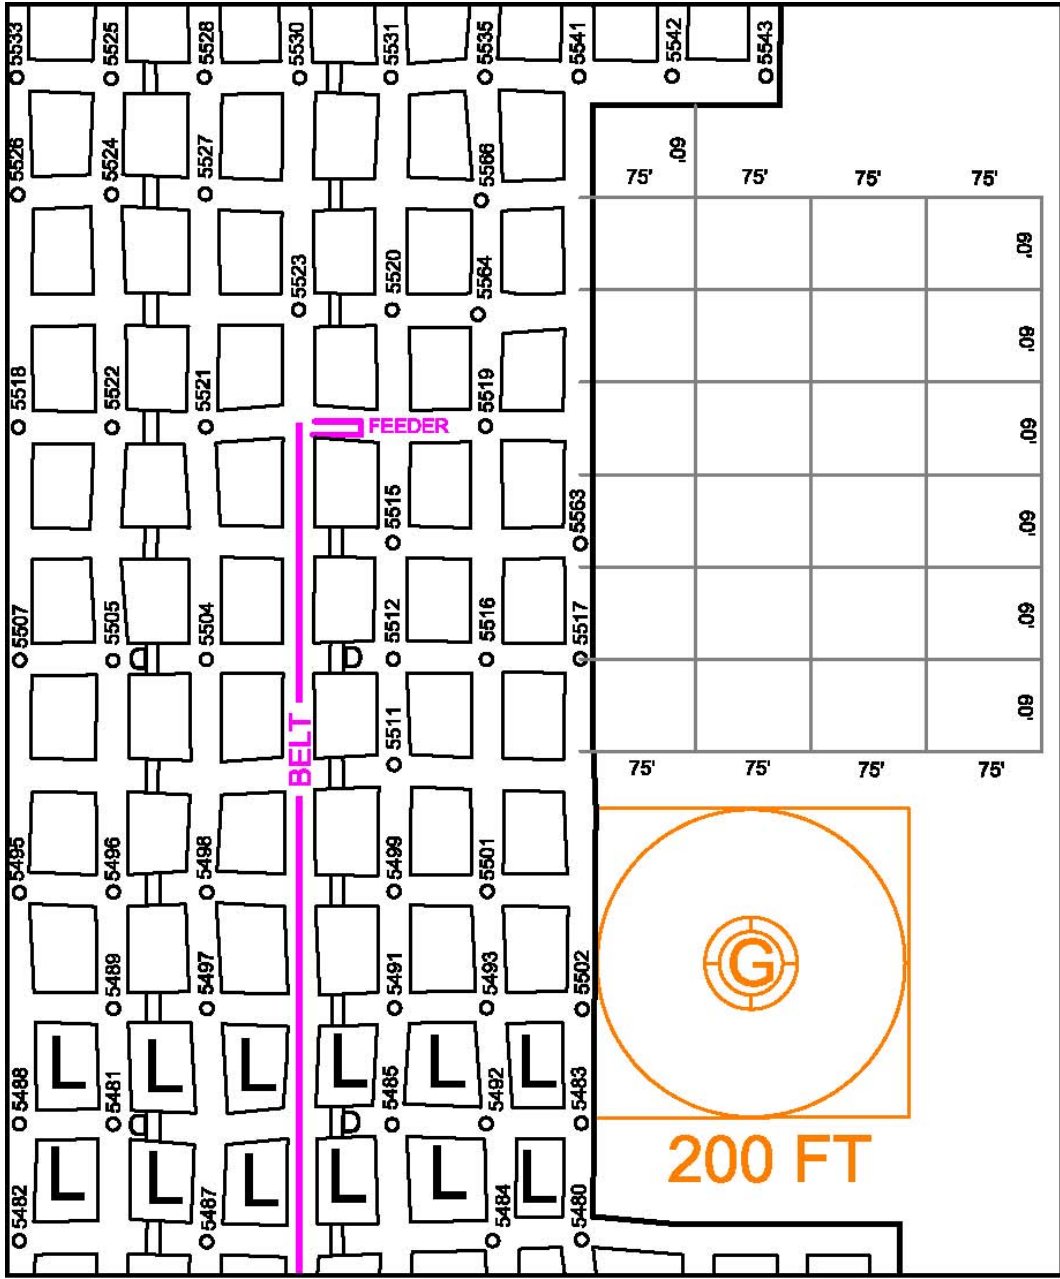
Orientation of Blocks as Approved in the Roof Control Plan

The Four East Panel had been developed on 60 foot minimum entry centers and 75 foot minimum crosscut centers in accordance with the approved roof control plan (see Appendix A).

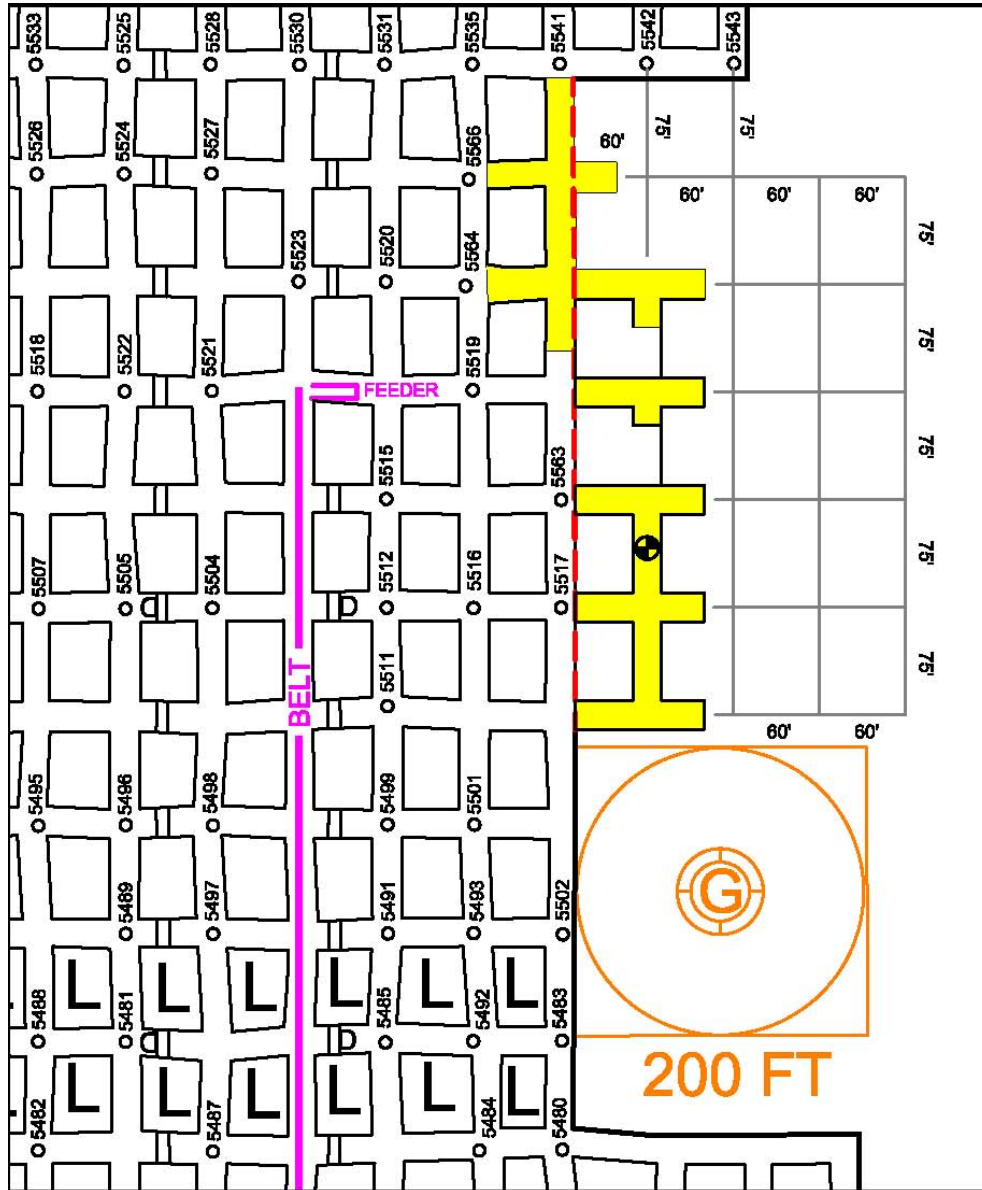
Orientation of Blocks as Designed by the Company

It was decided by the mine superintendent and mine management to mine rooms off the right side of the Four East panel for a distance of approximately four crosscuts and then pillar the area without changing the orientation of the coal pillars. The mine engineering department, safety department, and the operation president were consulted and agreed with the change. Maps with the revised projections were printed and posted at the mine. The rooms to be driven on retreat of Four East panel were projected to be 75 feet entry centers and 60 feet crosscut centers. The approved roof control plan required a minimum of 60 feet entry centers. The orientation of the blocks caused the entry centers to be 75 feet making the width of the block along the crosscut to be 55 feet instead of 40 feet. The miners were accustomed to cutting the 40 feet wide block through in two cuts. When a turn-in is made, three cuts are required to cut through the 55 feet wide blocks in order to comply with the approved roof control plan.

*Root Cause:* Administrative controls, policies, and procedures were not utilized by the operator to ensure compliance with the approved roof control plan when it changed the orientation of the coal pillars that were going to be mined without prior MSHA approval.

*Corrective Action:* The operator has discontinued mining the rooms off 4 East panel where the block orientation had been reversed.
