REPORT OF INVESTIGATION

Fall of Roof Accident
April 28, 2010

Dotiki Mine
Webster County Coal, LLC
Nebo, Hopkins County, Kentucky
ID No. 15-02132

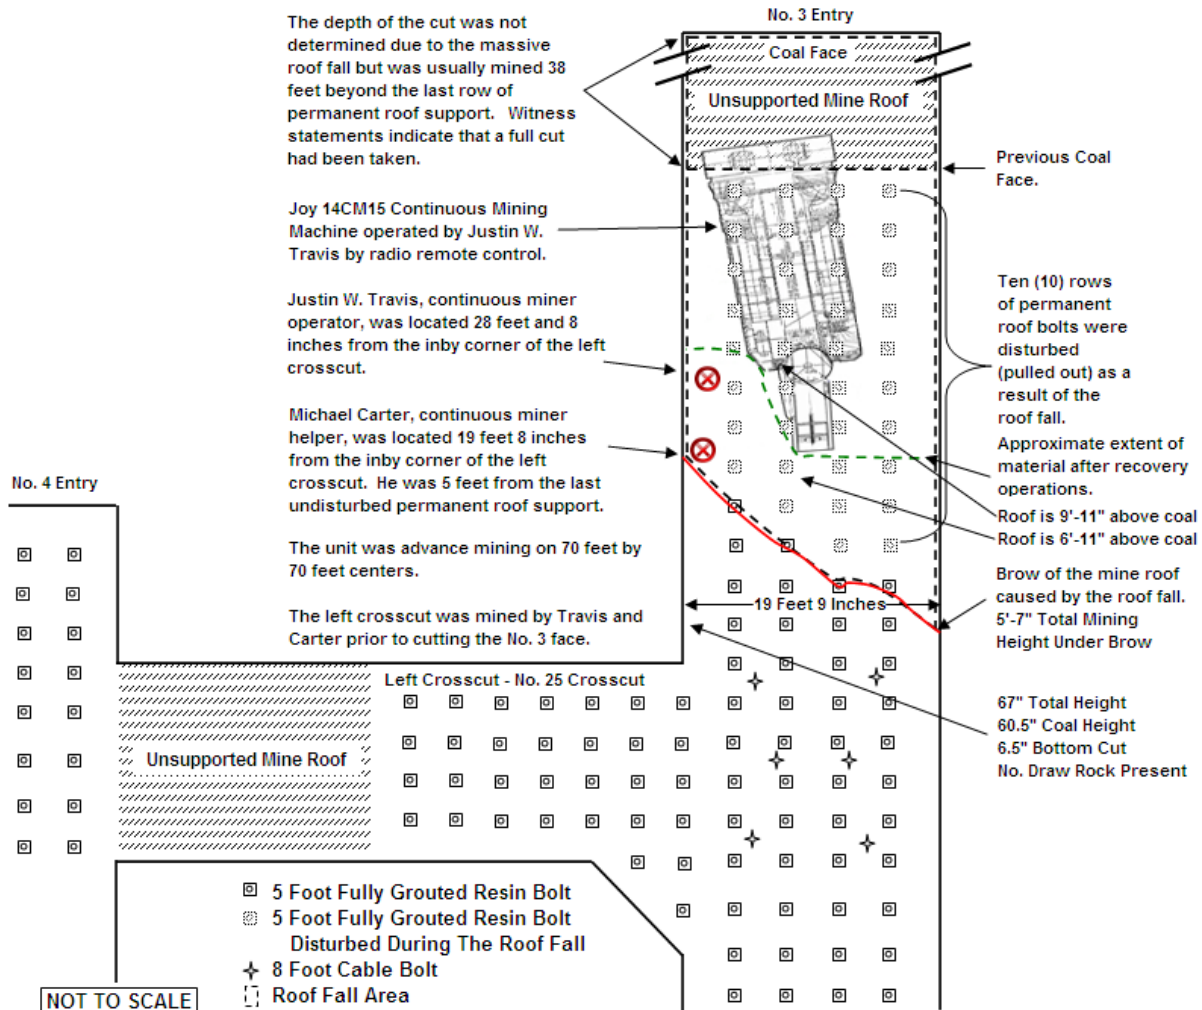
Drawing of the Accident Site

The collapsed mine roof extended from the brow toward the unsupported face area. The fall was 10 feet thick and 19 feet and 9 inches wide. The total length of the fall was not determined due to the area being inaccessible, but could be as long as 76 feet.

The maximum visible portion of the roof fall cavity extended approximately 10 feet above the coal. The roof fall extended rib-to-rib across the entry. During the rescue activity, roof fall rubble had been removed to where approximately 24 feet of cavity length was exposed, as measured along the entry center line. The fall rubble obstructed viewing the roof fall cavity walls beyond the exposed 24 feet length of the fall. The roof fall cavity was approximately 10 feet maximum height, 19.8 feet width, and up to 76 feet in length, assuming the fall extended the full length of the reported cut depth (See Appendix B, Exhibit 4).

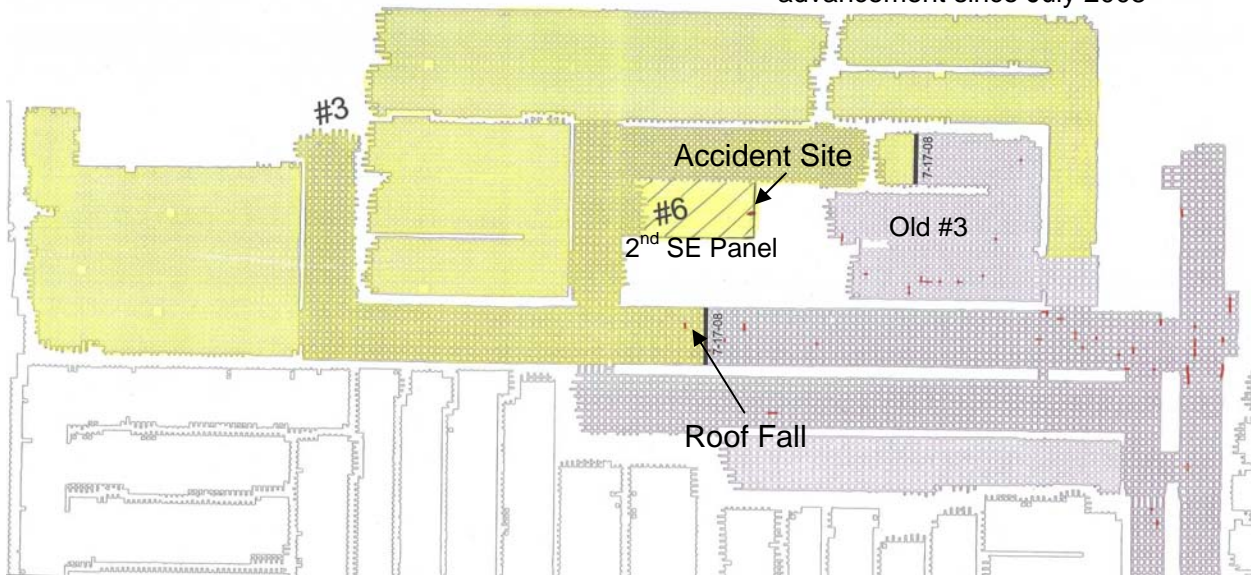
Exhibit 2

The mine site roof fall map indicated that the four closest roof falls were situated 1,100 to 1,430 feet from the accident site. Two of these roof falls were southeastward 1,125 to 1,430 feet away, located in the old No. 3 Section (now sealed) and two roof falls were southwestward 1,200 to 1,380 feet away in the 1st NW Sub-Mains. The mine operator sealed old No. 3 Section, 920 feet to the southeast of the accident site because of wet roof conditions and roof falls associated with these conditions. No wet roof conditions existed in the No. 6 Section face area where the roof fall occurred. No wet roof conditions were reported in the nine previously mined No. 6 Section panels surrounding the 2nd NE Sub-Mains. Additionally, no reportable roof falls had occurred in the No. 6 Section mining area since late summer 2008. The mine roof fall map indicated that because of the addition of the intersection supplemental support plan (installed in a "star pattern" at depths greater than 800 feet); there was a decrease in reportable roof falls. Since the intersection support plan has been implemented in this portion of the reserve, one roof fall has been reported (See Appendix B, Exhibit 2).

No. 3 and No. 6 Sections Overburden

Red = Roof Fall
Yellow = Area mined since Roof Ctrl Revisions in July 2008

880' Overburden @ accident site

- Approx. 4.5 miles from Dotiki IV portal to No. 6 Section
- Two roof falls since plan revisions in July 2008
- Approx. 48,700 feet of advancement since July 2008

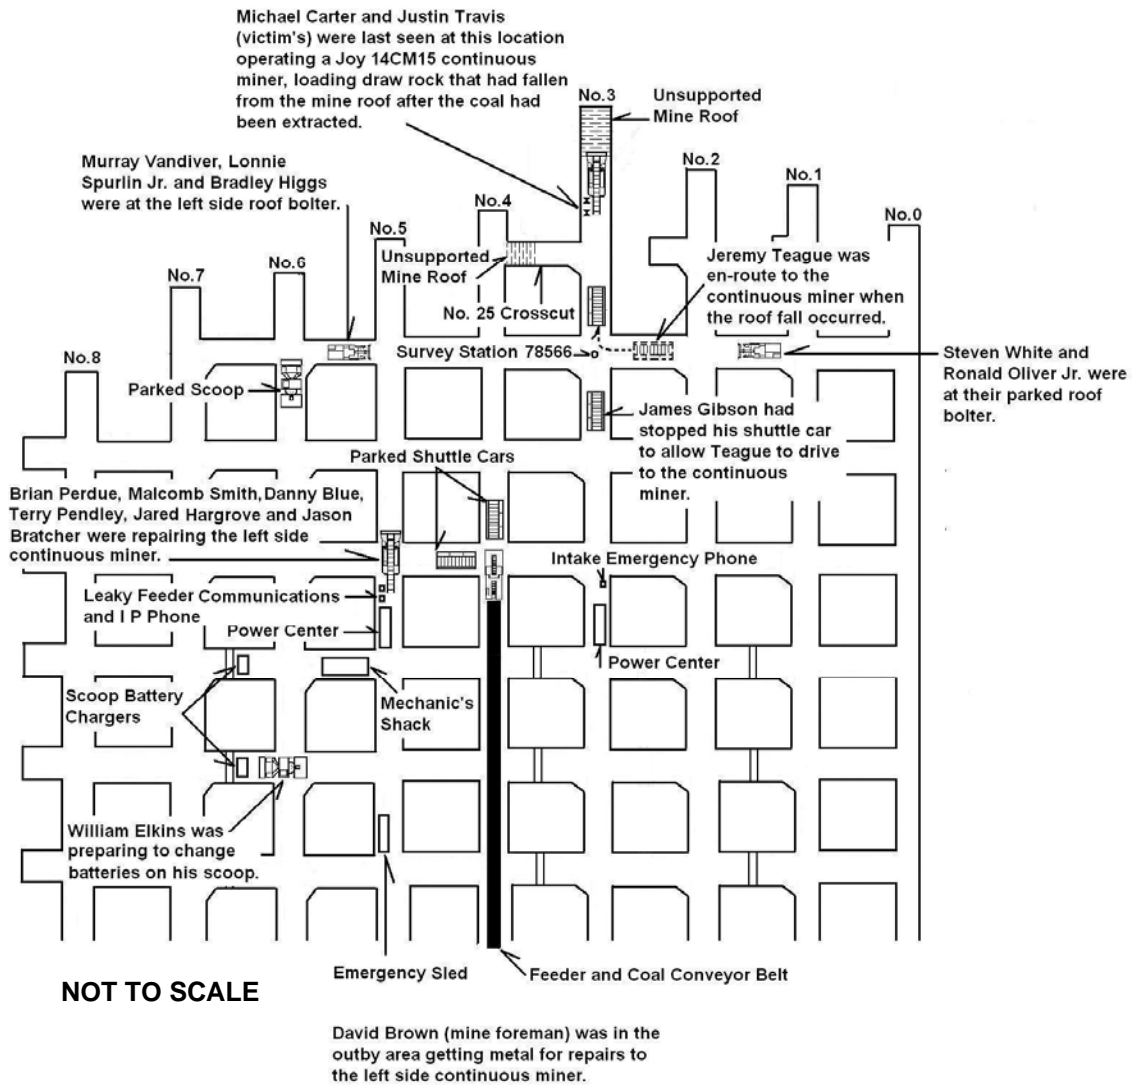
Exhibit 3

At the time of the accident, the continuous mining machine was positioned to clean draw rock from the left side of the cut and awaiting the next shuttle car. The head of the continuous mining machine was positioned approximately 12 feet in by the last row of roof bolts. The mining machine operator and helper were last observed by Gibson to be positioned and working under the third row of roof bolts out by the unbolted cut, approximately 8 feet from last row of roof bolts. This location referenced by Gibson was after his (Gibson's) shuttle car had been loaded and he was en route to the feeder. The two miners were recovered approximately 7 feet and 16 feet, respectively, out by their last observed work positions.

Location of Equipment and Employees before the Accident
(According to Statements)

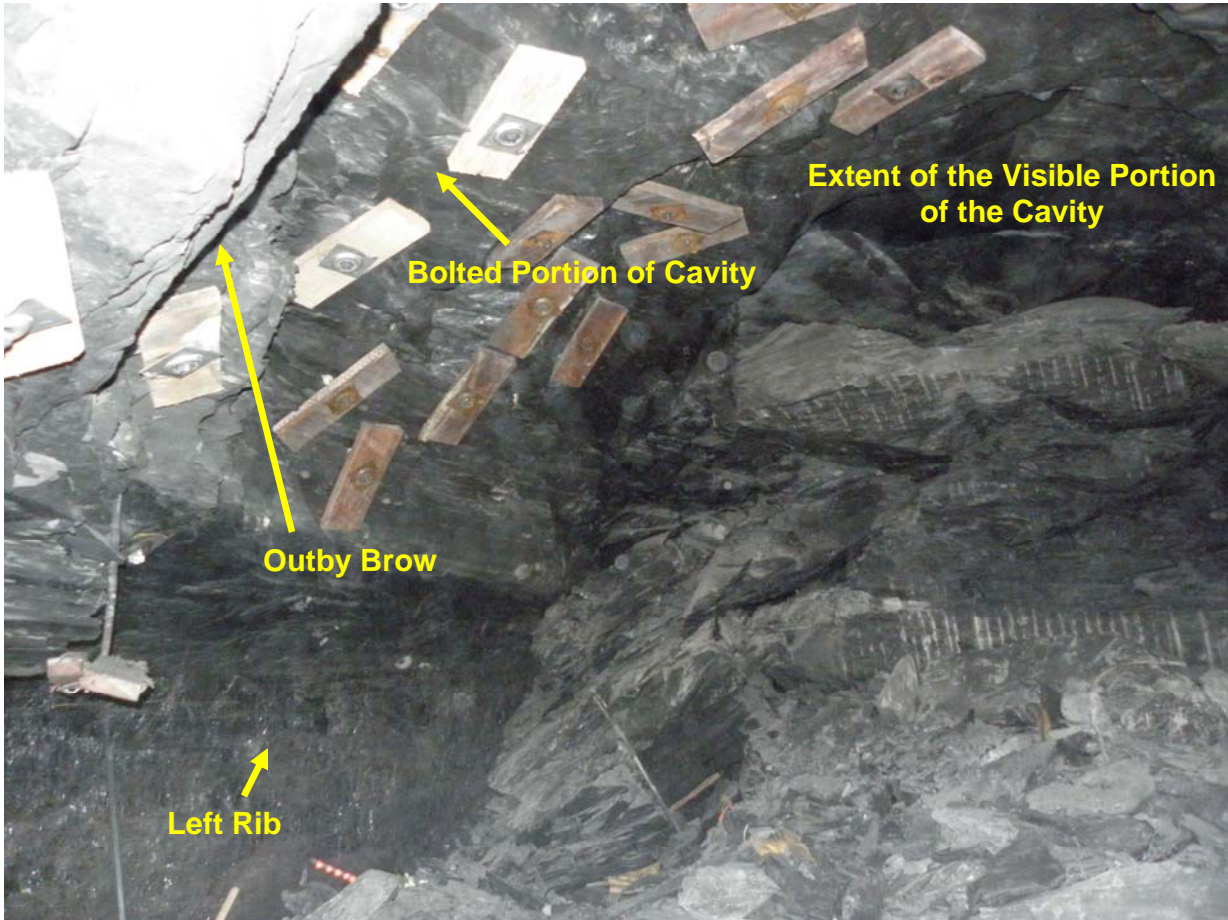
Exhibit 4

The No. 6 Working Section Accident Scene – No. 3 Entry Face Area

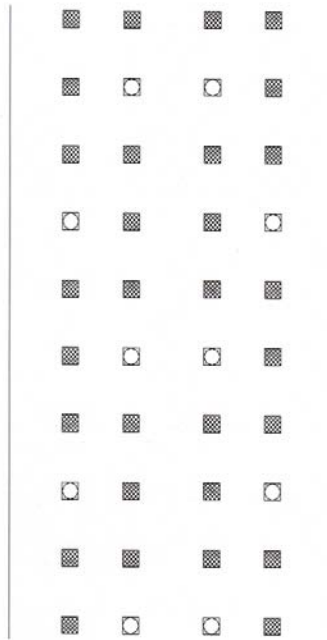
Exhibit 7
(In and Out Pattern)

The remote controlled continuous mining machine cycle uses a 40-foot deep cut plan, where the furthest penetration in by the last full row of permanent roof support shall be no greater than 40 feet. Reportedly, the operation typically mines a 38-foot deep cut depth. A minimum of two cuts are required to mine the crosscuts with the 70-foot crosscut centers on No. 6 Section. Pillar recovery is not conducted. Mining width is a maximum of 20 feet, and is normally between 19 to 20 feet. Primary roof support consisted of 3/4-inch diameter, grade 40, 5-foot fully-grouted, deformed bar roof bolts installed with 2 x 8 x 24-inch wood header boards and 6 x 6-inch bearing plates. Roof bolt spacing distance is 4.5 to 5 feet between bolts within the row, with a minimum of four bolts per row. Spacing between the outside bolts and the pillar rib is a maximum 3.5 feet. The rows of bolts are installed on a 4-foot, row-to-row spacing. The mine's roof control plan required additional roof support in areas with overburden greater than 800 feet, consisting of a minimum 8-foot cable bolts, installed in a "star pattern" (See Appendix B, Exhibit 6) in all intersections. Primary support in the No. 5 Entry supply road consisted of 5-foot, fully-grouted roof bolts and 8-foot cable bolts installed in every other row of bolts on an "in and out pattern" (See Appendix B, Exhibit 7).
