Fatality #32 - April 11, 2010
Machinery – Surface of Underground – Illinois
M-Class Mining LLC - MC#1 Mine

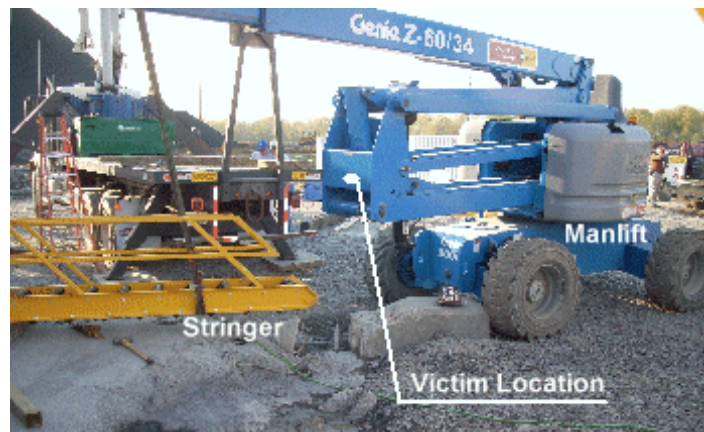
COAL MINE FATALITY - On April 11, 2010, a 61-year old contract iron worker/mine fireboss with 20 years of mining experience was fatally injured while installing pre-fabricated metal stairs on the side of a fan housing. The stair stringer had been hoisted into place and clamped at the top with two "locking pliers-type" C-clamps. The bottom of the inclined stringer was lying on a 6x6 inch timber. To level the stair treads, a 6x6 inch timber was going to be replaced with a 4x4 inch timber. To replace the 6x6 timber, rigging was fastened near the lower part of the stringer. The victim was standing on the ground holding the handrails. As the lower end of the stringer was hoisted by the crane, the clamps opened and the top end of the stringer fell. This caused the bottom end of the stringer to pivot up and swing out. This pushed the victim backward and pinned him against a nearby manlift.

- Ensure that all personnel stay clear of hoisted loads and areas where loads may fall if hoisting fails.
- Know the limitations of temporary supports and ensure they are used within their specifications.
- Ensure all components are adequately blocked and secured to prevent unintended motion.
- Use taglines on loads to be hoisted that will need steadying or guidance.
- Ensure that crane operators communicate with other workers in close proximity to loads that are going to be moved.
- Ensure that personnel are trained to recognize hazardous work procedures.
- Discuss work procedures and identify all hazards associated with the work to be performed, along with the methods to protect personnel.
