Fatality #37, June 8, 2010

**Ignition Or Explosion Of Gas Or Dust - Surface - Alabama
Taft Coal Sales & Associates Incorporated - Choctaw Mine**

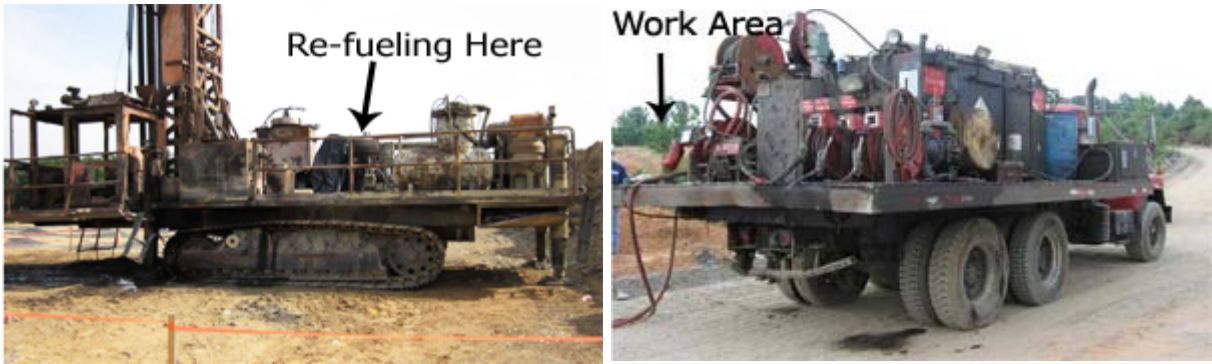
COAL MINE FATALITY - On Tuesday, June 8, 2010, a 38-year old service truck operator with seven years of mining experience, was fatally injured while in the process of refueling a diesel track-mounted highwall drill. The operator was apparently placing the fuel nozzle into the diesel fuel tank when an ignition/explosion erupted into a fire, engulfing him in flames.

- Open fuel tank cap slowly to relieve any pressure buildup.
- Ensure that the refueling area is well ventilated, especially in low areas where heavy fuel vapors can accumulate.
- Before refueling, turn off the engine(s) and motor(s) and eliminate other potential ignition sources.
- Check hydraulic lines and connections, especially those near hot surfaces, prior to operating the vehicle. Perform maintenance or repairs when necessary.
- Ensure that all affected persons are familiar with the Material Safety Data Sheets on fuels and lubricants in use.
