REPORT OF INVESTIGATION

Underground Coal Mine

Fatal Fall of Face, Rib, or Pillar Accident  
January 22, 2010

Bledsoe Coal Corporation  
Abner Branch Rider  
Big Laurel, Leslie County, Kentucky  
ID No. 15-19132

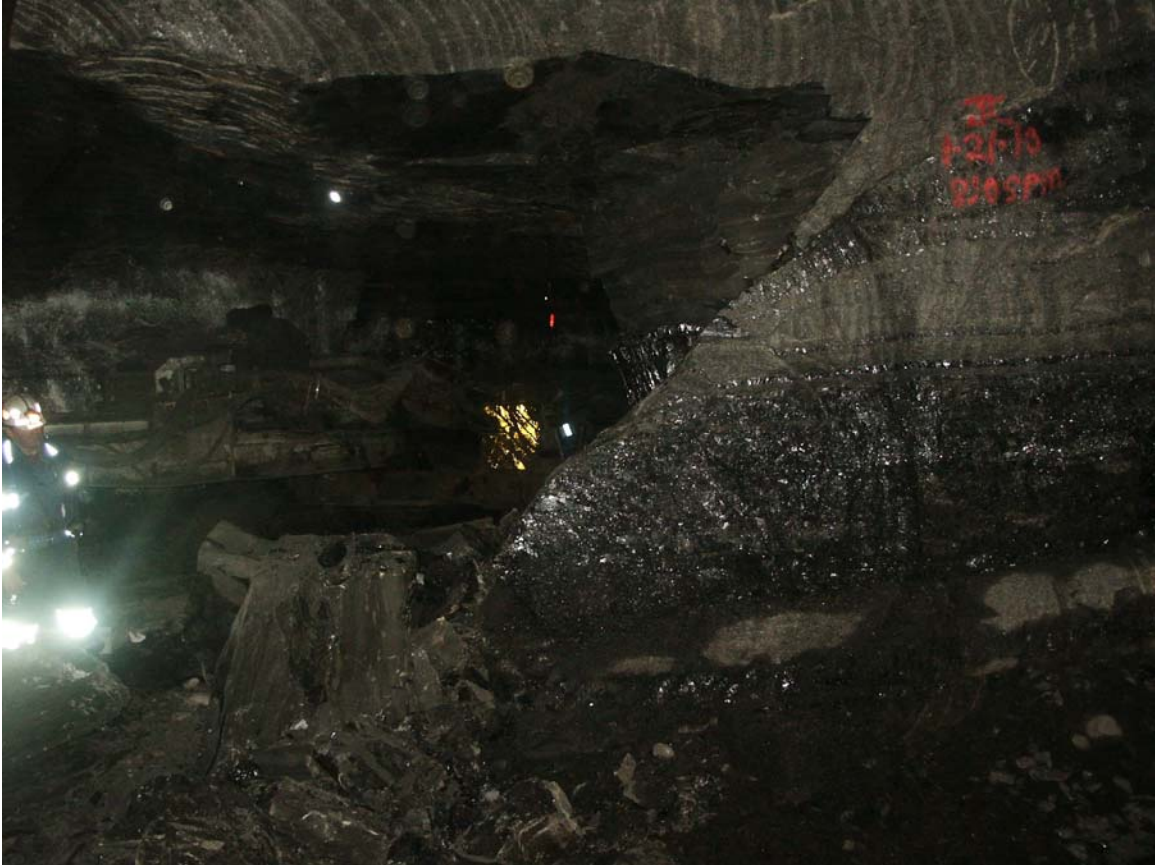
AREA WHERE RIB FELL

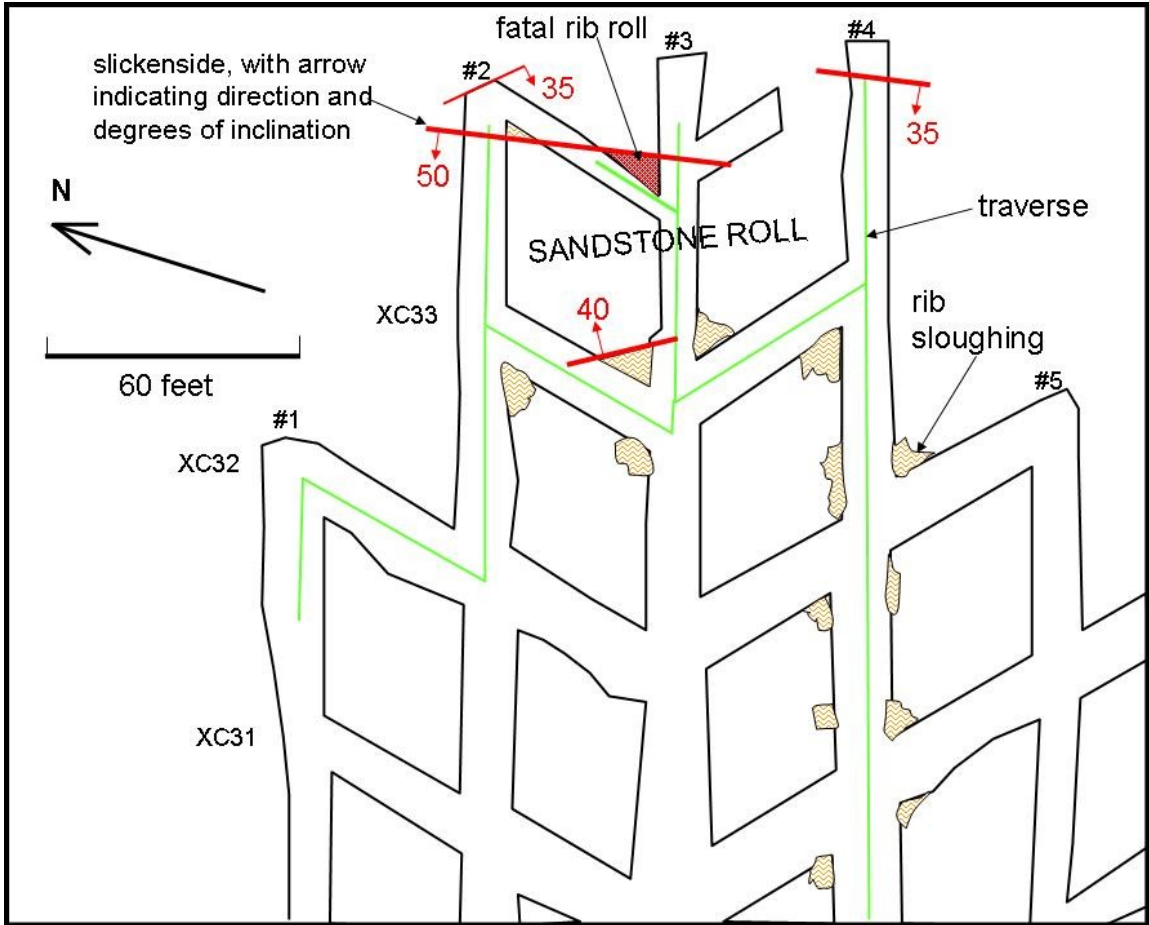
**FIGURE 2**

Inby the #34 Crosscut intersection, the interbedded sandstone and shale rose quickly with a related increase in coal thickness. The contact between coal and the overlying sandstone and shale was defined by an undulating slickenside plane that exhibited a strike of North 12° West and dip of 50° West. The slickenside was traced directly from the #3 to #2 Heading, trending through #34 Crosscut, and projected toward the #4 Heading, where a prominent, planar slickenside with the same strike was present in the roof (Figure 2, Appendix C). The 50° West dip of the slickenside defined a formative sliding plane through the acute-angled corner of the pillar on the inby side of #34 Crosscut (Figure 3, Appendix C).

Figure 2. Map of observations near the 8 Mains 001 MMU faces, showing location of N 12° W, 50° W slickenside that defined the fatal rib roll.

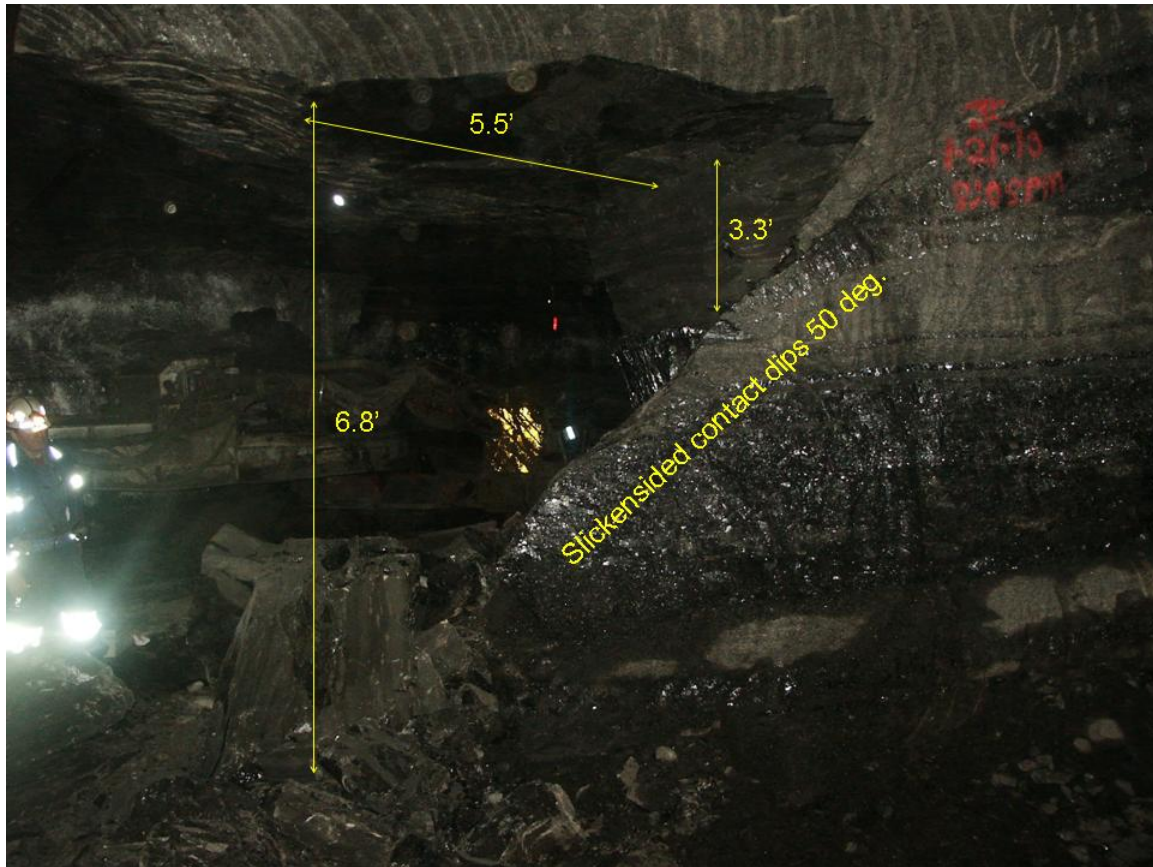
**FIGURE 3**

The fatal rock was defined by the North 12° W slickenside, which formed the undercutting formative plane that allowed sliding of the pillar corner down the 50° inclined surface (Figure 3, Appendix C). The top of the fatal rock separated along a smooth bedding lamination in the sequence of interbedded shale and fine-grained sandstone. The fallen pillar wedge consisted entirely of rock and was estimated to be 110 cubic feet in volume, weighing approximately 9.3 tons. The fallen wedge was trapezoidal in shape, defined by the inclined slickenside plane on the bottom, the horizontal delamination plane on top, and the two converging ribs. Part of the fallen wedge was defined by a plane of tensile failure in the fine-grained sandstone, which defined a planar fracture 9 feet long by 3.3 feet high, oriented vertically above the inclined slickenside plane and intersecting the horizontal delamination horizon (Figure 4, Appendix C). The plane of tensile (of tension) failure was 5.5 feet from the former pillar corner, and the fallen wedge tapered from a height of 6.8 feet at the pillar corner to 3.3 feet at the rear of the wedge as the slickenside rose into the pillar (Figures 3 and 4, Appendix C).

Figure 3. Profile view from #3 Heading of the dipping slickenside plane, which allowed the pillar corner, composed of shale and sandstone, to slide outward. Upper failure surface was defined by delamination along a smooth, bedding parting, and rear failure surface represents tensile failure in the rock

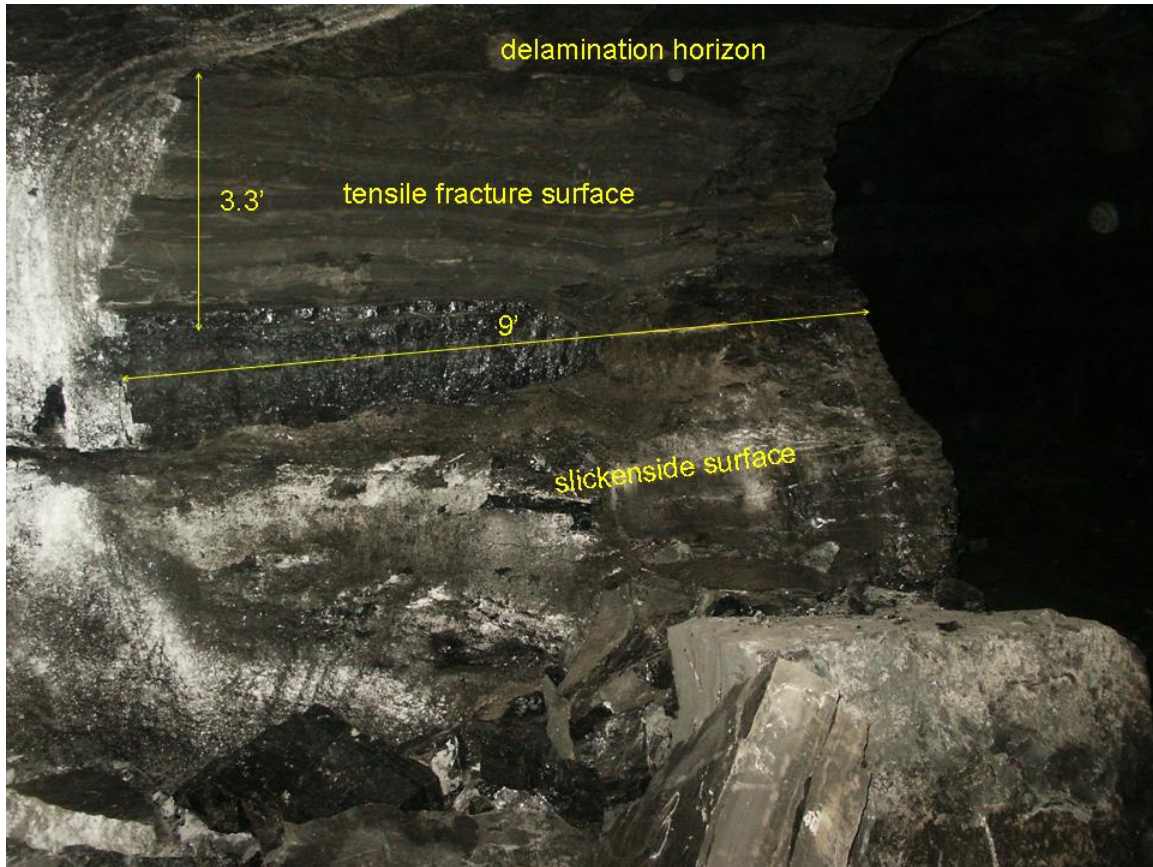
**FIGURE 4**

Figure 4. Frontal view of failed pillar corner, facing the inclined slickenside plane and rear tensile failure plane.
