REPORT OF INVESTIGATION

Fatal Machinery Accident
April 11, 2010

Coalfield Services, Inc. (R58)
Wytheville, VA

MC #1 Mine
M-Class Mining LLC
Macedonia, Franklin County, Illinois
I.D. No. 11-03189

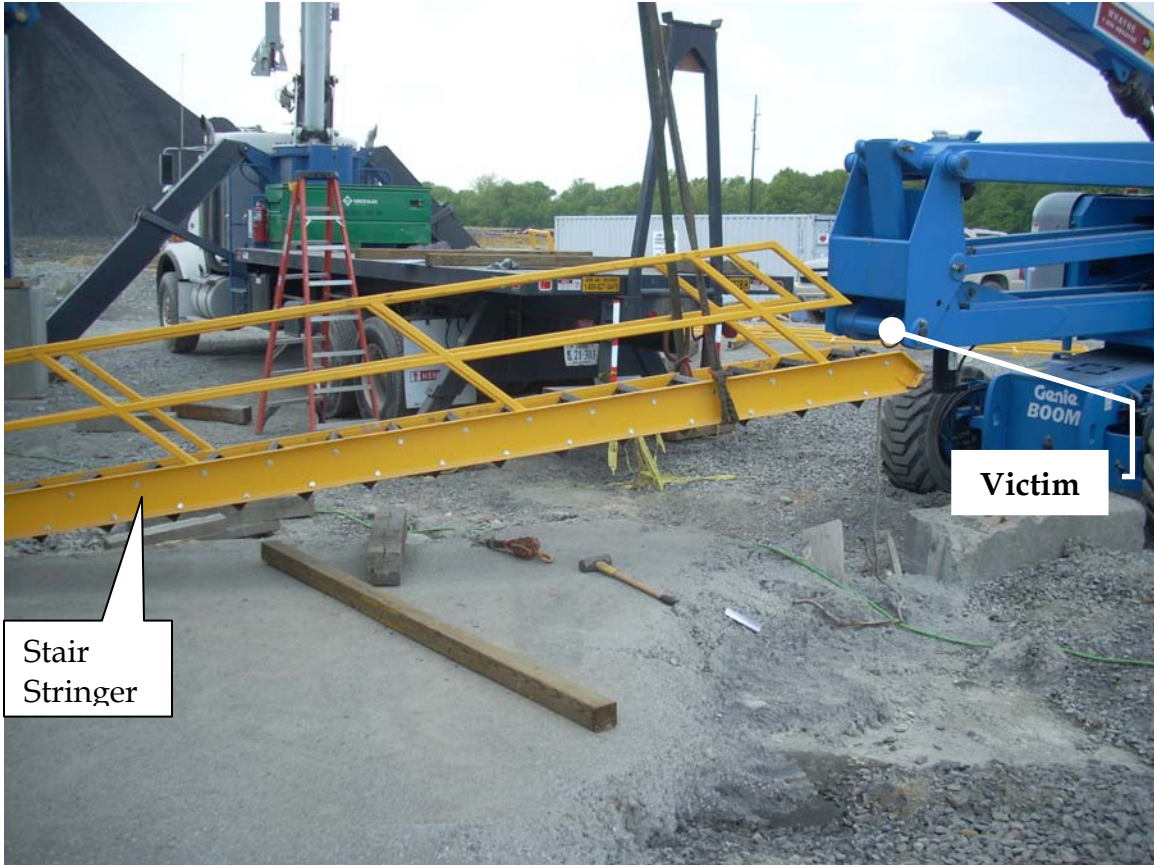
Photograph showing approximate position of the stair stringer and manlift when accident occurred.

not suitable to prevent movement. As the top of the stairs slid down, the bottom end of the stairs shifted away from the fan house and toward the victim. The stairs forced the victim backward against the frame of the articulating boom manlift that was parked directly behind him. The bottom of the stair section struck the victim in the chest as he was against the manlift.

The accident occurred because employees failed to stay clear of hoisted loads. The victim was standing at the bottom of the stair stringer as it was being hoisted. He was positioned between the stair stringer and the Genie manlift. When the stair stringer swung away from the air duct, it forced the victim back against the manlift. The stair stringer struck the victim in the chest, causing fatal injuries. In addition, a contributing factor to the accident was the method used to temporarily attach the stair stringer to the air duct. The method was not sufficient to support the weight of the stair stringer and hold it in place.

Corrective Action: All employees received training concerning proper hoisting and rigging procedures and have been instructed to stay clear of hoisted loads. The contractor also submitted a written statement to the District Manager detailing procedures to be followed for installing the stairs.
