REPORT OF INVESTIGATION

Fatal Machinery Accident
April 22, 2010

ICG Beckley LLC
Beckley Pocahontas Mine
Eccles (Raleigh County) WV.
MSHA ID No. 46-05252

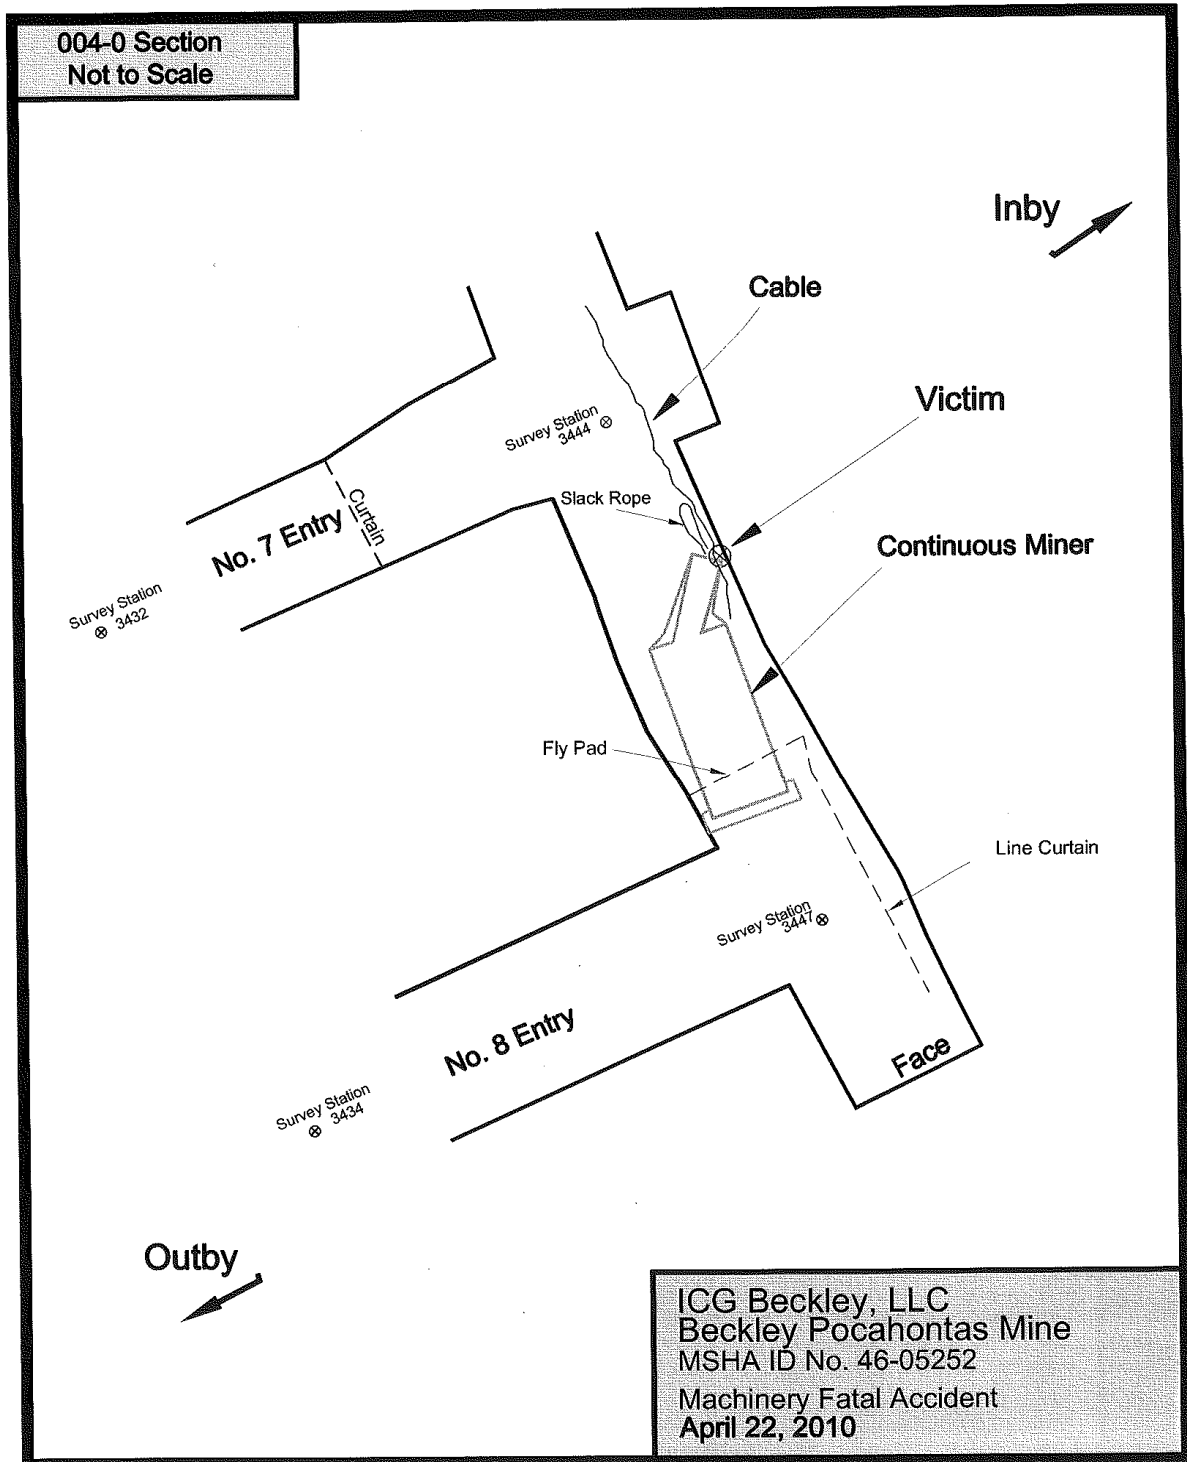
APPENDIX C

The accident occurred in the connecting crosscut between the No. 7 and No. 8 Entries. Dimensions in the area of the accident measured 5 feet 1 inch in height and 17 feet 8 inches wide. The width of the continuous miner measured 11 feet 6 inches at the cutter head and 10 feet 9 inches at the back bumper. The crosscut was developed on 70 foot centers. The elevation in the crosscut increased 3 feet from No. 7 to No. 8 Entry, with the steepest grade approximately 17 feet from the No. 8 Entry, the approximate location of the continuous miner when the accident occurred.

At or near the end of the crosscut, towards No. 8 Entry, there was a set of fly pads and curtain hanging. The continuous miner was close to the right coal rib and may have contacted the coal rib in an effort to miss the curtain, which was hung on the inby side of the No. 8 Right Crosscut. The continuous miner had trammed through the fly pads for a distance of 7 feet 5 inches when the accident occurred. The boom of the continuous miner was swung to the operator's side in an attempt to keep the slack cable against the coal rib.
