**UNITED STATES
DEPARTMENT OF LABOR
MINE SAFETY AND HEALTH ADMINISTRATION**

REPORT OF INVESTIGATION

**Fatal Ignition or Explosion Accident
June 8, 2010**

**Taft Coal Sales & Associates, Inc.
Choctaw Mine
Parrish, Walker County, Alabama
ID No. 01-00347**

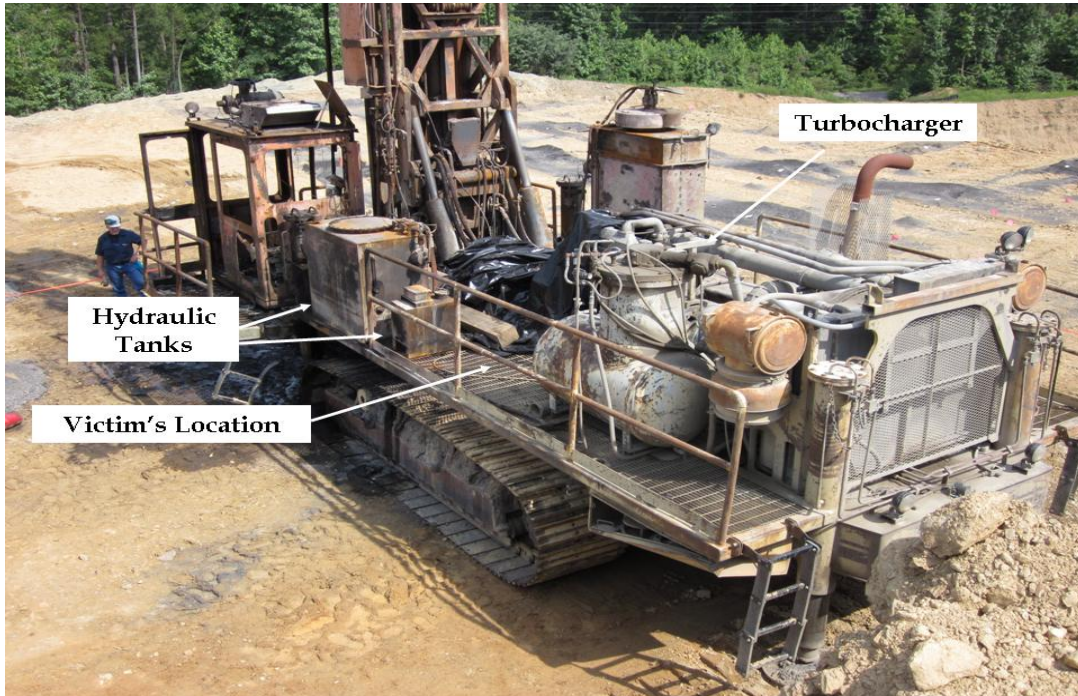
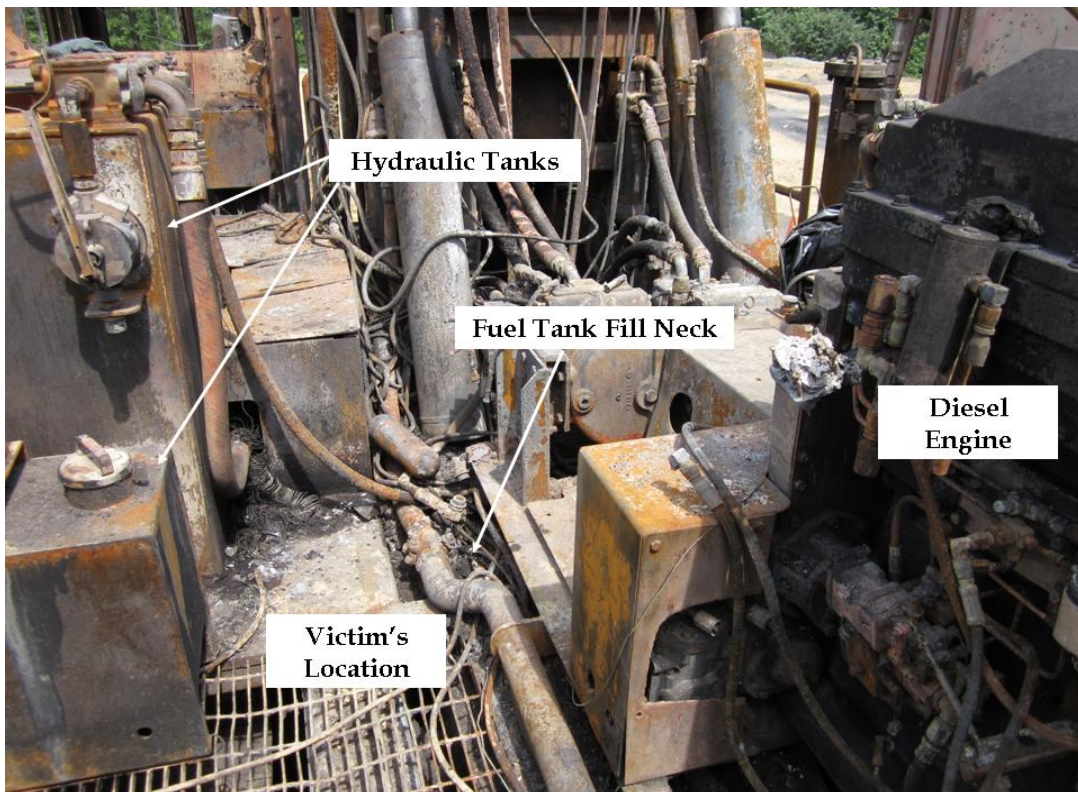
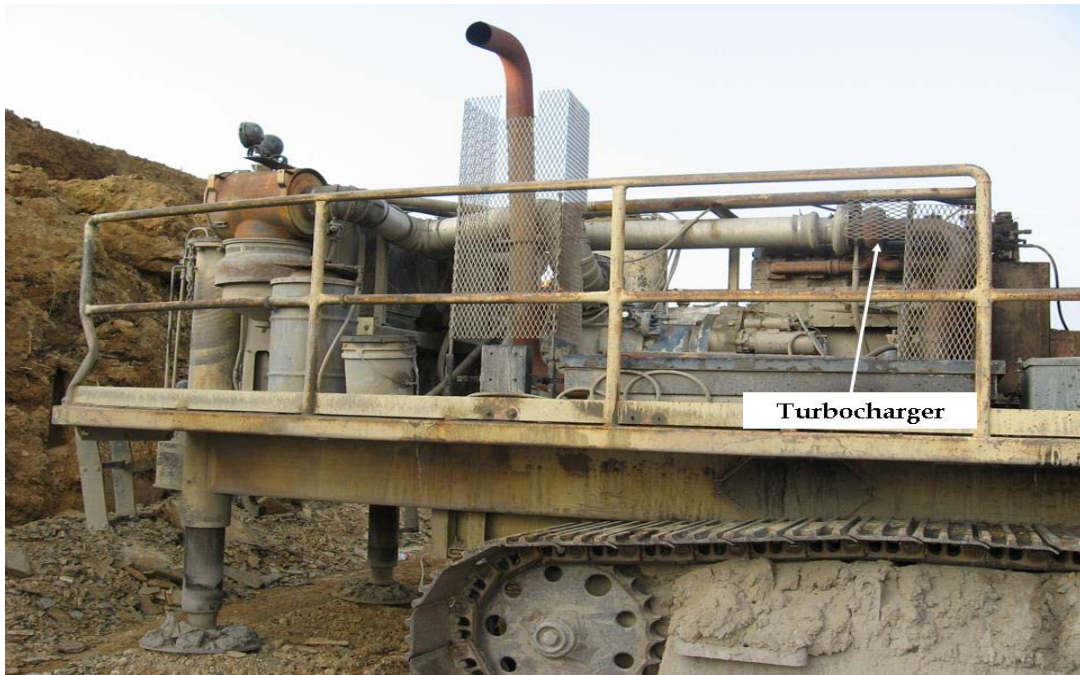
Company No. 515 Reed Highwall Drill Rig

The rock drill (Appendix C) was a Reed SK45/R45-Infinity Highwall Drill (Company No. 515, Serial No. 1Z68A64), powered by a Cummins KTA19-C turbocharged, six-cylinder, 630 hp diesel engine and used hydraulic and air actuated controls for drilling. The turbocharger was located opposite of where the victim was fueling (Appendix C).

The drill was equipped with a 320-gallon diesel fuel tank, located directly beneath the engine between the main frame rails and was fueled through a top-fill standard twist-off fuel cap with a 2-inch high filler neck. (Note: the fuel tank was estimated to have contained approximately 250 gallons of diesel fuel remaining after the fire). The hydraulic oil tank is located on the right side of the drill, directly in front of the operator cab (Appendix C) and has an approximate usable capacity of 190 gallons, based upon the external dimensions and the location of the top of the sight glass (transparent tube,

through which the level of fuel or oil can be observed). The tank was estimated to have approximately 60 gallons of SAE 10W oil remaining after the fire. Both tanks were equipped with non-pressurized fluid return lines.

(4) Diesel fuel accidentally sprayed onto the hot surfaces on and around the engine and hydraulic pump area immediately prior to fueling which vaporized and ignited.

The most likely scenario is that diesel fuel was inadvertently discharged onto the engine and adjacent hot surfaces when the victim crossed over from the service truck to the drill prior to fueling. The diesel fuel splashed onto the hot surfaces and generated a cloud of flammable vapors in the fueling area while the victim removed the fuel tank cap and inserted the fuel nozzle. The flammable vapors were present near the engine turbocharger at about the same time the nozzle was being inserted into the tank neck. The turbocharger ignited the vapors creating an explosion/flash fire, which in turn caused the victim to recoil, while still holding the nozzle in the on position, allowing additional fuel to be discharged onto the engine area and him, engulfing him in flames.

Corrective Action: The mine operator has modified the fueling procedures, which require highwall/rock drills to be shut off prior to fueling. The drill operators were trained in the new fueling procedures by their immediate supervisors and a record of the training was documented on MSHA 5000-23 Training Forms. In addition, the mine operator's approved CFR 30, Part 48 training plans are being updated to reflect the additional procedures requiring the highwall drills to be shut off prior to fueling and what actions to take in the event an accidental fuel discharge occurs. The mine operator will also further modify the fueling system or process to remove the service truck operator from close proximity to potential ignition sources and to minimize the possibility of accidental fuel discharge.

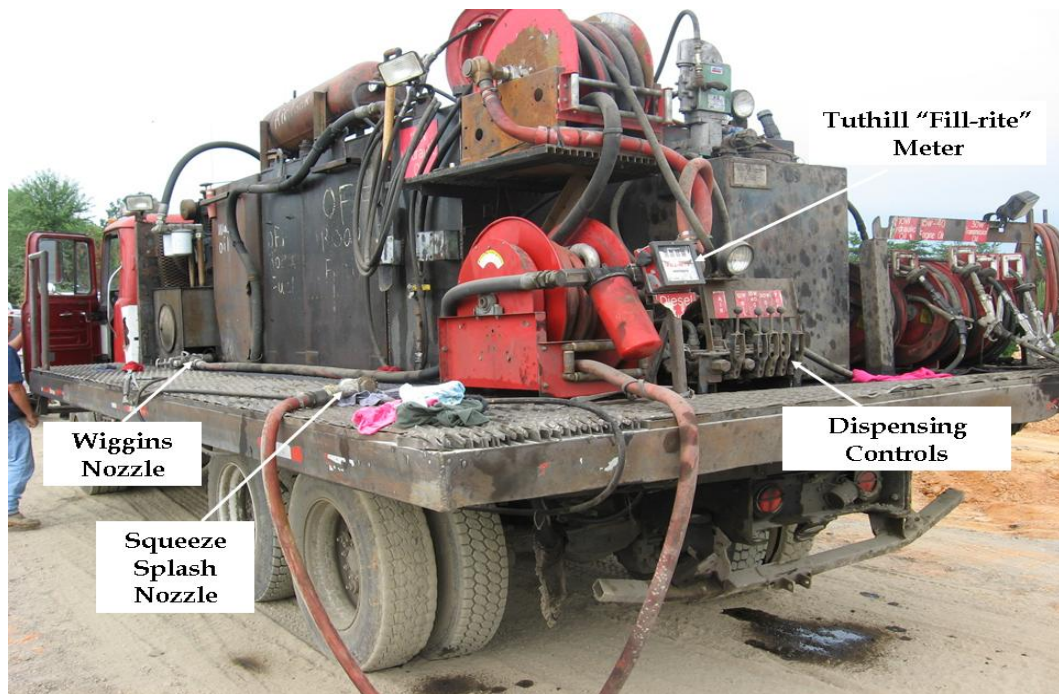
Company No. 764 Mack Service Truck

The service truck was a Mack DM690S (Company No. 764, VIN: 1M2B209CXRM014359) and was used to dispense diesel fuel and other lubricants from bulk tanks. The tanks were located on the fabricated open grate steel bed/deck of the truck, along with the associated pumps used to dispense the diesel fuel/lubricants (Appendix C).

The main hydraulic pump was driven off the truck's crank shaft and ran while the truck engine was running. The main pump received hydraulic fluid from a dedicated tank and provided the fluid pressure to the hydraulic motors, which in turn drove the individual transfer pumps. The transfer pumps move the diesel fuel and other lubricants from the bulk tanks to the equipment. A valve bank at the rear of the truck controls the transfer pumps. When the diesel fuel transfer pump was activated, it provided diesel fuel to either a hose reel equipped with a squeeze splash nozzle (similar to a standard service station nozzle), or a hose reel equipped with a Wiggins nozzle. Diesel fuel could be dispensed by either nozzle. The truck was also equipped with a Tuthill "Fill-rite" totalizing meter for measuring the quantity of fuel dispensed.

The original dispensing nozzle was damaged and could not be tested. The original nozzle was removed from the dispensing hose and a new, identical nozzle was attached. A flow test was then conducted and the new nozzle dispensed diesel fuel at a rate of approximately 42-gallons per minute, at maximum flow and could discharge a stream of fuel a distance of 4 to 8-feet.

The Tuthill totalizing meter indicated a total flow of 7-gallons of fuel had been dispensed since the last reset of the meter. Field observation of the meter function indicated that once the fuel transfer pump was engaged, the reading slowly increased even if no fuel was being dispensed. The meter would increase between 1 and 2-gallons a minute at zero flow, the rate of increase being somewhat erratic. Approximately 10-seconds would be required to discharge up to 7-gallons of diesel fuel.
