REPORT OF INVESTIGATION
Underground Coal Mine

FALL OF ROOF/RIB
June 16, 2010

Clover Fork No. 1
Lone Mountain Processing Inc.
Holmes Mill, Harlan County, Kentucky
ID No. 15-18647

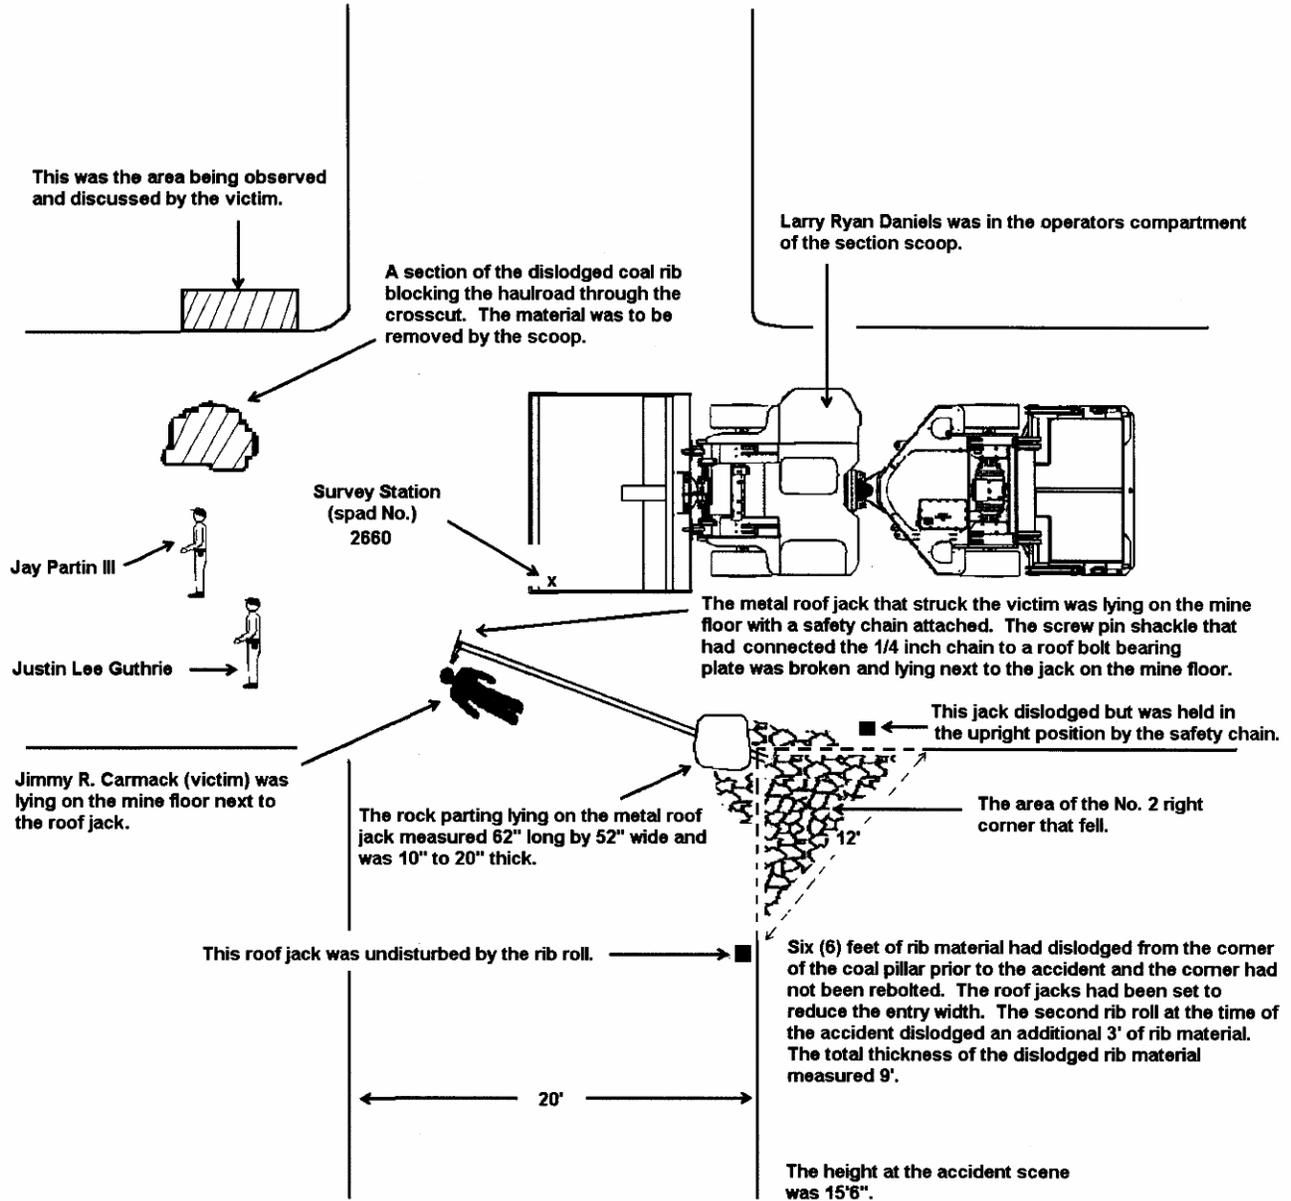
**Sketch No. 2
After The Accident
Not To Scale**

During the accident, two of the Heintzmann jacks were dislodged by the falling rib. The metal bearing plate on top of one of the jacks (approximately 8 inches by 8 inches and 3/8 inches thick) struck Carmack in the head. The top of the jack had been attached to a roof bolt bearing plate with a chain and a 1/4 inch clevis. The clevis broke, allowing the jack to fall and strike the victim.

A portion of the rock parting (separation) between the two coal seams came to rest on the fallen jack. This piece of rock measured approximately 62 inches in length, by 52 inches wide, and varied in thickness from 10 inches, up to twenty 20 inches.

**001 Section
The Accident Scene - No. 2 Entry**

Corrective Action: Prior to any other mining in the 4 North Panel, a rehabilitation plan was submitted by the Mine Operator, detailing how the area would be rehabilitated, in phases, to protect the miners. The affected area was provided with additional support. Comprehensive and systematic rib control measures have been made part of the Roof Control Plan.
