REPORT OF INVESTIGATION

Fatal Powered Haulage Accident
July 9, 2010

Willow Lake Portal
Big Ridge Inc
Equality, Saline County, Illinois
I.D. No. 11-03054

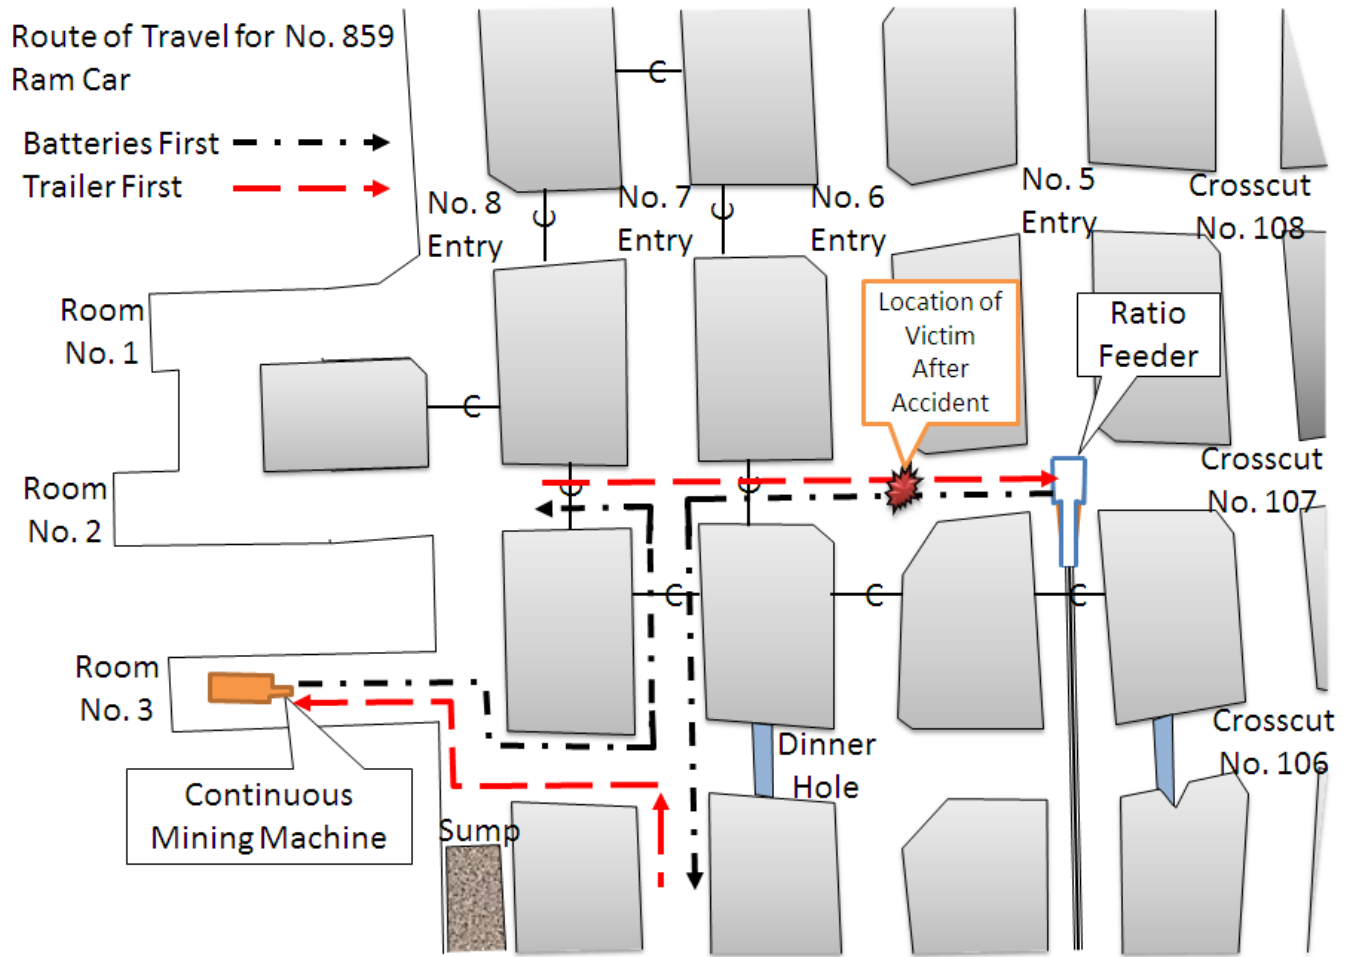
Area of Accident

At approximately 12:35 p.m., on Friday, July 9, 2010, a 61-year old Production Supervisor was killed in a powered haulage accident. Thomas N. Brown (victim) was located at or near a run-through check curtain hung in the travel-way, used to gain access to the ratio feeder on the No. 4 Section. While hauling coal from the continuous miner to the ratio feeder, a battery-powered coal hauler (ram car) traveled trailer first, through a check curtain, striking the victim and running over him. The section scoop operator discovered the victim lying to the immediate right of the intersection, about 42 feet from the check curtain, which was located between the No. 6 and No. 7 Entries at Crosscut No. 107.

The accident occurred at Crosscut No. 107 in the intersection of the No. 6 Entry. A run-through check curtain was installed, midway between coal pillars, in Crosscut No. 107, between the No. 6 and No. 7 Entries. Check curtains were used as ventilation controls to maintain the desired amount of ventilating air at the working faces. The check curtain was a heavyweight, translucent plastic curtain, with the top 18 inches made of white plastic. A supplemental curtain was installed in between the translucent curtains. The supplemental curtain was heavyweight white plastic, hanging three quarters of the way from the roof, toward the floor. A wooden board was roof bolted to the roof to hang check curtains. The curtains were nailed to the board with spads (survey markers). The check curtains attached at the top only, to allow equipment pass through, without pulling the curtain down. At the accident site, a piece of the curtain was pulled away from the top, causing a hole in the right side, middle portion of the check curtain.
