REPORT OF INVESTIGATION

Fatal Fall of Rib Accident
July 29, 2010

Loveridge #22
Consolidation Coal Company
Metz, Marion County, West Virginia
I.D. No. 46-01433

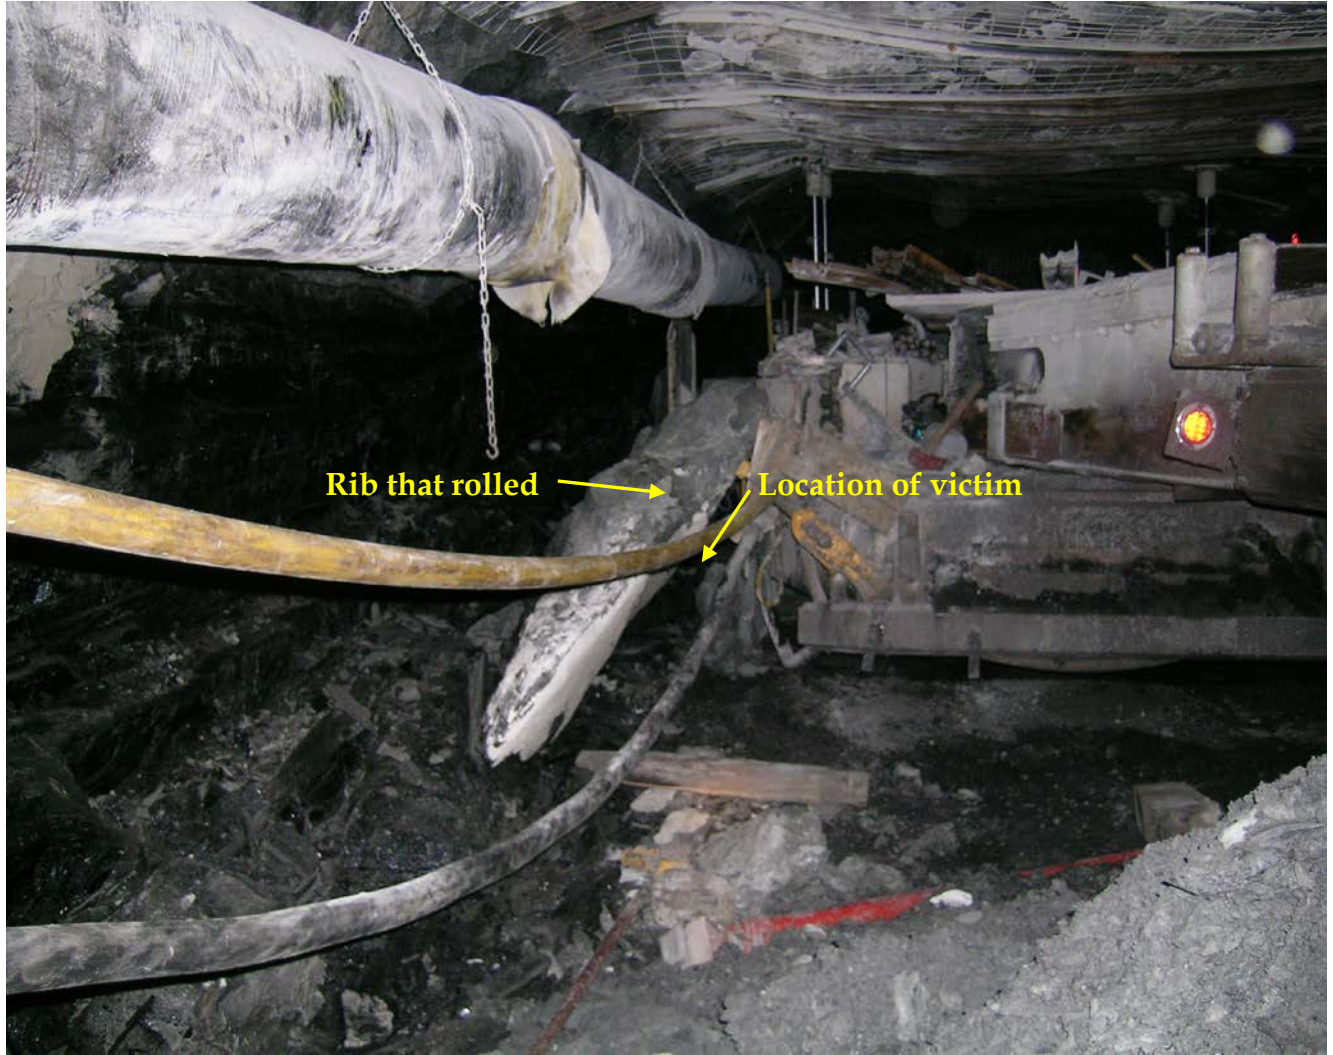
APPENDIX B _ Photograph of the Accident Scene

On July 29, 2010, at approximately 12:00 p.m., Jesse Adkins, a 39-year old Continuous Mining Machine Mounted Roof Bolter Operator (integral roof bolter) was fatally injured in a rib roll accident on the left side of the 9-South Mains section. The equipment involved in the accident was a continuous mining machine equipped with a roof bolting station mounted on each side of the machine. The crew had just started cutting the top portion of the 18D belt overcast between the No. 6 and No. 7 entries. The integral roof bolter operators were standing at their respective roof bolting stations along the sides of the continuous mining machine waiting to install the next roof strap. The continuous miner operator undercut the face, backed up and just started cutting the top when he noticed Adkins' light move. The continuous miner operator stopped the machine and walked around to the back side where he found the victim pinned between the machine and a section of rock rib measuring 193 inches long by 55 inches high and up to 16 inches thick. The rock broke at the rib protector and the broken piece extended an additional 83 inches inby (see photo of accident scene - Appendix B).

The rib failure was defined by a system of curvilinear (a series of curves along a plane), meandering, slickensides that ran nearly parallel with the trench rib and dipped steeply (roughly 55° to 60°) southward into the left rib of the excavation. It appeared that the slickensides allowed the upper gray claystone and some of the underlying coal/shale/ claystone to detach and fall against the continuous mining machine and the victim.

The rib material that rolled out was roughly 0.6 inches to 16 inches thick, ranging from 24 inches to 55 inches in height and was approximately 23 feet in length. It fell from the top of the 8 ½ foot high left side (south) belt trench rib. From the left rear bumper of the machine the rock extended 17 ½ feet inby (west) and 5 ½ feet outby (east) the machine bumper. The rib roll extended inby and outby the left side rib protector shield. The belt trench width after the rib roll was 18 feet 4 inches wide.

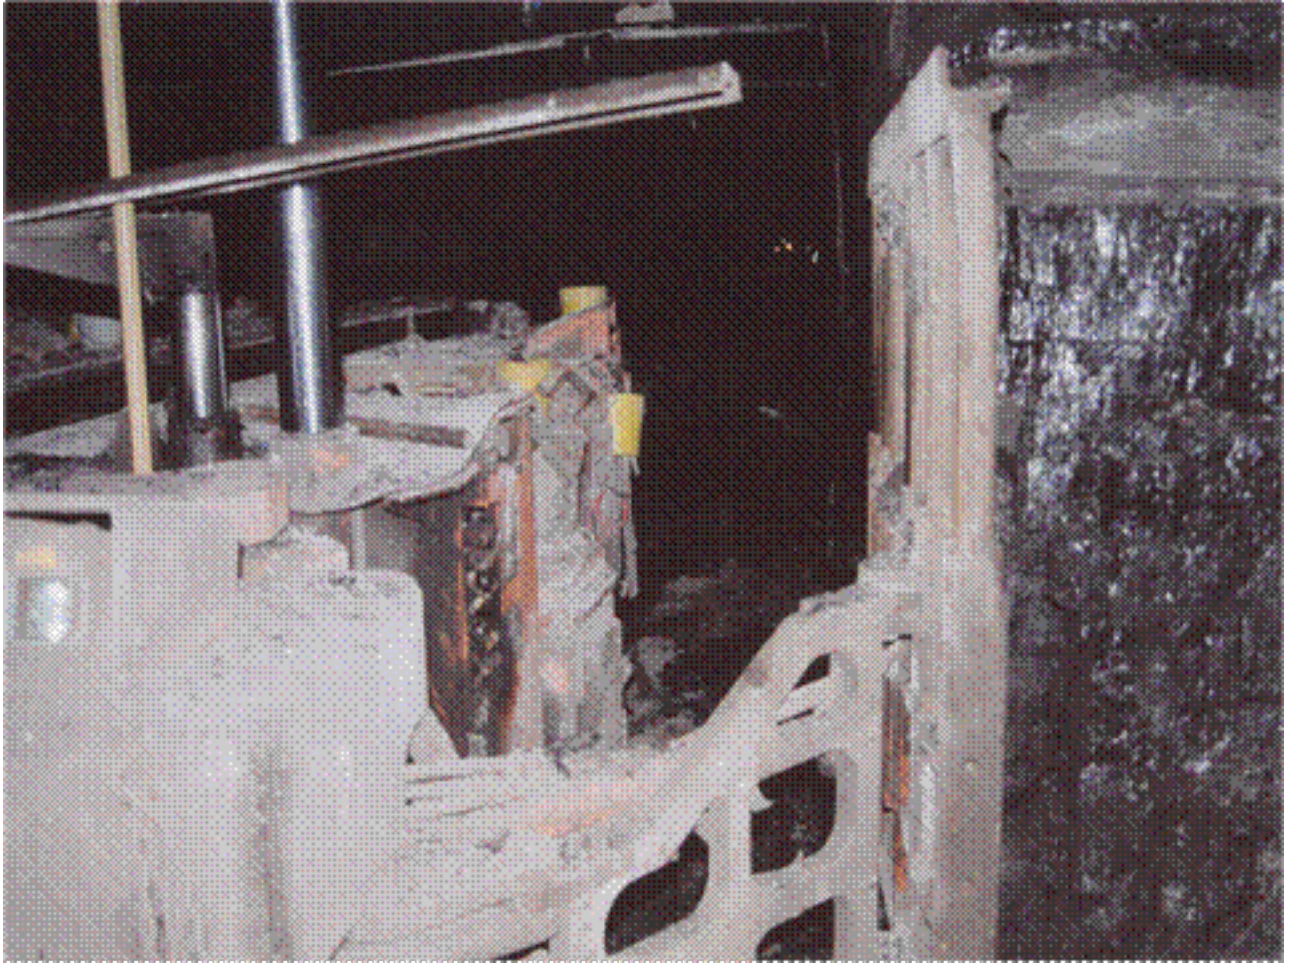
APPENDIX E _ Typical Rib Protector

The general practice of the integral roof bolter operators at the Loveridge #22 Mine was to stand towards the rear of the machine, outside the protection of the rib protector (see photo of rib protector in Appendix E) while the continuous miner was cutting the roof for an overcast. They chose to stand at this location so they would not be struck by flying rock and debris.

The continuous mining machine was a radio remote controlled Sandvik MB450 (formerly or commonly know as a Voest Alpine or ABM 14) with fixed integral roof bolting equipment mounted on each side. The integral bolting stations are approximately 11 feet 9 inches from the tip of the cutting drum and 13 ½ feet from the rear of the machine. The machine was equipped with Joy specified rib protectors. The rib protection extends approximately 45 inches outby from the drill head location.

Corrective Action: Rib drills were retrofitted to the continuous mining machine to install rib bolts as mining advanced.
