REPORT OF INVESTIGATION

Fatal Powered Haulage Accident  
August 31, 2010

Dewey's Super Transport, Inc. (Q254)  
Spencer, Indiana

Freelandville Underground Mine  
Triad Underground Mining, LLC  
Edwardsport, Knox, Indiana  
ID # 12-02316

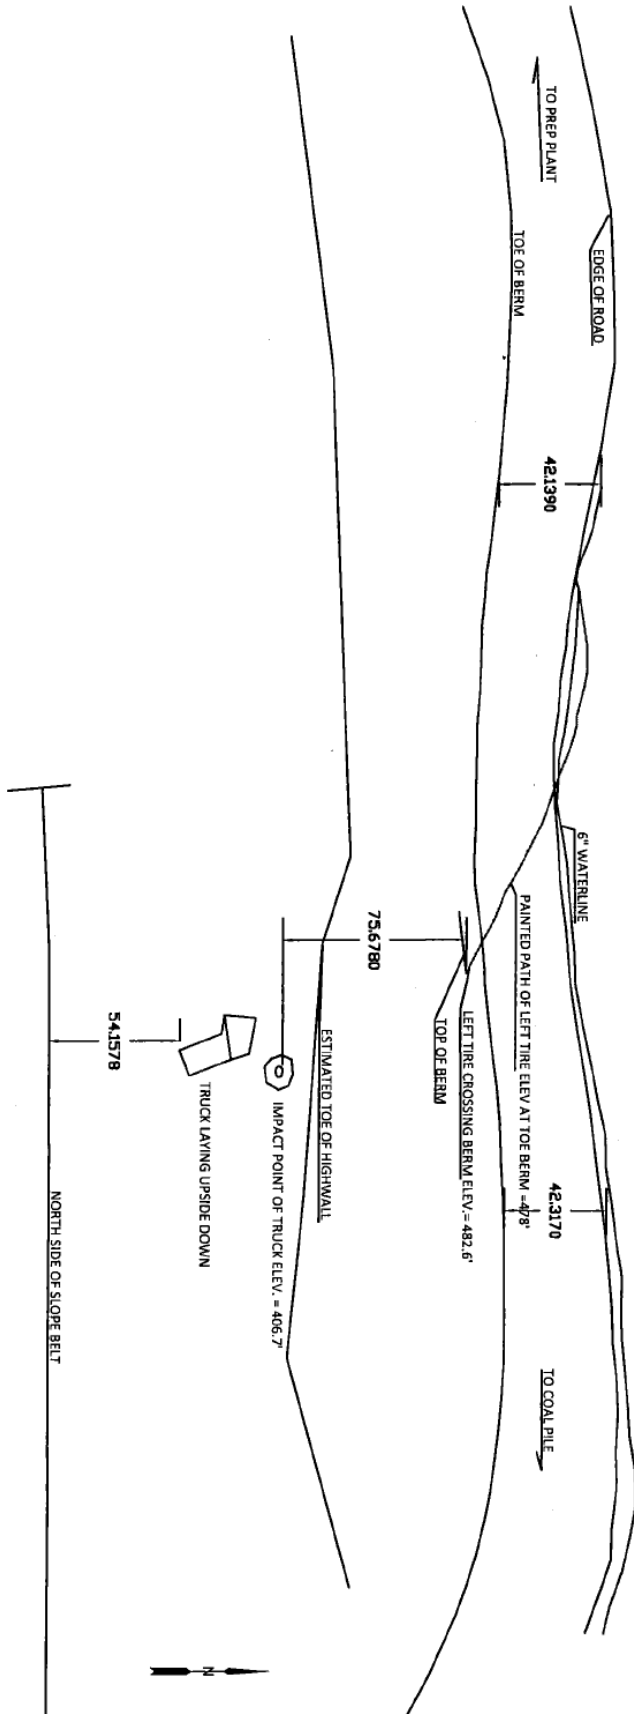
# ACCIDENT SCENE SKETCH

The operator lost control of the vehicle, striking the left embankment and then veered across the haulage road, traveling over the berm on the opposite side. The vehicle continued over the highwall landing in the pit 72-feet below. The accident occurred because the operator failed to maintain full control of the Volvo A40D Articulating Truck while in motion. In addition, the operator of the truck was not trained adequately to control the truck when in motion.

*Corrective Action:* All employees of Dewey's Super Transport, Inc. were required to be retrained on the safe operation of the Volvo A40D Articulating Trucks. The retraining included special emphasis on control of the truck when in motion.
