REPORT OF INVESTIGATION

Fatal Fall of Roof Accident
October 11, 2010

Kingston No. 1
Kingston Mining, Inc.
Scarbro, Fayette County, West Virginia
ID No. 46-08625

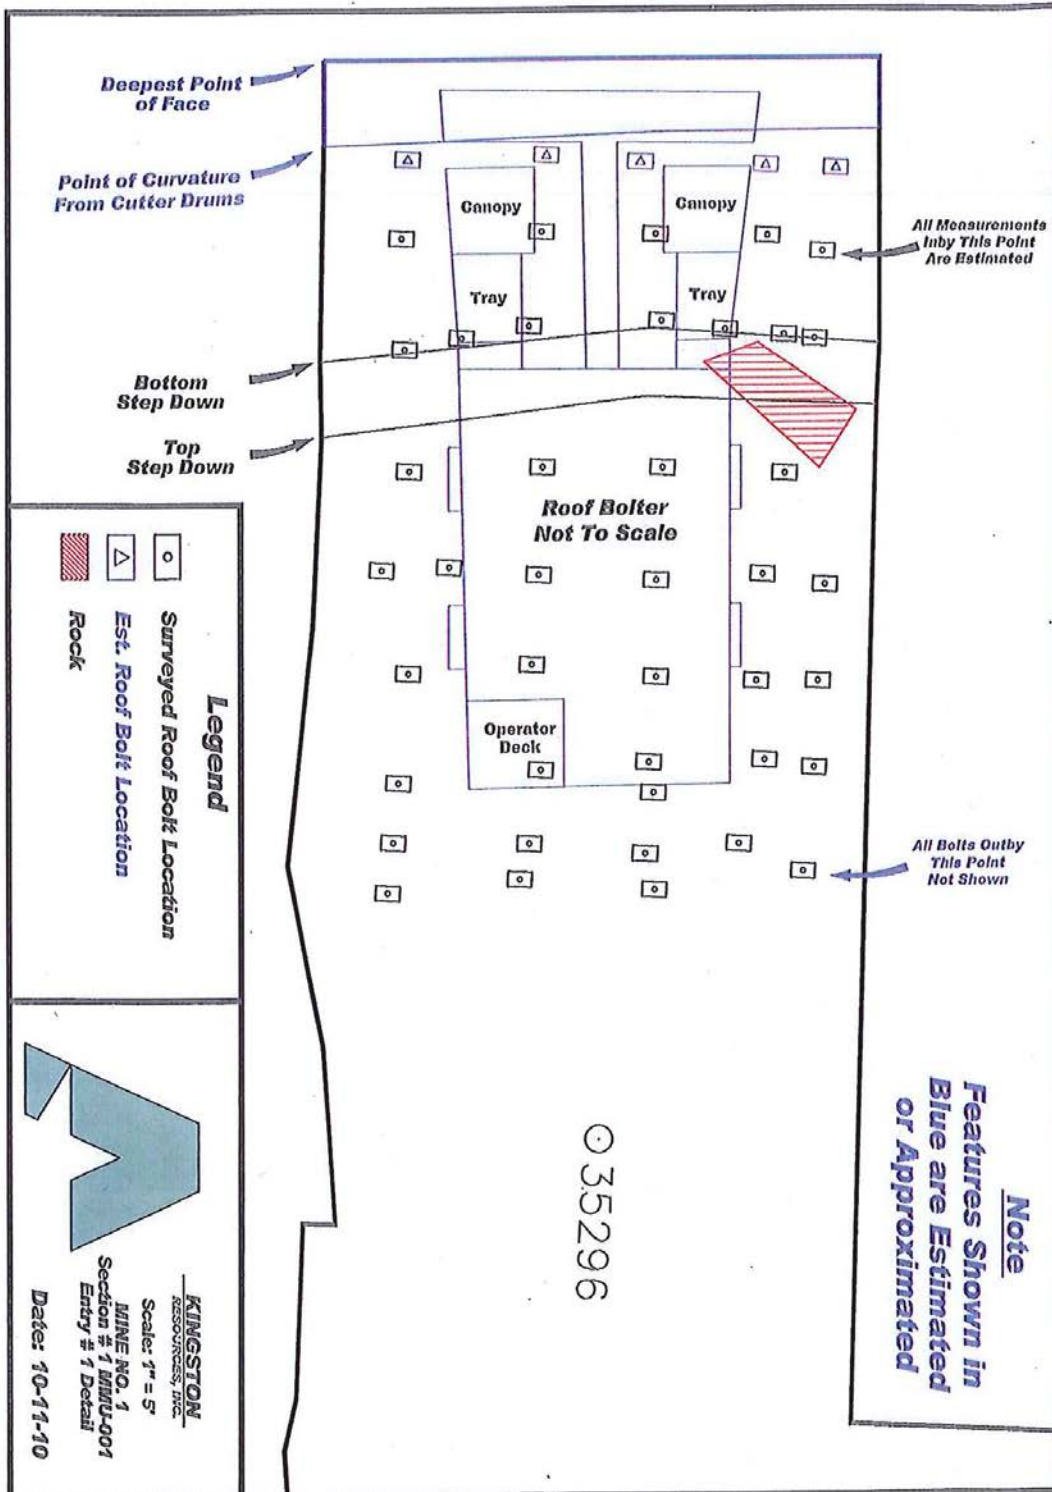
MINE NO. 1
Section # 1 MMU-001
Entry # 1 Detail

The initial 15 foot portion of the cut was mined during the evening shift on Friday, October 8, 2010. Draw rock fell in the cut over the weekend, leaving a height of 8 feet, 8 inches in the center. The continuation of the cut included cleaning up the draw rock and extracting an additional 10 feet. In mining the last 10 feet of the cut, the return to normal seam height created a brow across the entry (See Sketches of Accident Scene in Appendix E).

Roof conditions in the No. 1 entry were caused by a difference in mining height, resulting from a fall of draw rock and then a return to normal mining height. The difference in the mining height produced an area of transition resulting in a vertical rock face 30 inches in height.

The resulting accident occurred because the operator failed to identify hazards created by mining an extended cut in adverse roof conditions and improperly supported the roof in an area that contained adverse roof. Three roof bolts were spaced wide due to the angle of the brow, measuring distances from 56 ½ inches wide, to 58 inches wide.

Corrective Actions: Strapping, screening, and additional roof bolts were installed in the affected area. Requirements for the installation of straps, screening, and additional roof bolts, when adverse roof conditions are encountered, was included in a revision to the mine operator's Approved Roof Control Plan. The operator also upgraded the roof control plan to require that all cuts be roof bolted within 24 hours.

Corrective Actions: The operator has conducted and documented safety meetings with each shift, outlining the requirements for extended cuts, listed in the approved roof control plan. A provision was added to the roof control plan requiring that when abrupt vertical steps greater than 12 inches occur, the mine roof will be sloped or tapered from the upper horizon to the lower horizon to facilitate roof bolt installation in those areas.

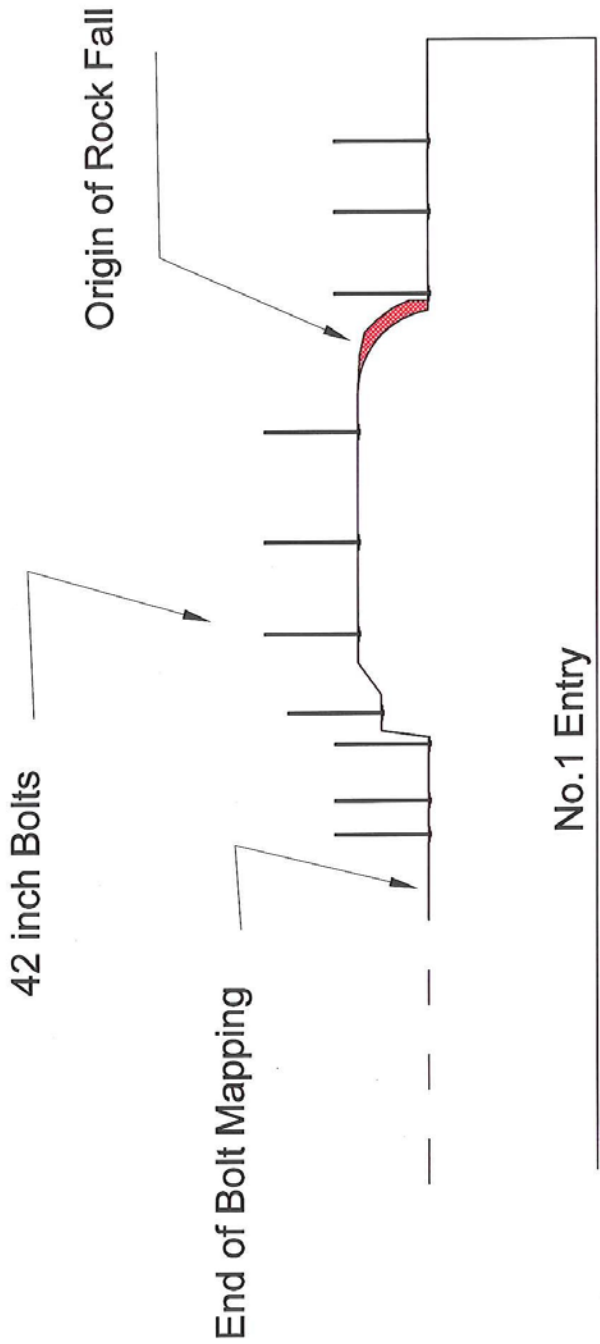
Kinston Resources, Inc.
Mine No. 1
MSHA ID No. 46-08625
Rock Fall Fatal Accident
October 11, 2010

The accident occurred in the No. 1 entry, in by Survey Spad No. 35282, on the 001-MMU working section. Dimensions in the area of the accident measured 8 feet, 8 inches in height in the center of the cut, tapering down in the face area to a height of 6 feet. The width of the entry was 19 feet, 6 inches at the center of the cut. The roof bolting machine had a 60-inch walkway on the side where the rock fell.
