REPORT OF INVESTIGATION

Powered Haulage Fatality
October 27, 2010

River View Mine
River View Coal LLC
Waverly, Union County, Kentucky
ID No. 15-19374

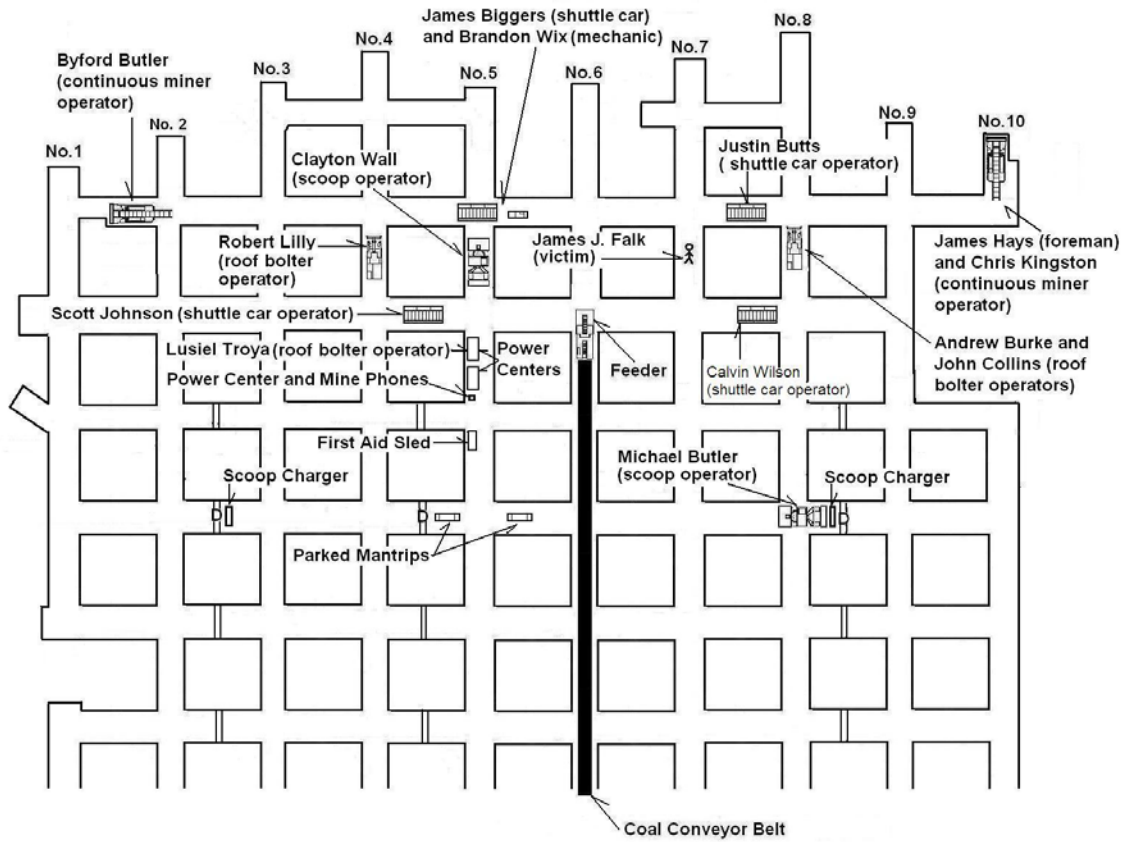
Exhibit 1

Calvin Wilson, Right Side Shuttle car Operator, was leaving the feeder and observed Falk in the No. 7 Entry on the left side near the rib (location described from Wilson's view point, looking inby), making a repair to the check curtain. Falk had raised the curtain and made visual contact with Wilson as he passed by, traveling to the No. 10 Face. At this time Falk was on the inby side of the curtain with his back toward the last

No. 6 Working Section - No. 11 seam
Location of miners prior to accident

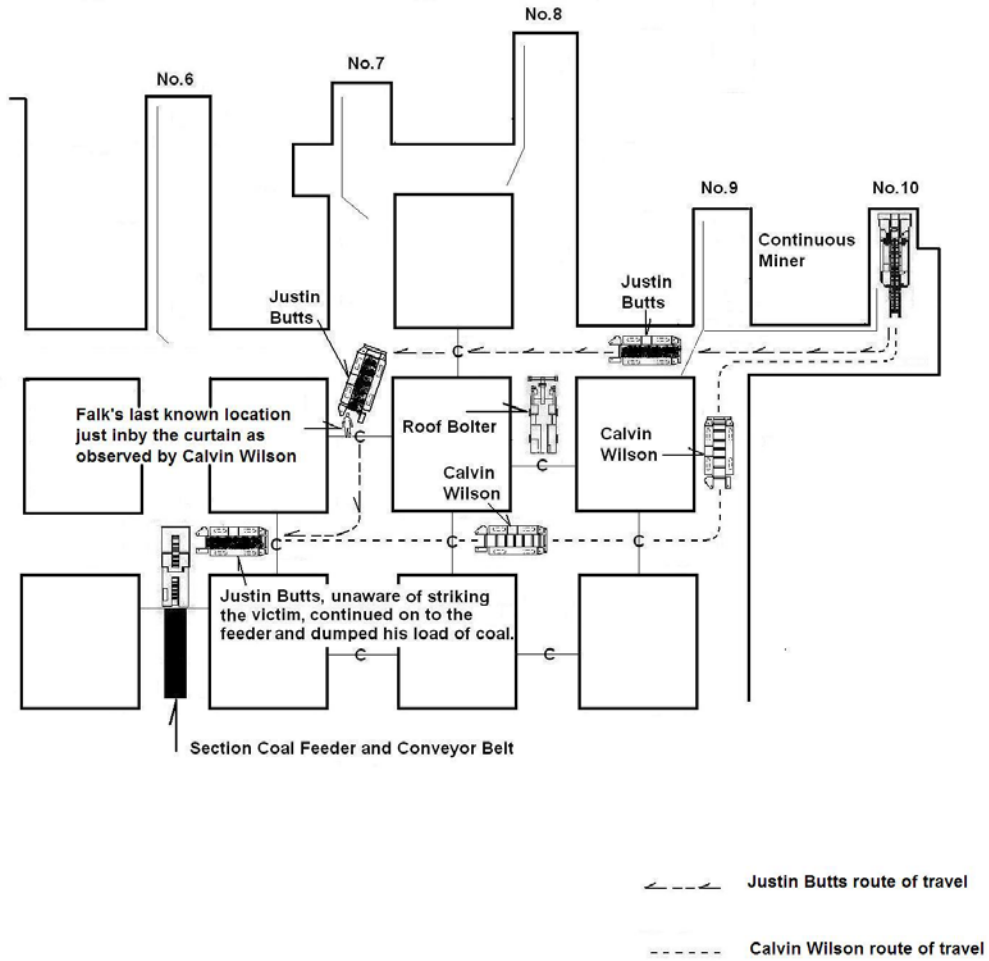
APPENDIX B (cont.)
Exhibit 2

The accident site is located in the No. 7 Entry, approximately 36 feet outby Spad (survey station) 30+40 (Crosscut 38) and approximately 43 feet inby the No. 6 Section belt feeder (set in No. 6 Entry, Crosscut 37).

The No. 6 Working Section - 11 Seam
Accident Scene

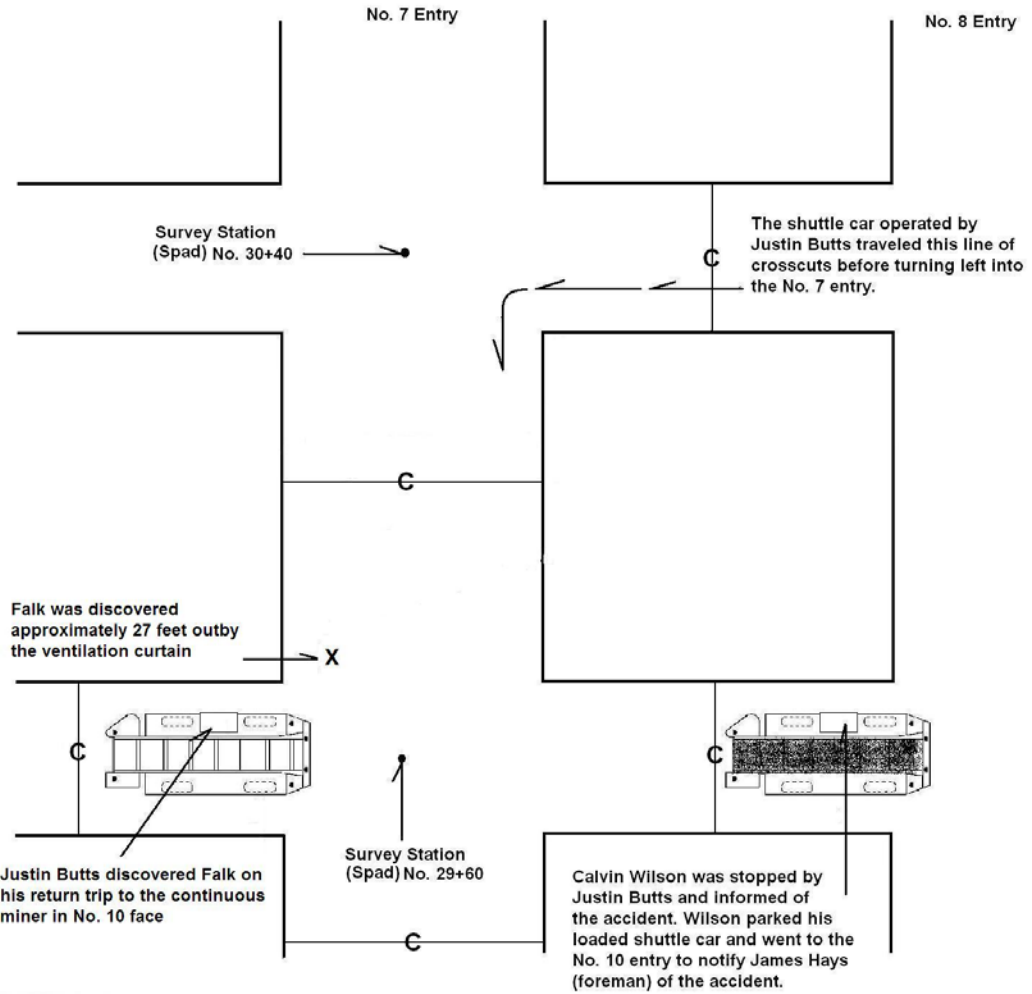
APPENDIX B (cont.)
Exhibit 3

The No. 6 Working Section - 11 seam
Post Accident Scene

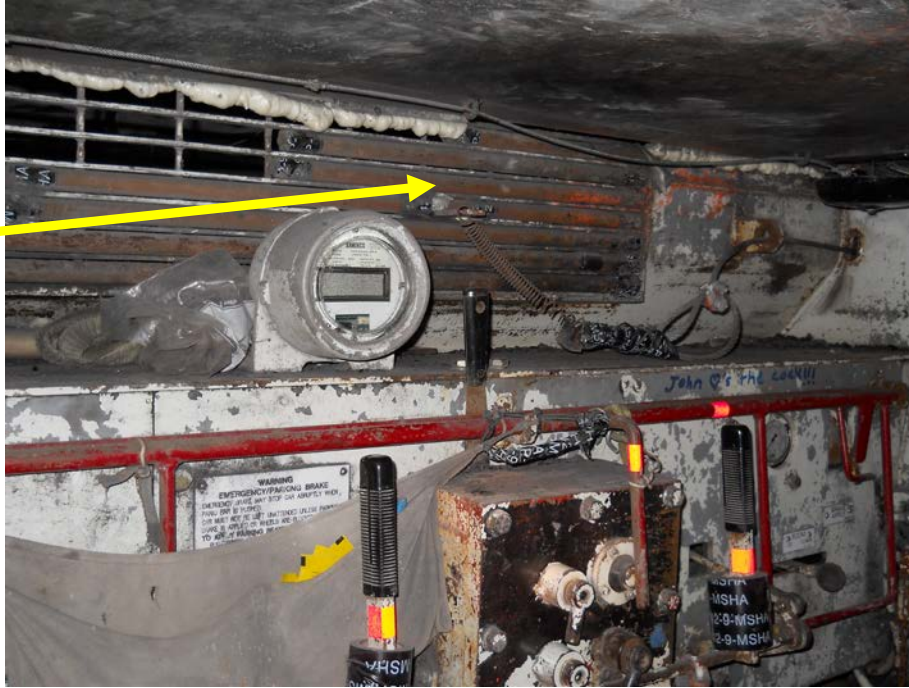
APPENDIX C
Exhibit 1
(Car involved in accident CO# 1109)

The shuttle car is typically loaded with a heaped load of coal to within 3 to 4 inches of the mine roof. The mining height in the No. 11 seam is approximately 60 to 68 inches. The operator's compartment was originally equipped with 8 ¼ inch x 48 inch bar grating with 1 inch x 4 inch slots positioned in the side board at the operator's compartment to allow visibility. The operator's compartment had been altered in the following manner: The bar grating had been partially blocked by seven pieces of roof bolting drill steel, ranging in lengths of 13 inches to 34 ½ inches, to prevent coal from spilling into the operator's compartment. Also wooden boards and a metal mounting bracket for the Matrix tracking system were installed and/or placed in the operator's field of view when traveling toward the ratio feeder. Testing showed that a person standing at the dump end of the loaded shuttle car, where the victim was struck, was not visible to the operator. The car operator's field of view for the original design of the shuttle car when loaded is limited. The results of the visibility study conducted by MSHA Technical Support in conjunction with OMSL and CMI Gardner reveal that the alterations further restrict the car operator's field of view from that of the original design (See Appendix C, Exhibits 1, 2 and 3).

Root Cause: Alterations made to the cab compartment impaired the shuttle car operator's vision, when traveling toward the dumping point while the shuttle car was loaded.

A 104(a) Citation, No. 8502171, was issued for a violation of 30 CFR § 75.1725(a). The Shuttle Car, Serial No. 1109, was not being maintained in a safe operating condition. The operator's compartment was altered by metal tubing placed in the metal grating cover of the window area and wooden boards were placed between the canopy and the machines frame which further restricted or limited the operator's field of vision from that of the manufacturer's original design.

Cab Modifications -
bolter steels placed in
the grating to prevent
coal from entering
operator's cab

Corrective Action: The operator restored all shuttle cars at the River View Mine to the original manufacturer's design.

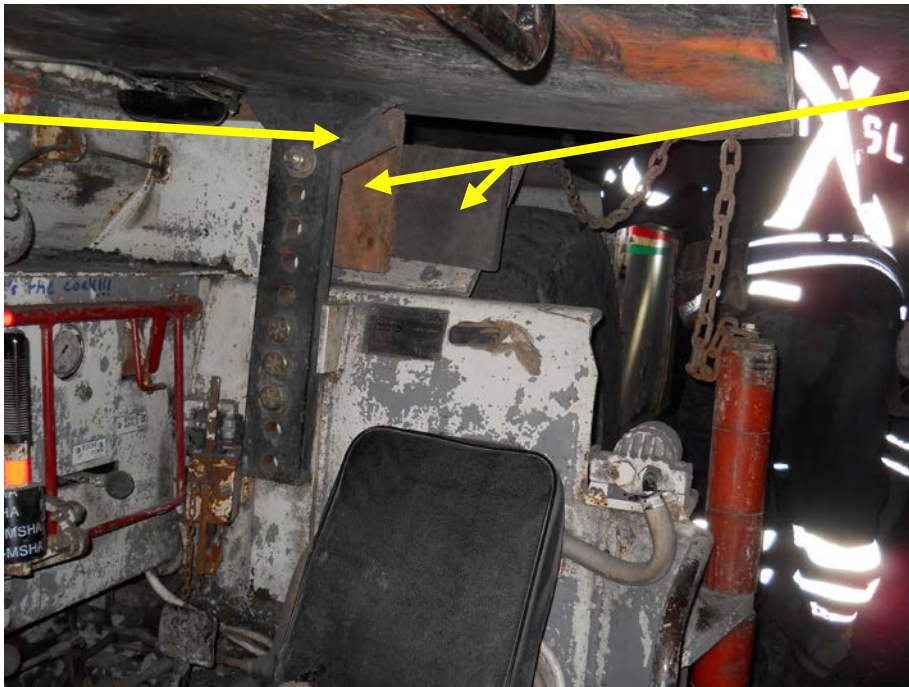
Metal mounting bracket
for Matrix Tracking
System

Wooden boards to
prevent coal spillage
into operator's
compartment

(Operator's Visibility traveling toward dump point)

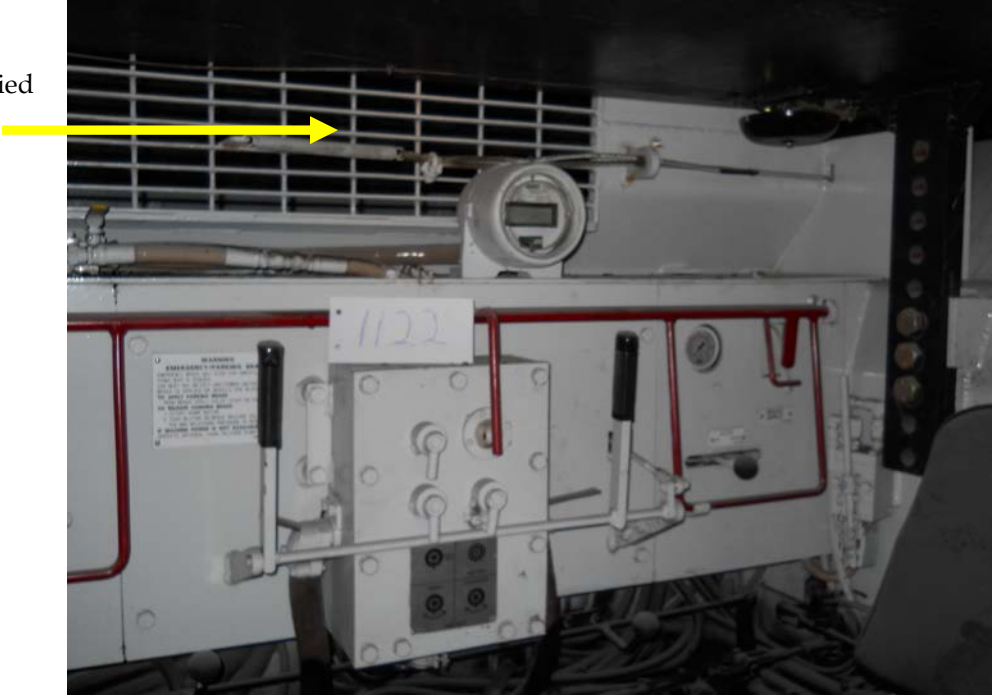
APPENDIX C (cont.)
Exhibit 2
(Original car design as delivered)

Grating is not modified

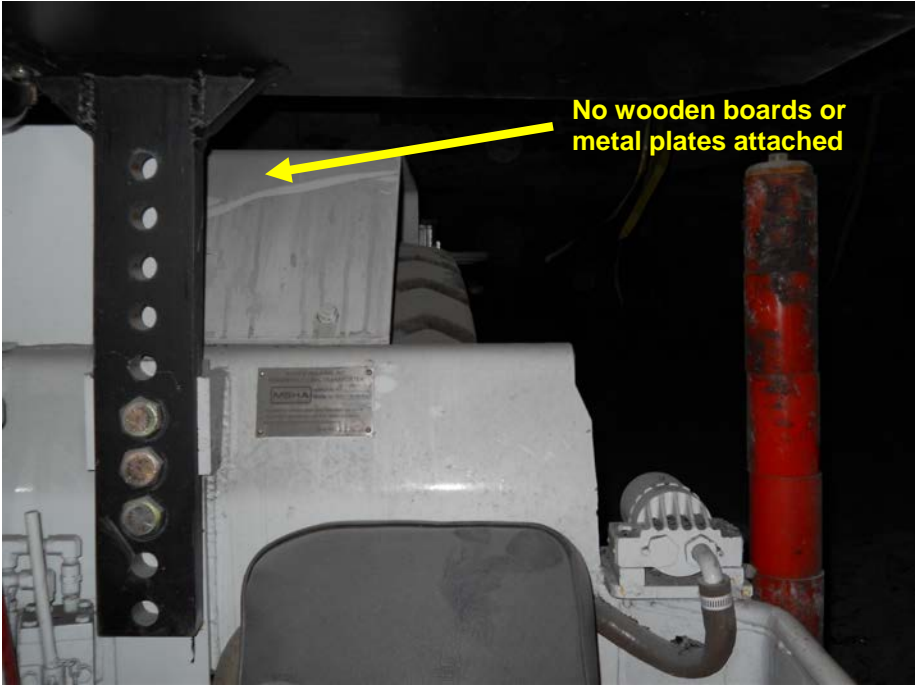
No wooden boards or metal plates attached

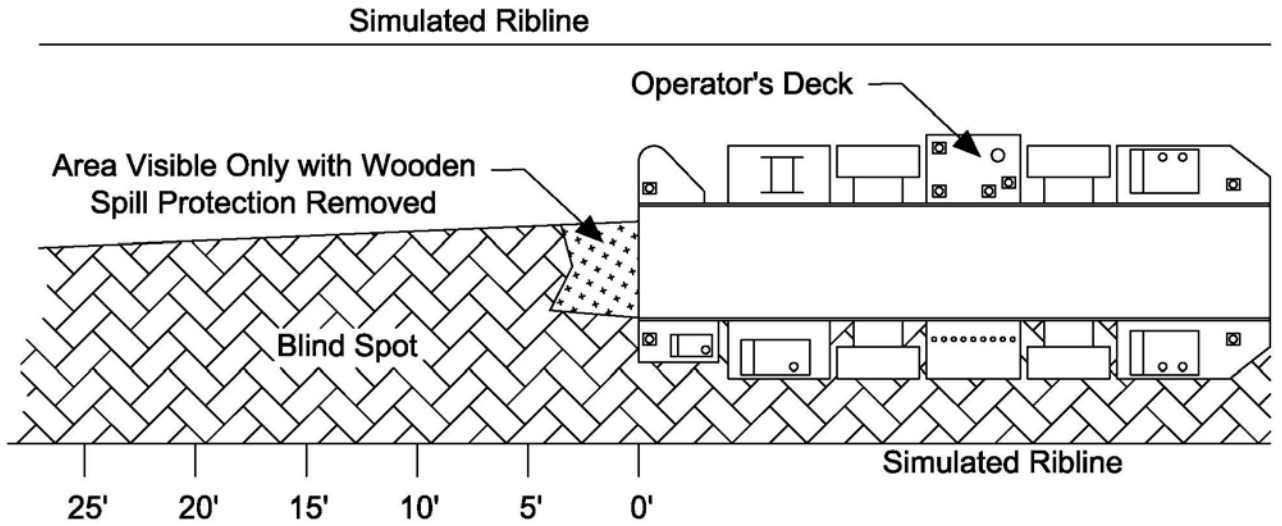
APPENDIX C (cont.)
Exhibit 3

RIVER VIEW MINE
MSHA ID: 15-19374
VISIBILITY SURVEY
Auxier Coal Transporter - SN 1109
Simulated Load
Target: 63 Inches from Bottom
