**REPORT OF INVESTIGATION
(Surface Coal Mine)**

**Fatal Accident (Power Haulage)
November 23, 2010**

**Rex Strip # 1
Rex Coal Company, Inc.
Grays Knob, Harlan County, Kentucky
MSHA I.D. No. 15-19069**

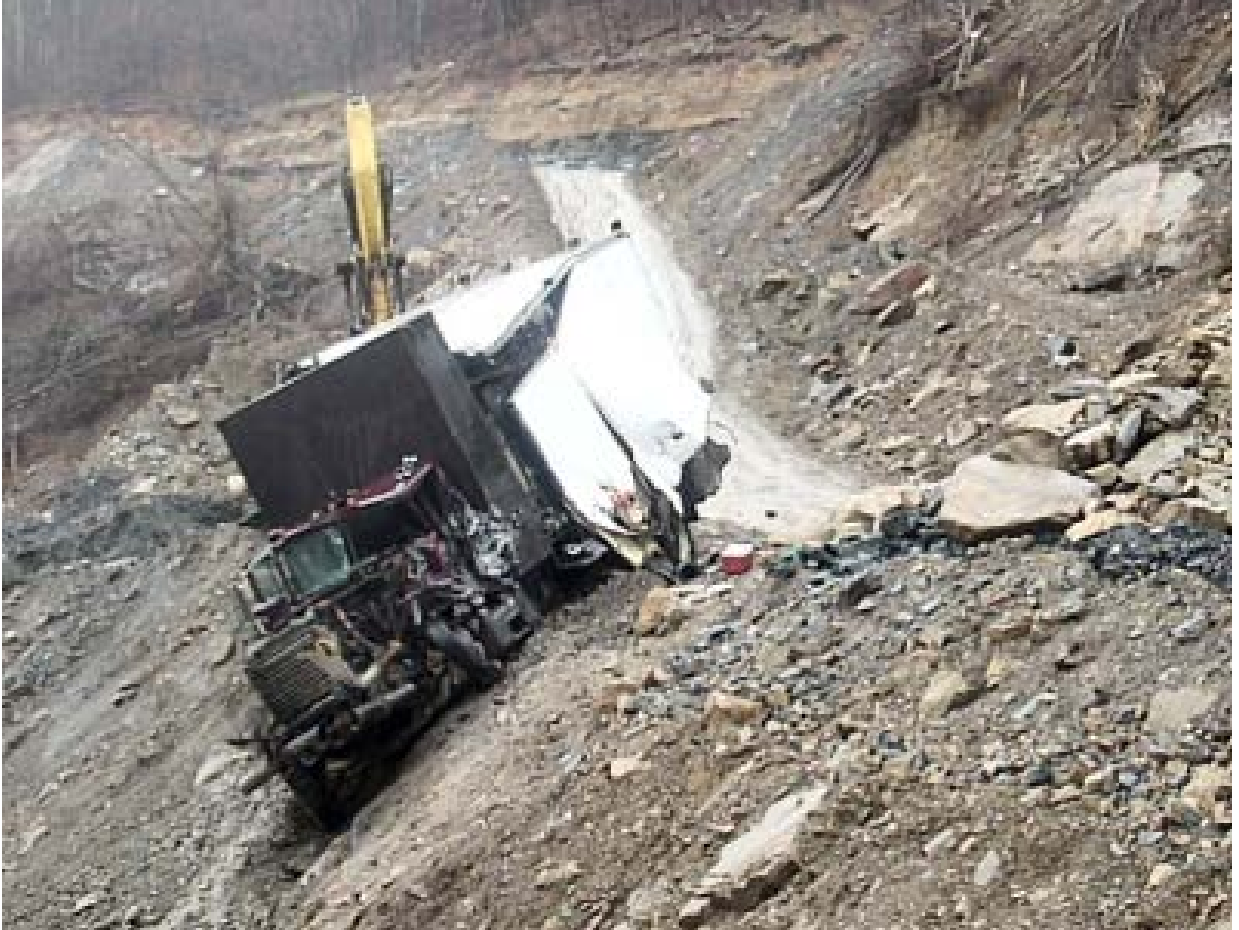
PHOTOGRAPH OF ACCIDENT SCENE

At approximately 12:15 a.m. on November 23, 2010, Rhett Lee Mosley, a 32-year old lube truck operator with 6 years of mining experience, was killed on the Rex Coal Company Inc., Rex Strip # 1, Lowsplint coal seam pit access roadway. The accident occurred on a section of roadway used to provide access for mobile equipment traveling between the Highsplint and Lowsplint coal seam work areas. Mosley lost control of the DM-690-SX Mack tandem axle lube truck while descending the roadway. The truck encountered the outer roadway barrier near the bottom of the roadway, traveled approximately 77 more feet and overturned on its left side, onto back dumped spoil material. Mosley apparently either jumped or was thrown from the truck and was found lying under the service bed of the truck.

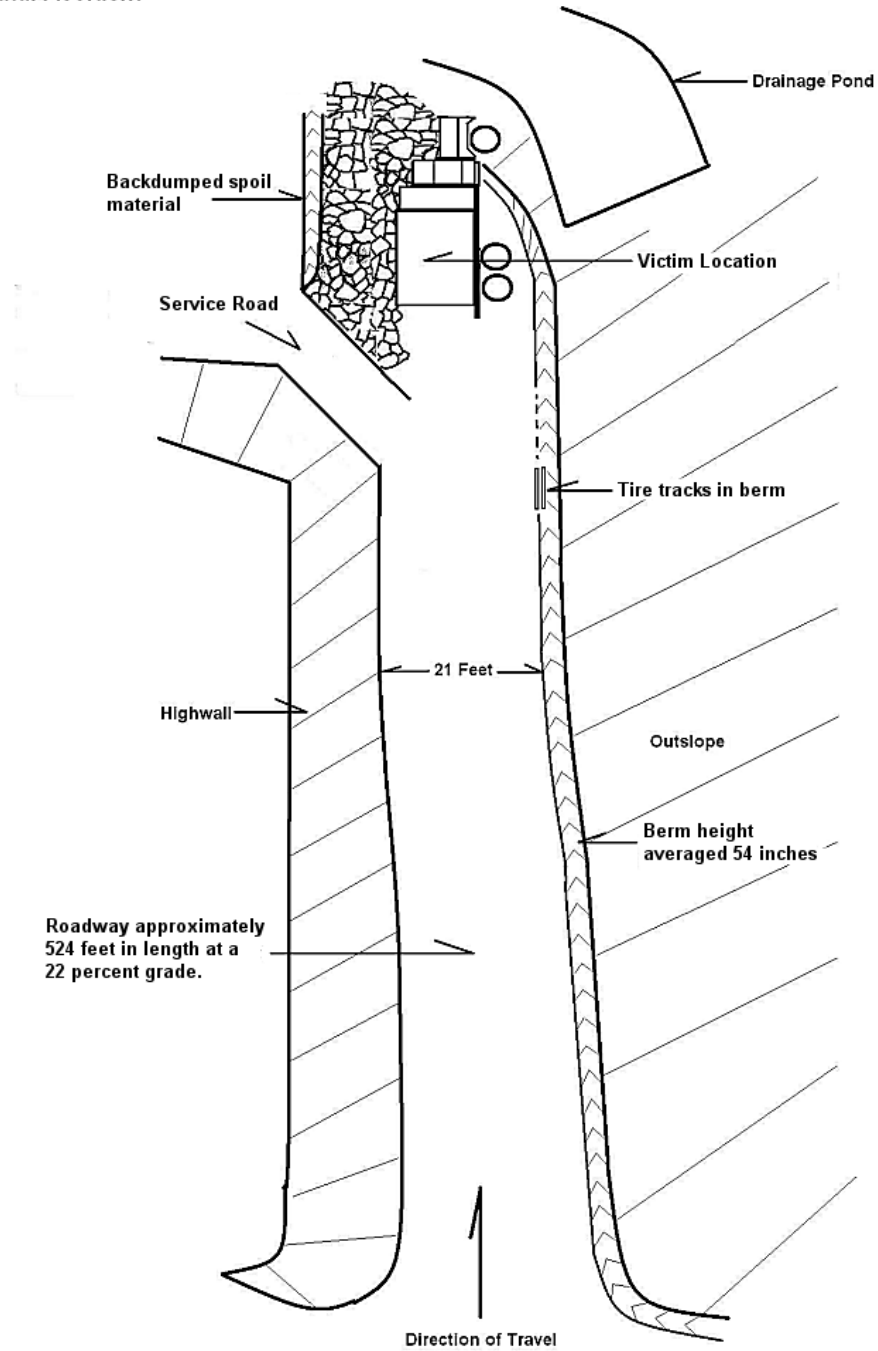
Sketch of Accident Scene

The pit road from the Highsplint to the Lowsplint work area was relatively straight throughout the entire descent. It was approximately 524 feet in length, 21 feet wide, and had an overall grade of approximately 22 percent. The outer edge barrier (berm) averaged 54 inches in height. The road was constructed of compacted spoil material and road conditions were dry at the time of the accident.
