REPORT OF INVESTIGATION

Fatal Falling Material Accident  
October 7, 2011

Owlco Energy LLC  
Mine No. 1  
Partridge, Letcher County, Kentucky  
ID No. 15-18870

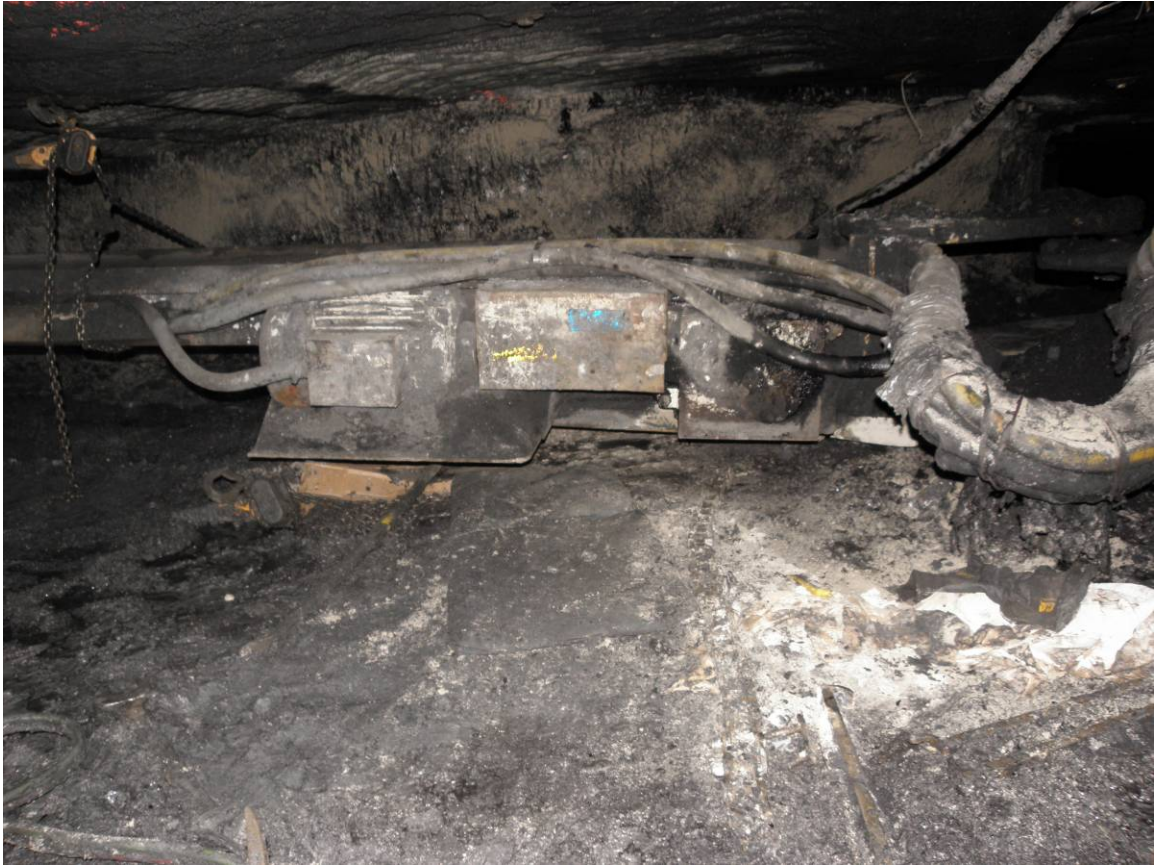
Photo of Accident Site

At approximately 2:00 a.m. on Friday, October 7, 2011, a fatal falling material accident occurred at the Owlco Energy LLC, Mine No.1. The accident occurred when a piece of mined roof rock used to support the raised Jeffrey Model 506 mobile bridge conveyor became dislodged, causing the bridge conveyor to fall and strike the victim. As a result, the victim was pinned between the mobile bridge conveyor and the mine floor, causing fatal injuries.

The accident occurred because of mine management's failure to ensure that raised equipment was blocked properly before allowing miners to work beneath it and miners were not trained in proper blocking techniques.

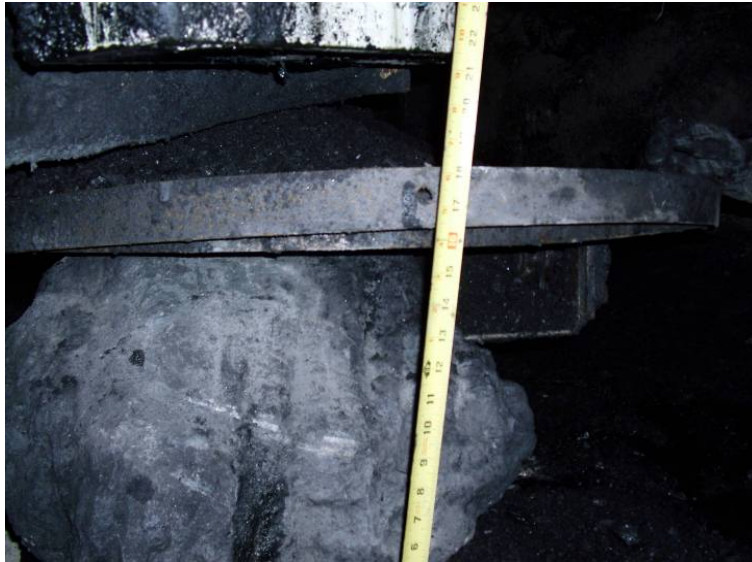
**Figure 1- Depicting rock under receiving hopper**

Prior to the accident, a rock was placed under the receiving hopper (referred to as the soup bowl) under the bridge conveyor, which was connected to the bridge carrier boom. This rock was used as blocking while repairs were made to the chain conveyor system. It could not be determined how or why the rock slipped or fell. The rock was placed in a vertical position as shown in Figure 1 below. The rock height of 17 inches and width of 24 inches is depicted.

*Corrective Action:* The operator has developed and implemented a written procedure for the proper blocking of equipment to be repaired. A minimum of two crib blocks will be placed under any raised equipment before repairs are made. If the height of the equipment requires additional blocking, the courses will be alternated to ensure stability. All blocking will be set on a firm, stable surface. The blocking will be checked for stability before any person begins work by lowering the machine in question until it is not supported by any hydraulic circuit but fully by the blocking material. The operator has trained the miners in this new procedure and results of the training were documented. The training for proper blocking was incorporated into the mine operator's approved training plan.

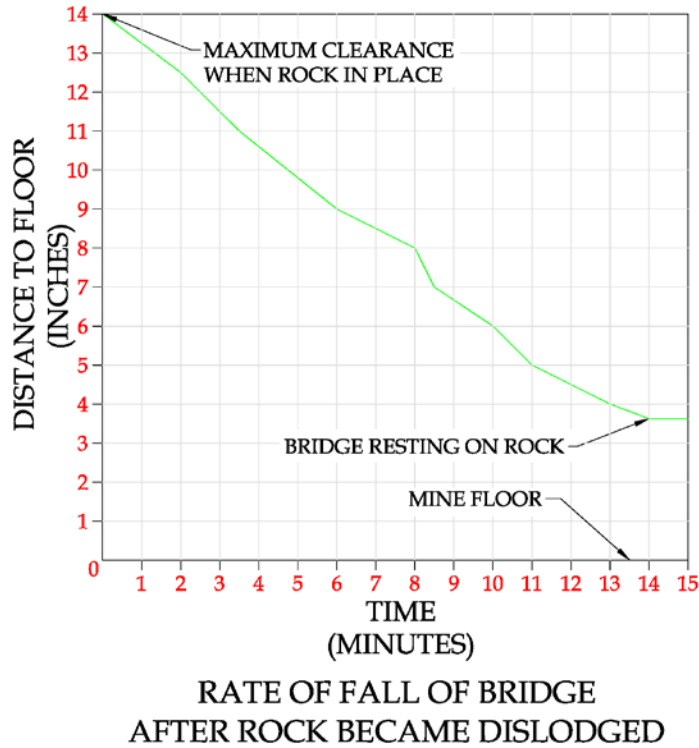
**Figure 2 - Graph of boom drop rate**

Tests were conducted by the accident investigation team to quantify the rate at which the conveyor system collapsed to the floor. The boom from the bridge carrier was lifted up while connected to the bridge conveyor. The machine had not operated for approximately 12 hours. This left the hydraulic fluid temperature cold, as was the case at the time of the accident. The tests were conducted twice on October 7 and again on October 8. In each of the tests, failure of the boom to lift, as reported when the accident occurred, could not be reproduced. Figure 2 below, illustrates the rate at which the weight of the boom compressed the single action boom jacks. The boom system came to rest on a 2-inch thick rock on the mine floor after 14 minutes.

The curve in Figure 2 shows the rate at which the boom dropped.

The boom jack was evaluated. It was able to raise and lower the boom while it was attached to the mobile carrier. Leakage around the bushing where the hydraulic hose goes into the boom jack on the operator side (right side) of the mobile bridge was observed when the boom was raised. There was no leakage observed when the boom came to rest on the ground. There was no leakage observed on the left side boom when the boom was raised or lowered to rest. The hydraulic oil level was checked and found to be within the manufacturer's recommended range.
