Fatalgrams and Fatal Reports

Fatality #5 - May 14, 2011 Machinery - Surface - West Virginia Apogee Coal Company LLC - Guyan

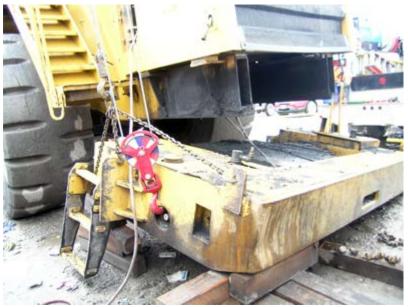
COAL MINE FATALITY - On Saturday, May 14, 2011, a 37-year old mechanic with 14 years of mining experience and 1½ years of experience as a mechanic, was killed while removing a counter weight fuel tank assembly from a front-end loader. He was positioned beneath the front-end loader when he removed 14 of the 16 mounting bolts that secure the counter weight. When the victim attempted to remove the next to last bolt, the remaining two bolts failed allowing the 11,685 pound counterweight to fall on him. The counter weight had not been blocked to prevent it from falling.

- Install blocking materials before removing mounting bolts from machinery components which can fall during disassembly.
- Follow known safe maintenance procedures.
- Follow the equipment manufacturers recommended maintenance procedures when performing repairs to machinery.
- Train new mechanics in the health and safety aspects and safe work procedures related to their assigned tasks.
