Fatality #13 - August 8, 2011
Machinery - Underground - Ohio
American Energy Corporation - Century Mine

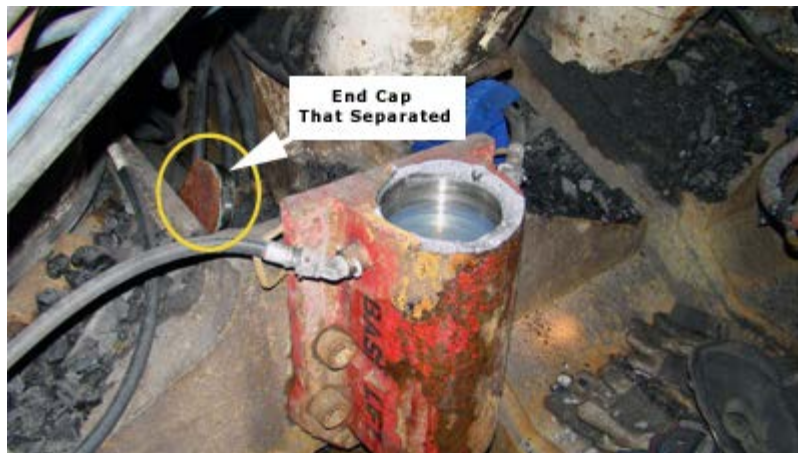
COAL MINE FATALITY - COAL MINE FATALITY - On Monday, August 8, 2011, a 41-year-old longwall mechanic with nine years of mining experience was killed when he was struck in the chest by a piece of metal from the top of a base lift jack mounted on a longwall shield. The jack catastrophically failed resulting in the end cap separating from the cylinder and striking the victim.

- Do not alter hydraulic circuits in a manner that could result in the trapping of pressurized hydraulic fluid.
- When isolating hydraulic components for repair, ensure that the hydraulic system has a means to bleed the pressure from the components being repaired.
- Evaluate potential energy sources before working in tight spaces. Click on the following link for more information: [MSHA - SLAM Risks the Smart Way - Safety and Health Outreach Program Home Page](#)
- Ensure re-built components meet original equipment manufacturer (OEM) specifications.
- Ensure miners are adequately trained in proper maintenance procedures and plan requirements.
- Examine and periodically inspect all hydraulic components for defects.
- Ensure the ratings of hydraulic components are compatible with their intended use.
